# UTILITY MAP REPORT

<b>PROJECT LOCATOR</b>	Ryan Bradbury
<b>DATE</b>	25/05/2026
<b>SITE ADDRESS</b>	15 Villa Street, Annerley
<b>CLIENT</b>	Insight Planning Development
<b>SITE CONTACT</b>	Anthony Colwell
<b>CLIENT EMAIL</b>	anthony@insightplandev.com.au
<b>CLIENT NUMBER</b>	0413 608 612

CCTV investigation on stormwater assets conflicting with scope of works.

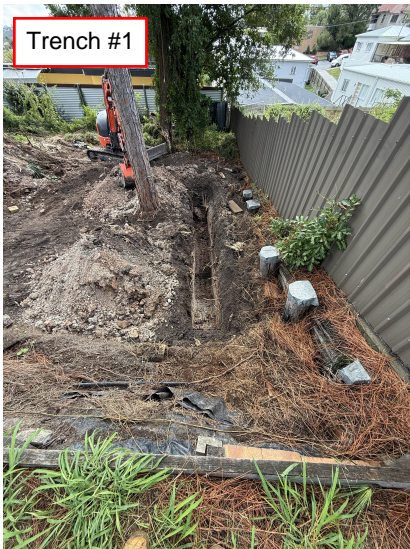
Trench #1  
Trench depth approximately 1.4m to 1.6m  
Offsets:  
8.65m from the north western boundary fence.  
1.65m from the retaining wall.  
Please see photos on the following page.

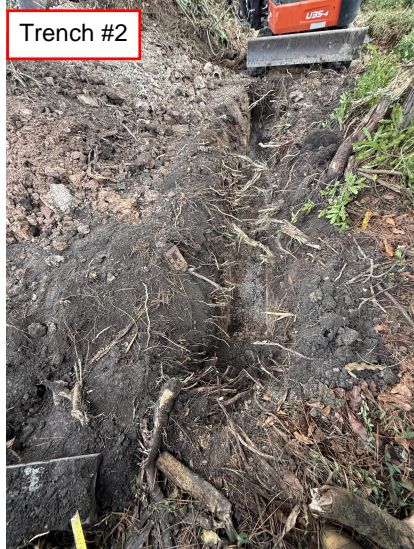
Trench #2  
Trench depth approximately 1.5m to 1.8m.  
Offsets:  
1.3m from the north eastern boundary fence.  
14.85 from the south western boundary fence.

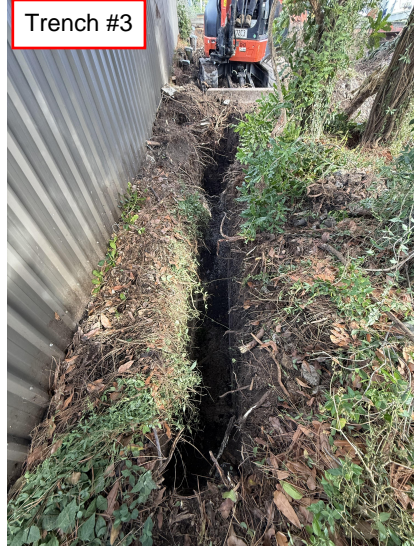
Trench #3  
Trench depth approximately 1.4m to 1.8m  
Offsets:  
1.3m from the north western boundary fence.  
8.5m from the retaining wall.

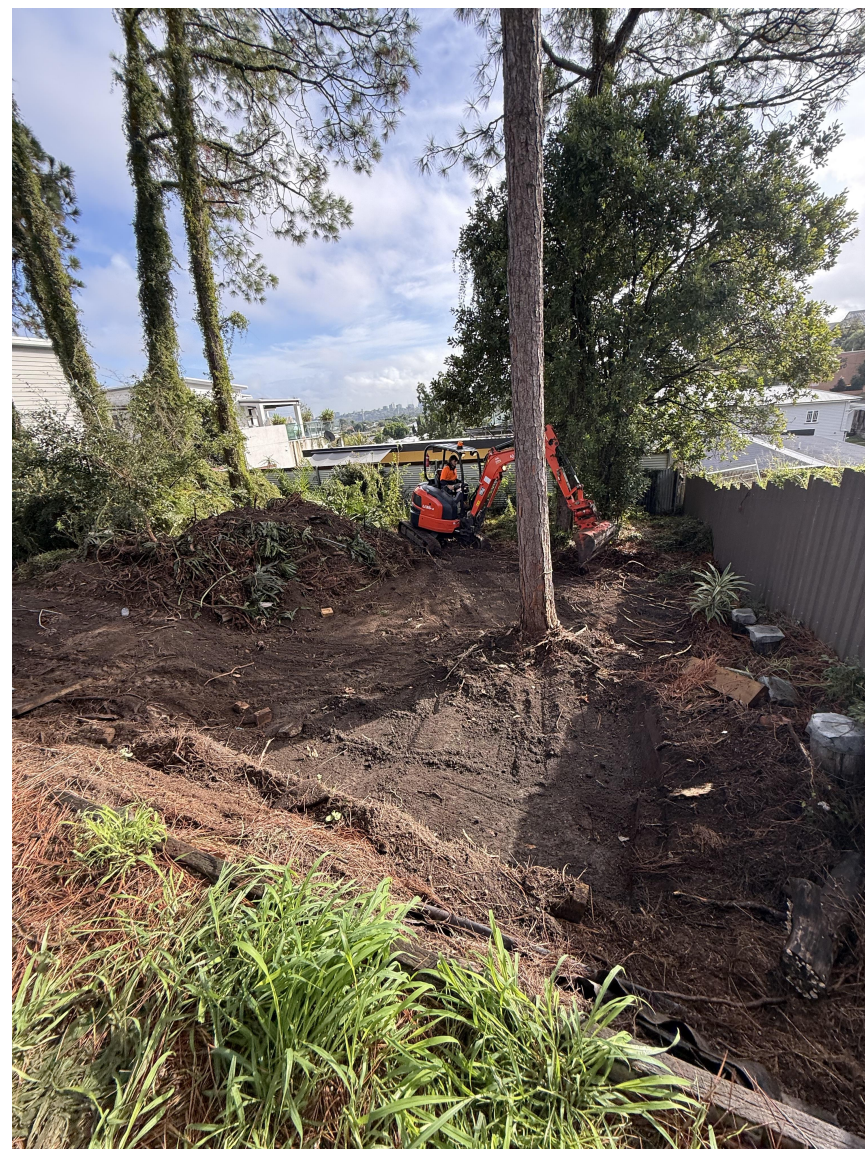
After today's investigations, it **appears possible** that the stormwater assets no longer exist.

This pit is not visible as may be built over or not existing.

Unable to find this pit due to the dense scrub and debris within the back yard.

Unable to access the pipe from this pit, as it drops into another chamber. The required pipe enters through the chamber wall, and attempts to navigate the crawler into the pipe were unsuccessful due to limited access. Please refer to the photo provided in the email.

I tried using a push camera to locate pit from Downpipe but was unsuccessful due to the mass amount of debris and silt within the piping.

HIGHLY RECOMMEND NON DESTRUCTIVE DIGGING SERVICES IN THIS AREA
