## Section Inspection - 2/04/2026 - NP237288

| Project name<br>2026_04_02_SW_JEFF_South Brisbane_CCTV28 | Contract No. | Coding Standard<br><b>WSA 2020</b> | Name of operator<br><b>Daniel Cornwell</b> | Job ID<br><b>01</b> |

| Address<br><b>Dorchester St</b> | US MH<br><b>01</b> | Total Length<br><b>0.00 m</b> |

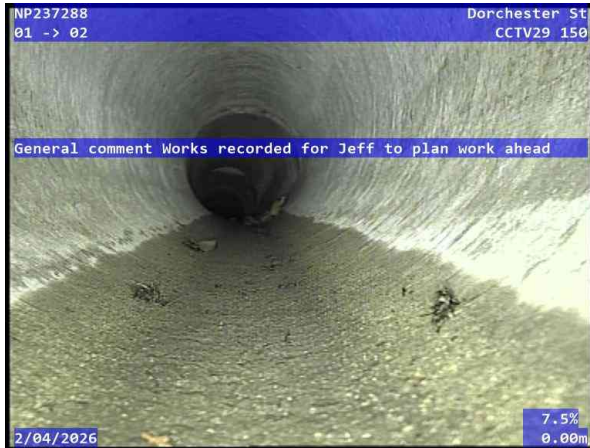
1, 00:00:00, 0.00  
General comment / Works recorded for Jeff to plan work ahead

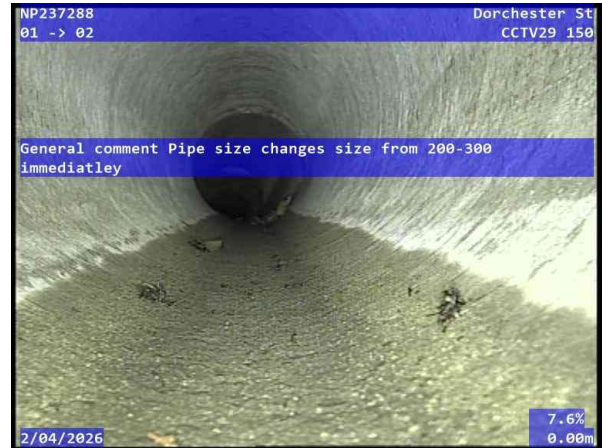
2, 00:00:17, 0.00  
General comment / Pipe size changes size from 200-300 immediatley

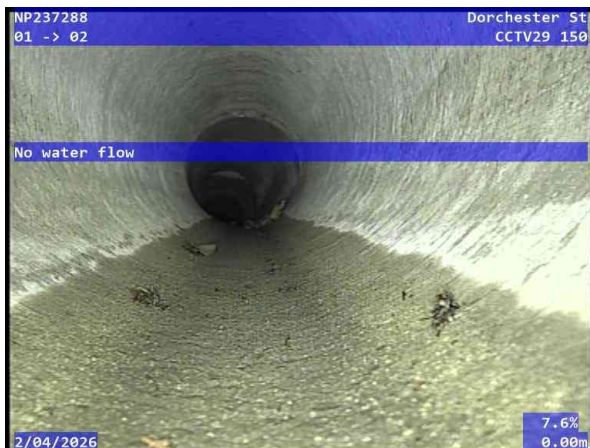
3, 00:00:21, 0.00  
No water flow

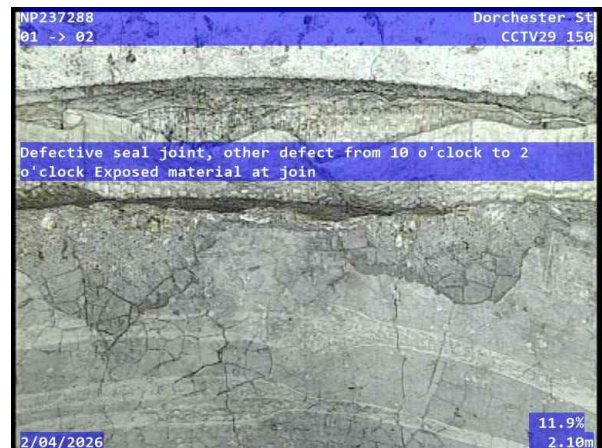
| 1:141 | m+ | Code | Observation Text | Grade |
|---|---|---|---|---|
| | 2.10 | JDSZ | Defective seal joint, other defect from 10 o'clock to 2 o'clock / Exposed material at join | |

4, 00:01:33, 2.10  
Defective seal joint, other defect from 10 o'clock to 2 o'clock / Exposed material at join

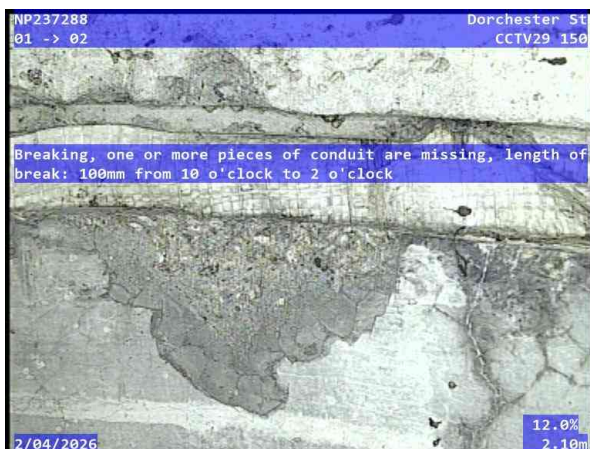
| 1:141 | m+ | Code | Observation Text | Grade |
|---|---|---|---|---|
| | 2.10 | BM | Breaking, one or more pieces of conduit are missing, length of break: 100mm from 10 o'clock to 2 o'clock | 3 |

5, 00:01:13, 2.10  
Breaking, one or more pieces of conduit are missing, length of break: 100mm from 10 o'clock to 2 o'clock

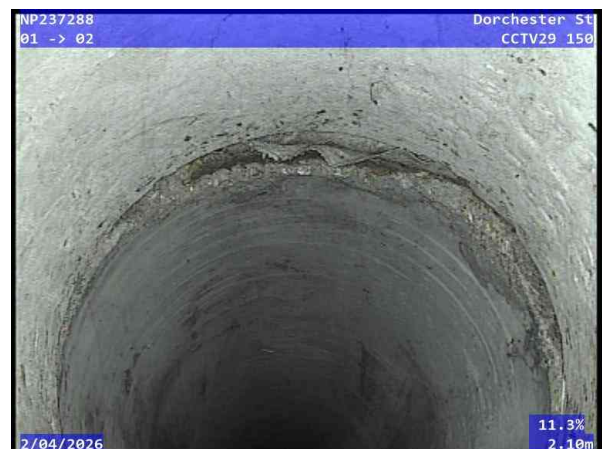
6, 00:01:13, 2.10  
Breaking, one or more pieces of conduit are missing, length of break: 100mm from 10 o'clock to 2 o'clock

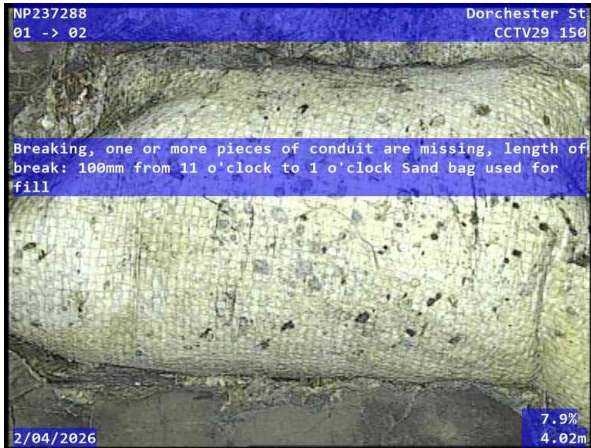
| 1:141 | m+ | Code | Observation Text | Grade |
|---|---|---|---|---|
| | 4.02 | BM | Breaking, one or more pieces of conduit are missing, length of break: 100mm from 11 o'clock to 1 o'clock / Sand bag used for fill | 3 |

7, 00:02:01, 4.02  
Breaking, one or more pieces of conduit are missing, length of break: 100mm from 11 o'clock to 1 o'clock / Sand bag used for

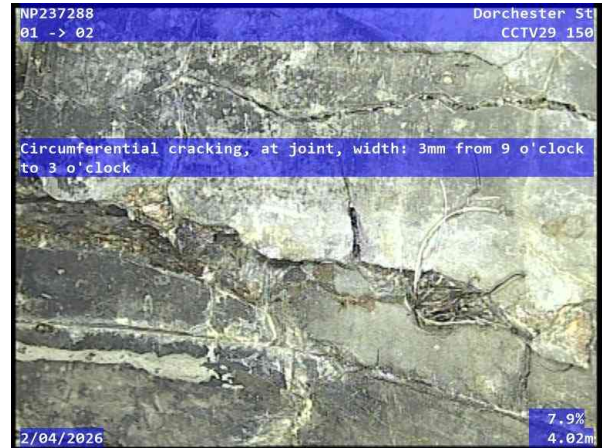
| 1:141 | m+ | Code | Observation Text | Grade |
|---|---|---|---|---|
| | 4.02 | CC | Circumferential cracking, at joint, width: 3mm from 9 o'clock to 3 o'clock | 3 |

8, 00:02:10, 4.02  
Circumferential cracking, at joint, width: 3mm from 9 o'clock to 3 o'clock

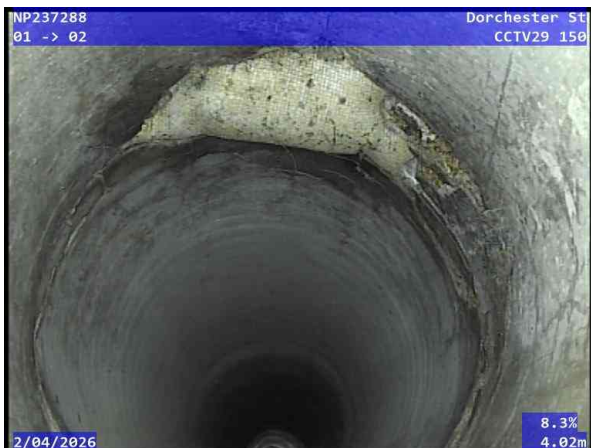
9, 00:02:10, 4.02  
Circumferential cracking, at joint, width: 3mm from 9 o'clock to 3 o'clock

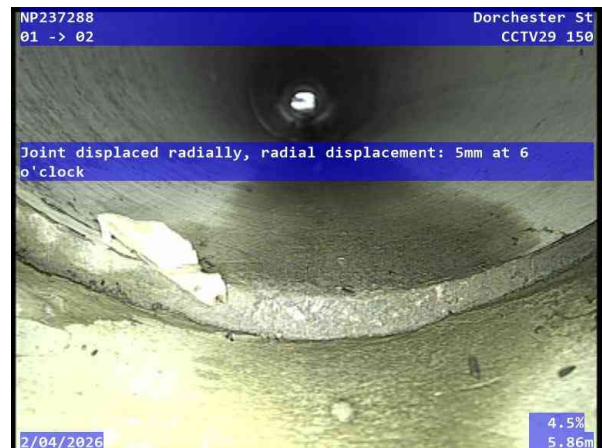
| 1:141 | m+ | Code | Observation Text | Grade |
|---|---|---|---|---|
| | 5.86 | JDR | Joint displaced radially, radial displacement: 5mm at 6 o'clock | 1 |

10, 00:03:28, 5.86  
Joint displaced radially, radial displacement: 5mm at 6 o'clock

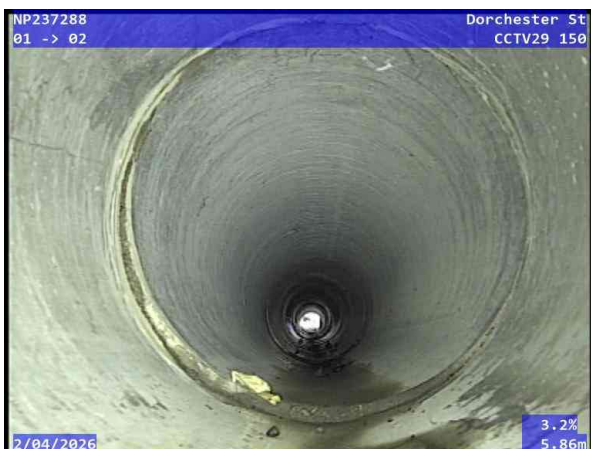
11, 00:03:28, 5.86  
Joint displaced radially, radial displacement: 5mm at 6 o'clock

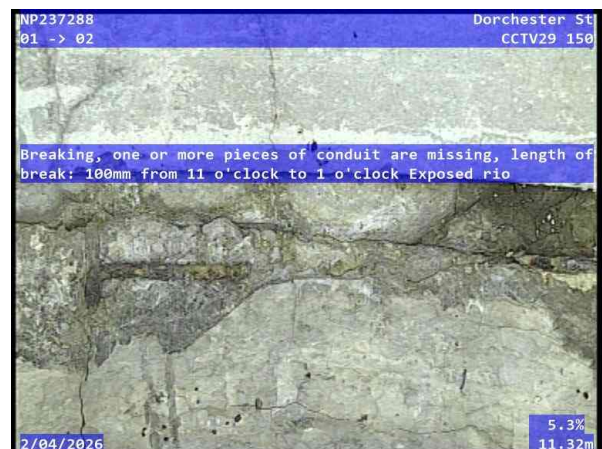
| 1:141 | m+ | Code | Observation Text | Grade |
|---|---|---|---|---|
| | 11.32 | BM | Breaking, one or more pieces of conduit are missing, length of break: 100mm from 11 o'clock to 1 o'clock / Exposed rio | 3 |

12, 00:05:00, 11.32  
Breaking, one or more pieces of conduit are missing, length of break: 100mm from 11 o'clock to 1 o'clock / Exposed rio

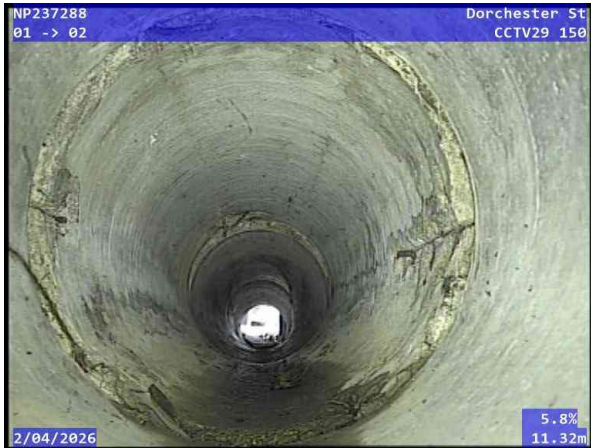
13, 00:05:00, 11.32  
Breaking, one or more pieces of conduit are missing, length of break: 100mm from 11 o'clock to 1 o'clock / Exposed rio

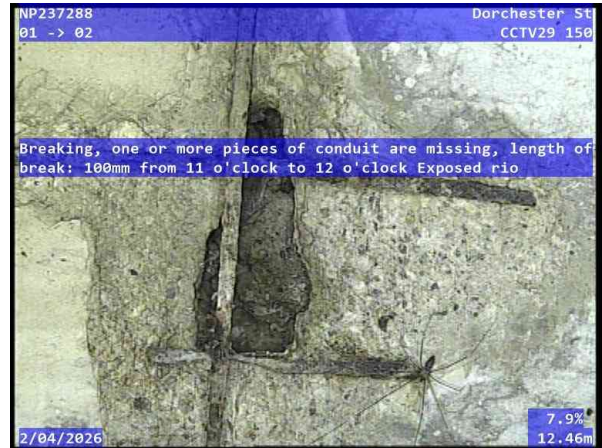
| 1:141 | m+ | Code | Observation Text | Grade |
|---|---|---|---|---|
| | 12.46 | BM | Breaking, one or more pieces of conduit are missing, length of break: 100mm from 11 o'clock to 12 o'clock / Exposed rio | 3 |

14, 00:05:53, 12.46  
Breaking, one or more pieces of conduit are missing, length of break: 100mm from 11 o'clock to 12 o'clock / Exposed rio

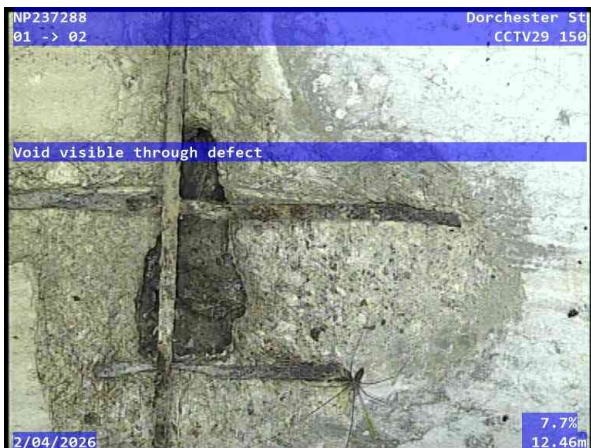
| 1:141 | m+ | Code | Observation Text | Grade |
|---|---|---|---|---|
| | 12.46 | VV | Void visible through defect | |

15, 00:06:01, 12.46  
Void visible through defect

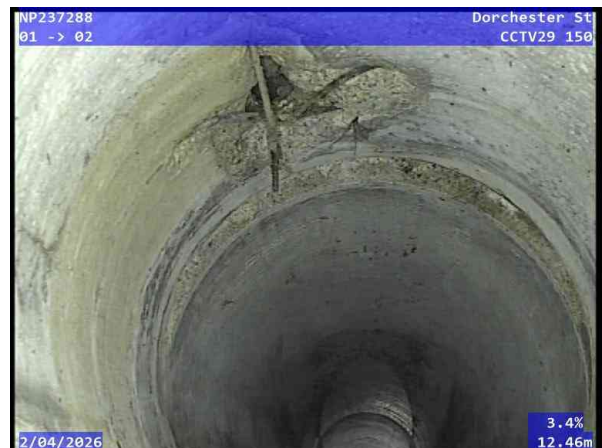
16, 00:06:01, 12.46  
Void visible through defect

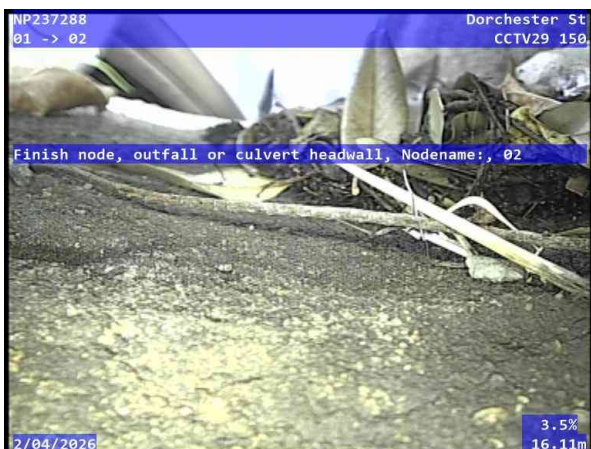
17, 00:08:18, 16.12  
Finish node, outfall or culvert headwall, Nodename:, 02
