**RE: Structural Review of Relocation of Existing Heritage Listed Huts**

ALTERATION AND RELOCATION OF TWO EXISTING HERITAGE BUILDINGS  
UNITING CHURCH BRIGHTON CHILDCARE  
Structural Condition Report

December 2024  
Project No.: 24373  
Revision No.: B

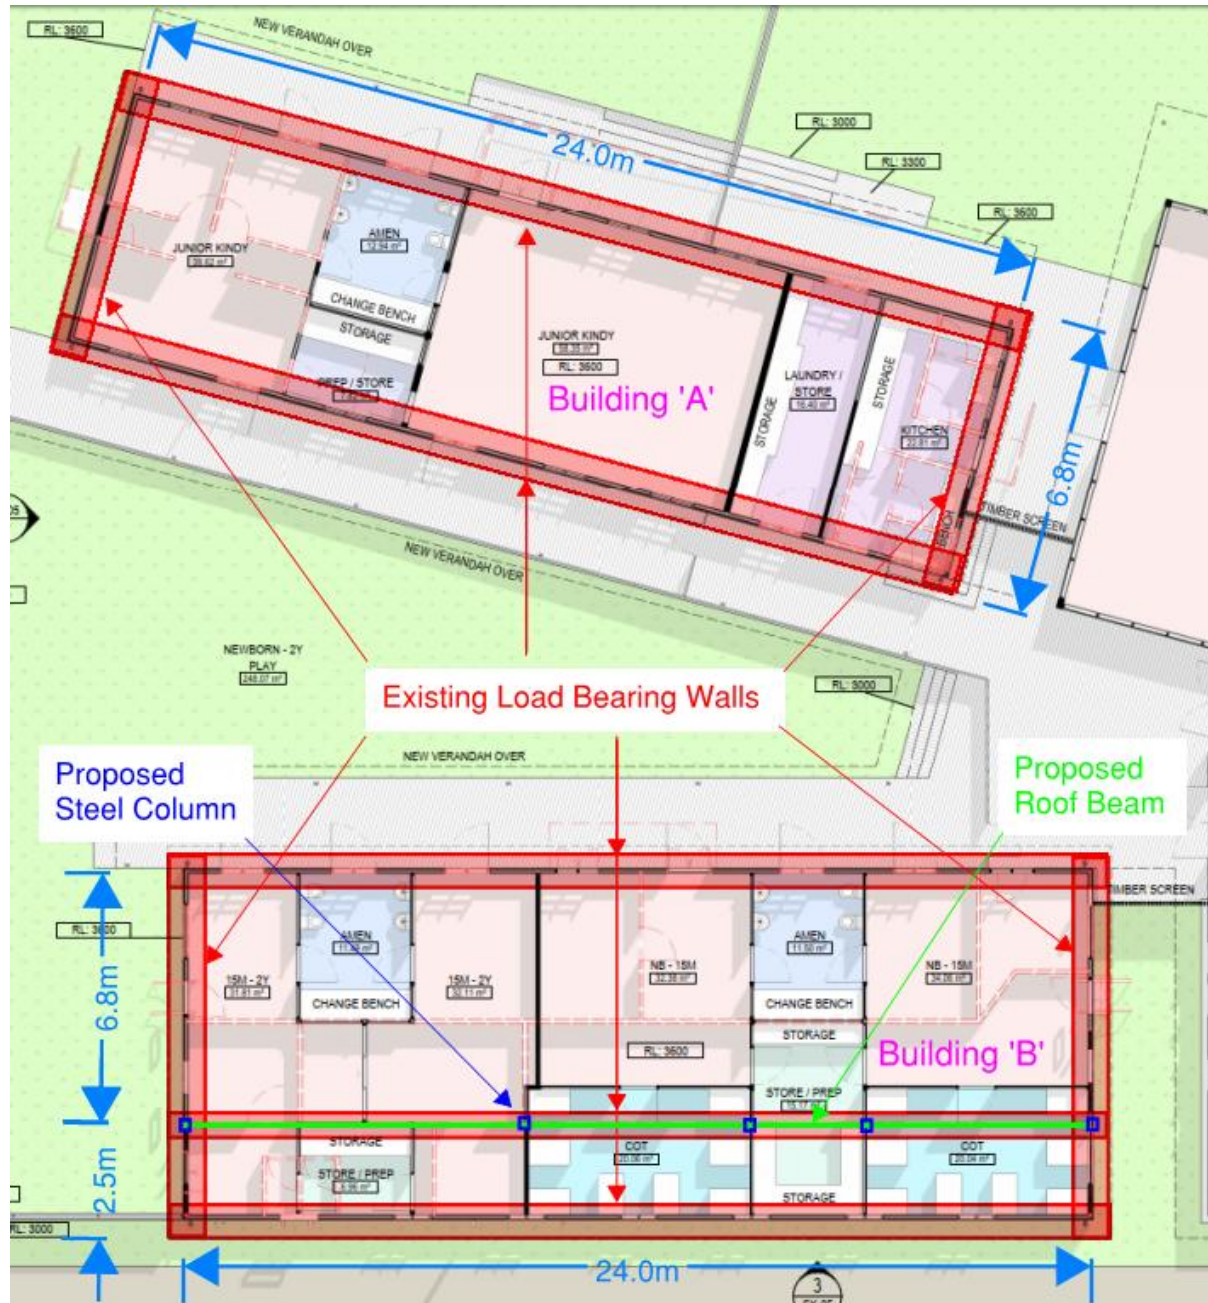
Figure 1: Load Bearing Wall Layout

Four main areas were identified that required structural input for both buildings. These will be evaluated in the section below and categorised as Building 'A' and 'B' in Figure 1. Refer to Appendix A for sketch layout plan and detail markup. In addition, inspection photographs taken is attached in this report in Appendix B. At time of inspection, it was noted that the floor and roof framings are made of hardwood timber. Both buildings are elevated approximately 1m above ground with reinforced concrete stumps. It is believed that the roof loading is distributed to the width of the building which is 6.8m. Building 'A' was noted that the perimeter walls are load-bearing and internal walls are non-load bearing. Whereas Building 'B' with larger roof area, one of internal walls and perimeter walls is believed to be load bearing wall (refer Figure 1). Further discussions and recommendations of moving the buildings are elaborated in this report in below section 'e'.

The existing wall framing was cover up with wall sheeting, hence the internal wall framing was not able to inspected. The internal area of the wall sheeting and ceiling appeared to be in adequate condition except for Building 'A' where the gable end wall which was observed to be damaged (Photo 7). Further assessment is required to examine the wall bracings, insulations and wall tie-downs between roof-wall and wall-floor framing. It is known that the internal walls are consider non-load bearing walls for Building 'A' as shown in figure below. Whereas for Building 'B', one of the internal walls is believed to be load bearing that is proposed to be

removed. Hence, we proposed to install new roof beam and columns or additional studs to replace the internal load bearing walls that will be removed in Building 'B'. Take note that the proposed roof beam might effect a down stand of the beam from ceiling or a bulkhead. Furthermore, the removal of internal wall with bracings shall be assessed and substituted to any new walls or to existing perimeter walls. It is also recommended to retrofit tie-down from the wall bottom plate to floor framing for both buildings.

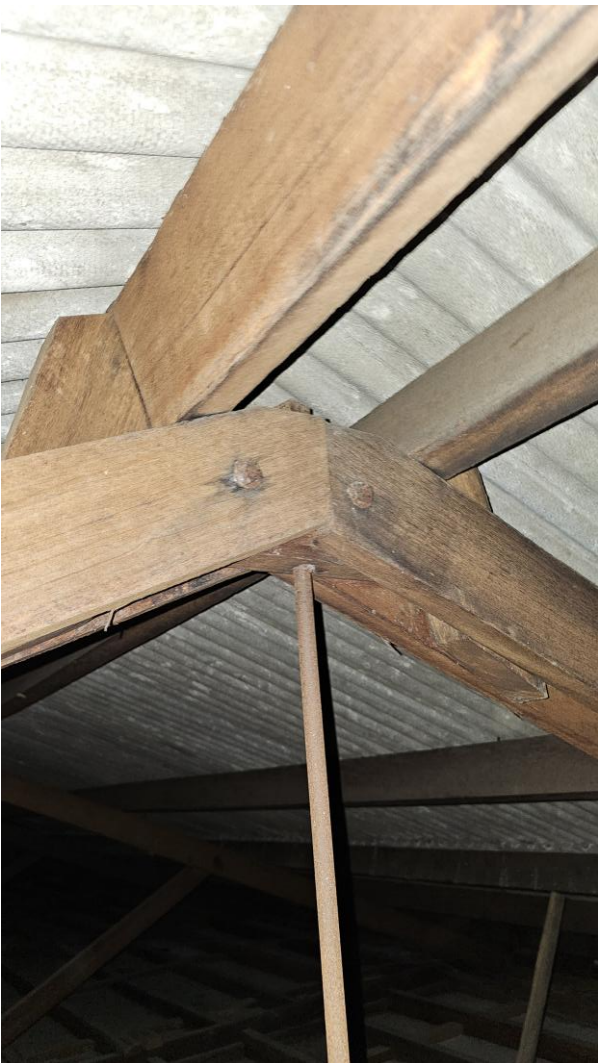
At time of inspection, the roof structural framing appears to be in sound condition for its age. The roof purlins, truss members, bracings and ceiling joists are found to be intact and workable condition. However, roof insulations and truss tie-downs were not found during the inspection. The condition of the existing roofing sheet was found to be in deteriorating condition (Photo 8). The bolt fixings between the truss members were observed to be rusting and diagonal member to bottom chord joints were notched without any screw/bolt fixings (Photo 2 and 5).

Photo 2 (Right): Bolt Connection on Roof Truss Top Chords

It is recommended to replace the roofing sheet with new and install roof insulation in accordance with Building Code of Australia if required. Furthermore, the connection fixing between the roof truss members shall be replaced with new bolts or screws. It is also recommended to install new metal strap at each end of the roof truss as tie-down to the wall top plate or roof beam which accordance to AS1684.2:2021.

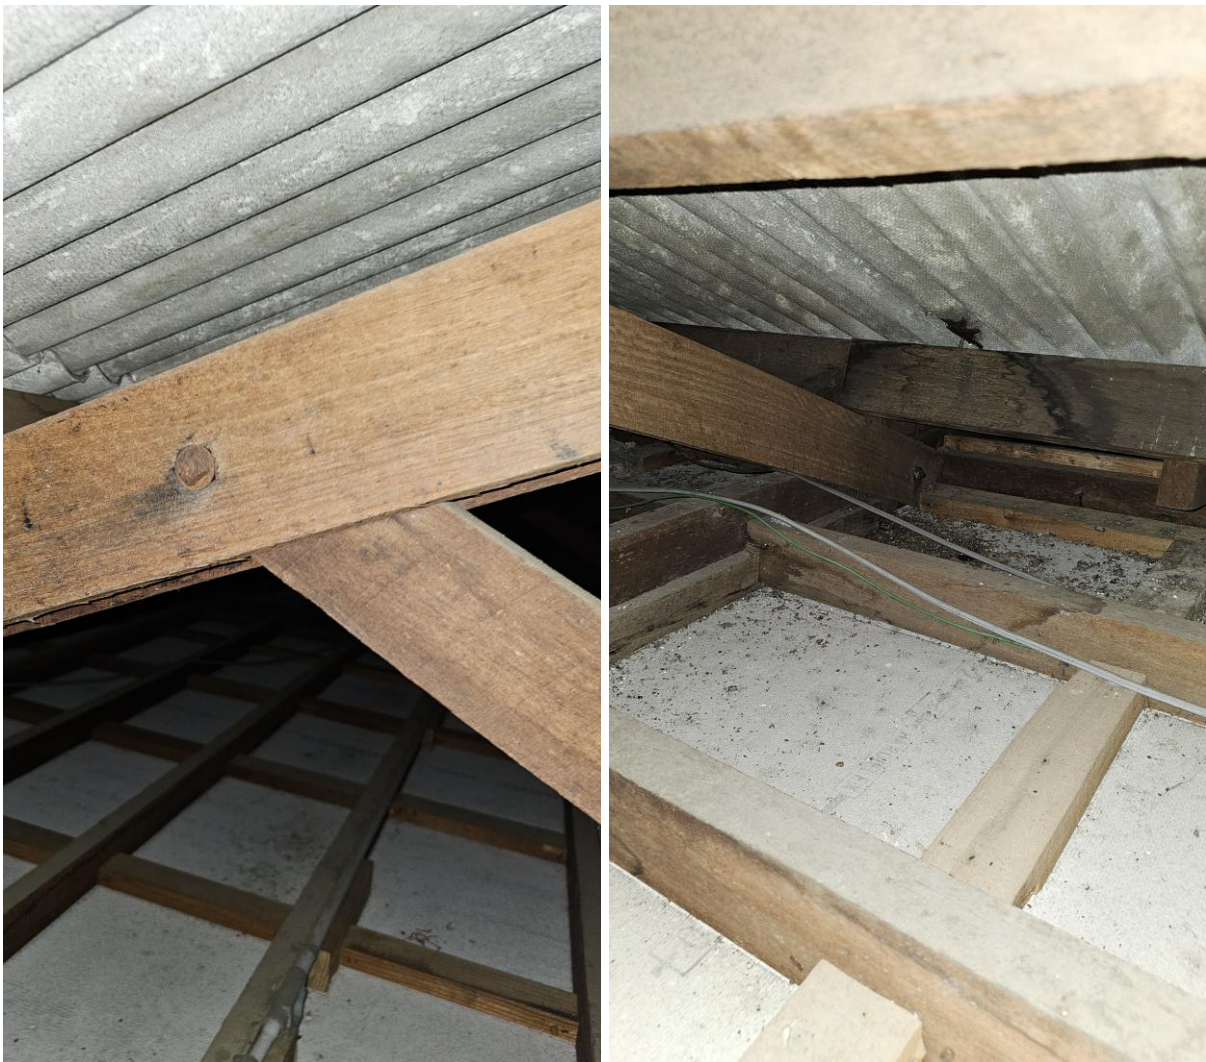
Photo 5 (Left): Bolt Connection Between Truss Members

Photo 6 (Right): Roof Truss Support at External Wall

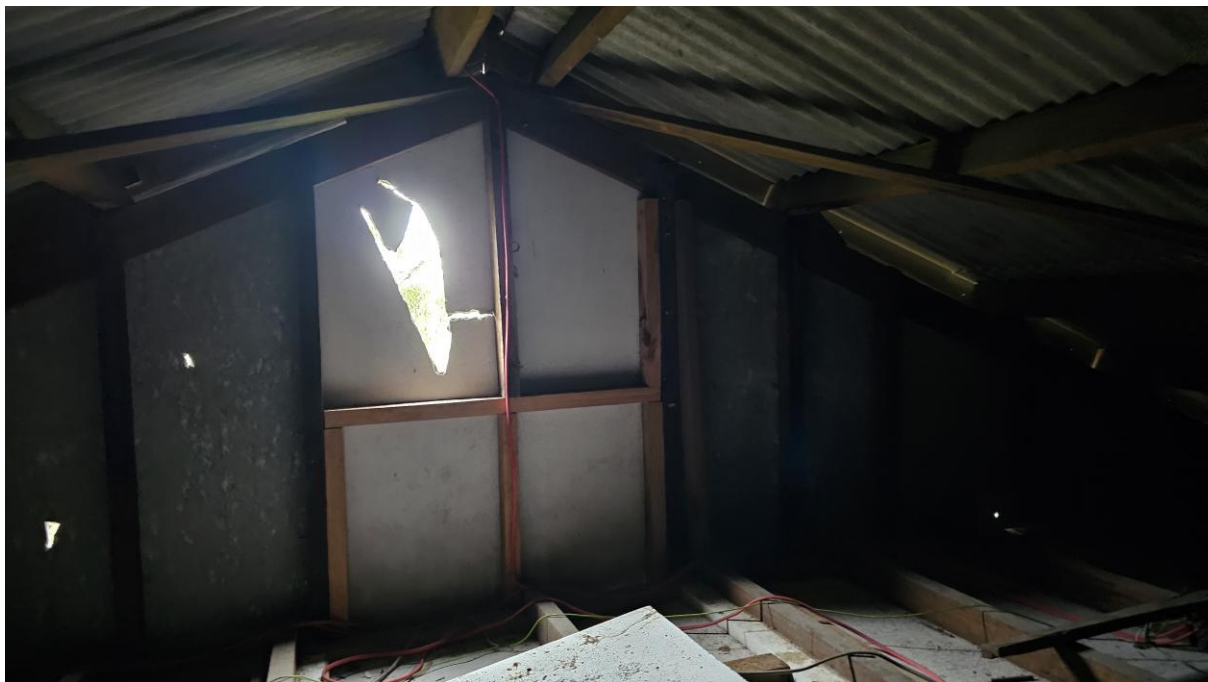
Photo 7: Gable End Wall – Damage Wall Cladding

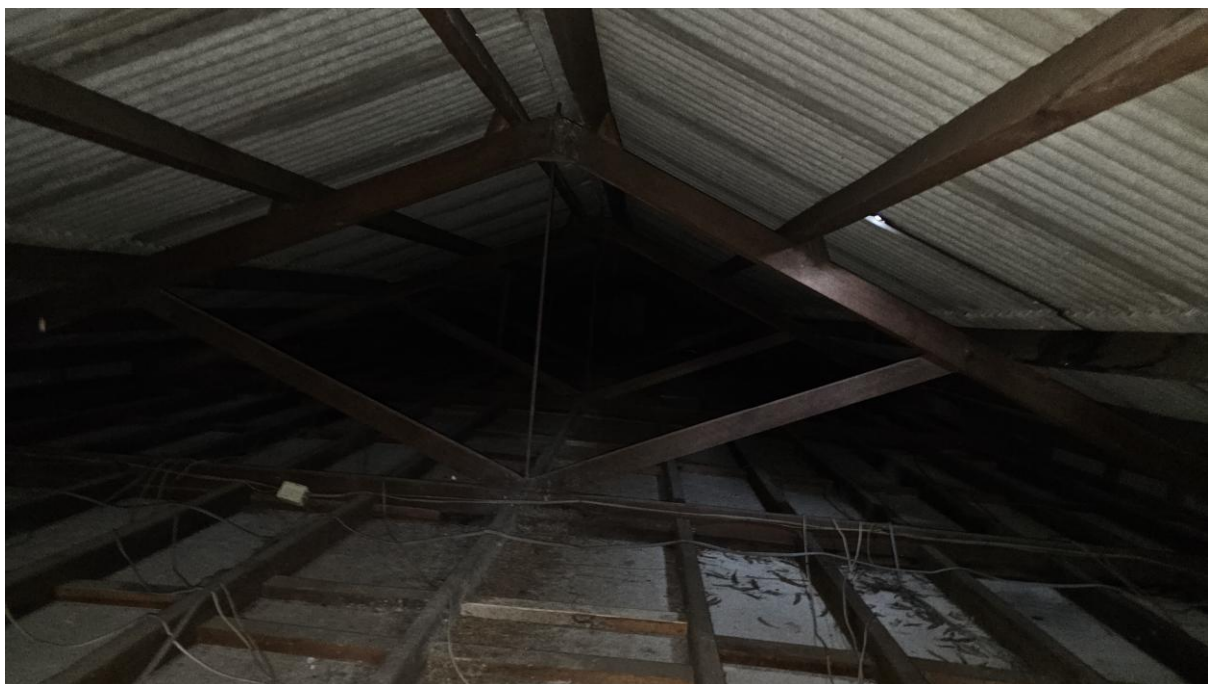
Photo 8: Roof Framing – Damaged Roof Sheeting
