# Management (Identification) Survey *Asbestos Survey Report*

**10059445-C1**

16 Twenty Fourth Avenue, Brighton QLD 4017

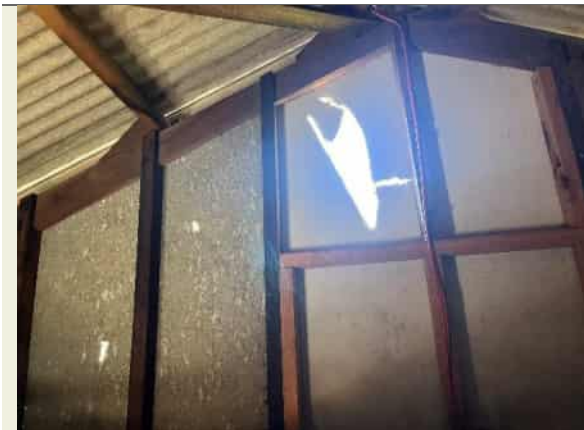
In areas where soffit linings have been damaged, it was observed that the external asbestos cement cladding extends above the soffit line and into the roof void. This configuration may complicate the removal of the affected cladding and should be considered during planning of the remediation works.

*Figure 8-1: Damage to external cladding in roof void*

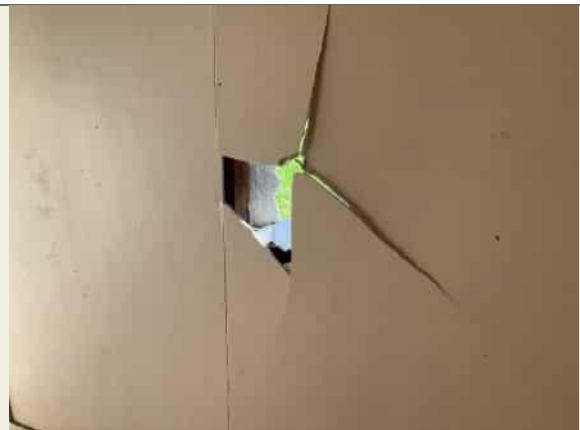
Damage to the external cladding and soffits has resulted in the accumulation of asbestos-containing debris on the ground surrounding and beneath the buildings. In some locations, ACM debris has also migrated into internal areas and roof void spaces through openings created by vandalism and the throwing of objects into the structures. Beneath the southern building, this includes stockpiled and unused ACM roofing materials, which will require removal. In addition, ACMs fixed to the ground will

*Figure 8-2: Damage to external cladding coming into internals*

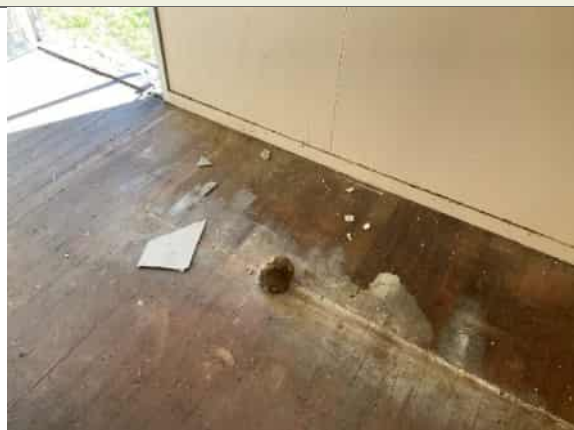
*Figure 8-3: Debris from external cladding damage*

- Prior to access being granted for relocation planning, all damaged ACMs and asbestos debris should be removed or otherwise made safe. Until such works are completed, warning signage should be installed, and access limited to personnel wearing appropriate PPE and RPE.

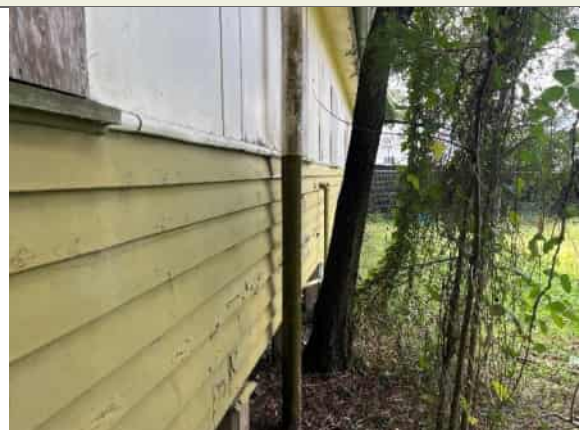
*Figure 8-4: ACM waste vent pipe fixed to ground*

- Prior to the relocation of the buildings, asbestos-containing materials (ACMs) should be removed where practicable. As a minimum, all damaged or deteriorated ACMs, the asbestos cement roofing materials, and the asbestos-containing waste vent pipe fixed to the ground should be removed by a suitably licensed asbestos removal contractor. Consideration should also be given to the removal of all remaining ACMs prior to relocation to minimise the risk of disturbance, damage, and asbestos fibre release during lifting, transport, and refurbishment activities.

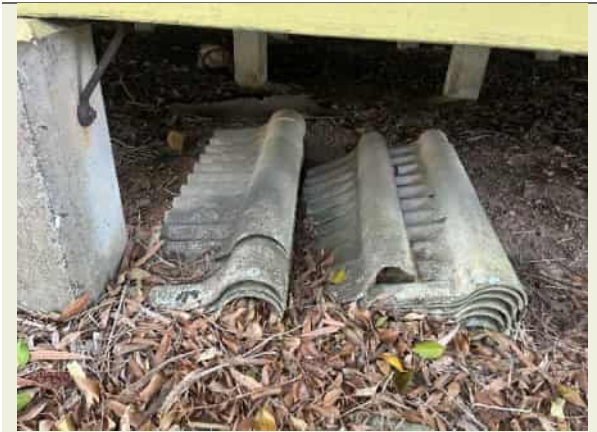
*Figure 8-5: Disused ACM roofing material below building*

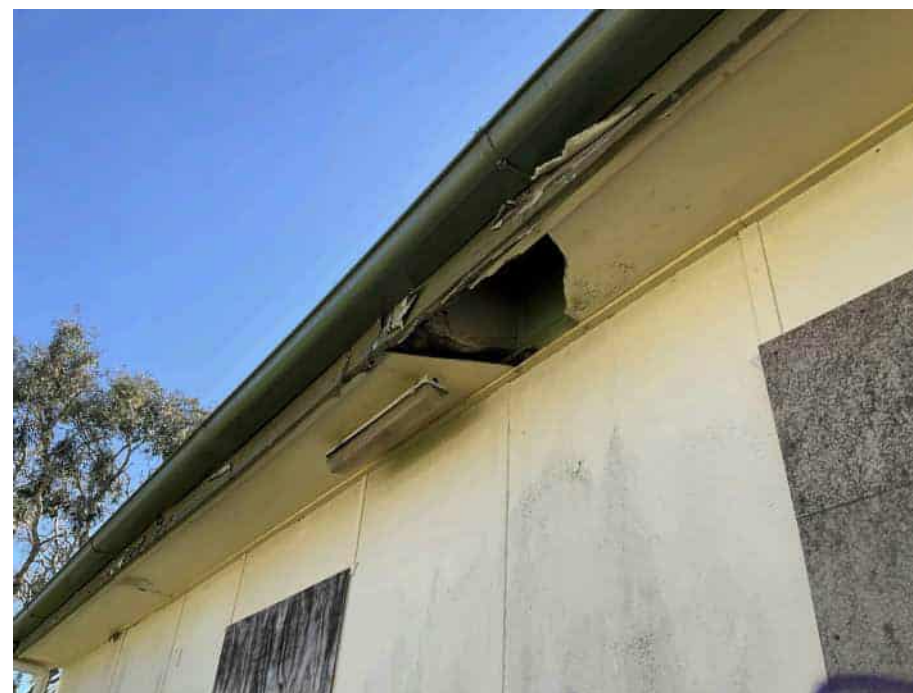
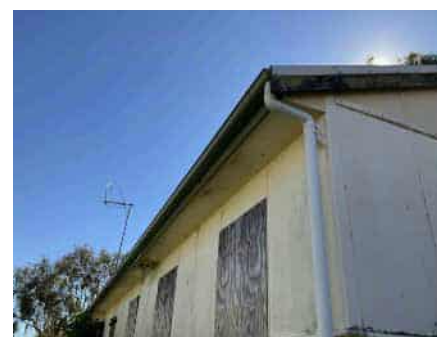
Soffits to north and south showing damage

Damage to soffit lining

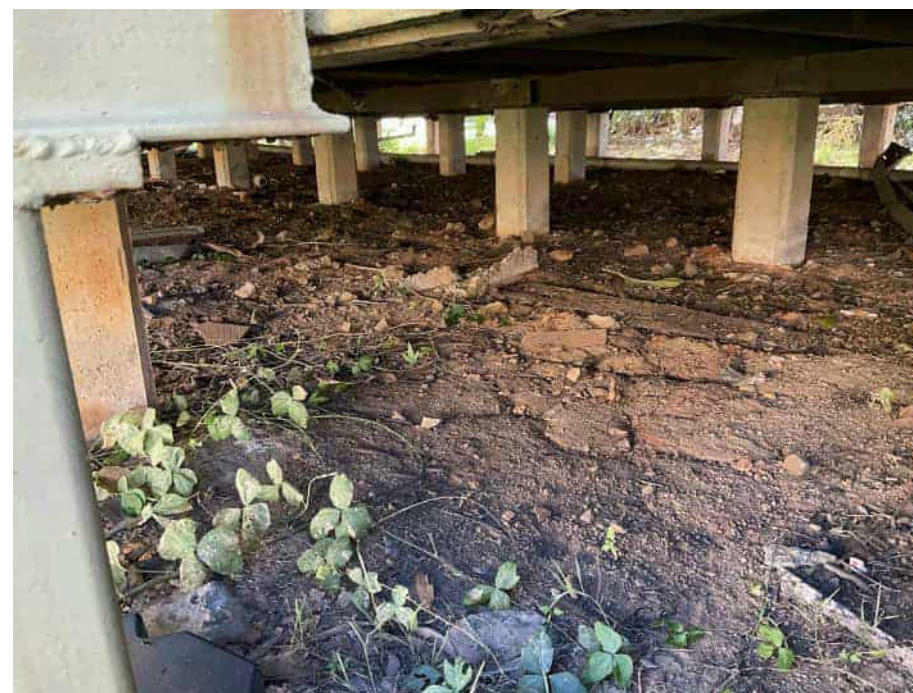
ACM debris below building

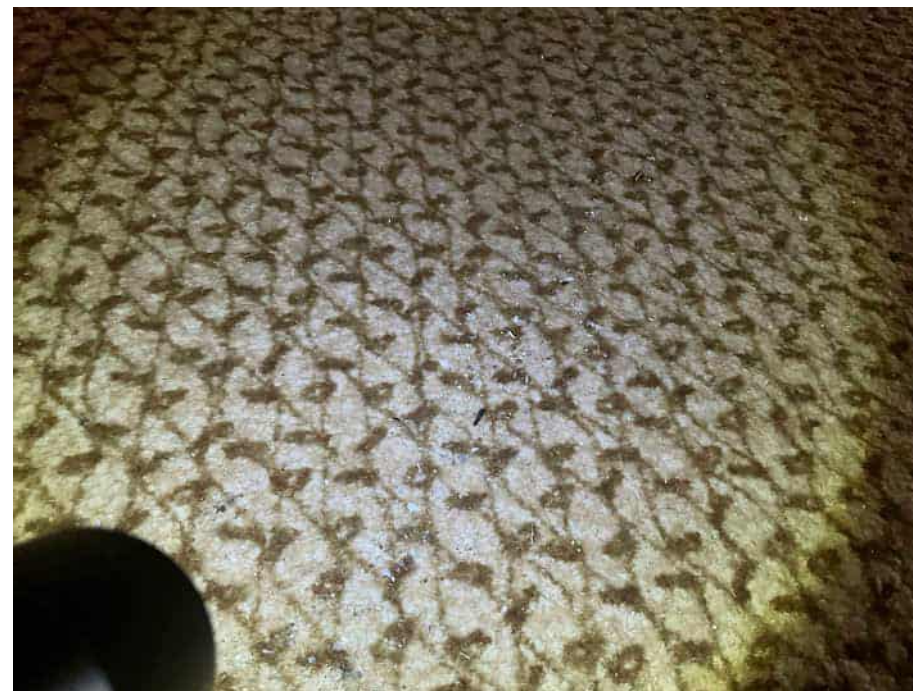
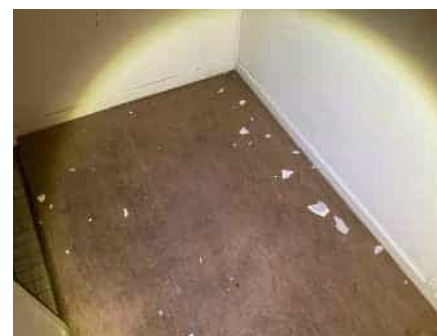
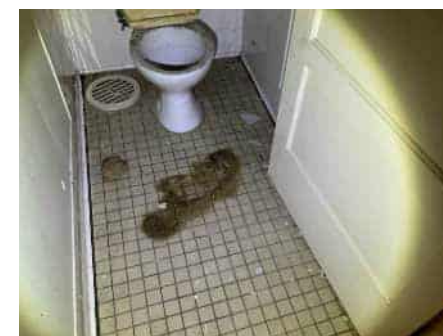
Throughout internals debris from damaged linings is present. This can be removed during the asbestos removal of linings though it is recommended that that is removed from the building is disposed of as Asbestos contaminated waste including carpet.

Debris on ground from damage to linings

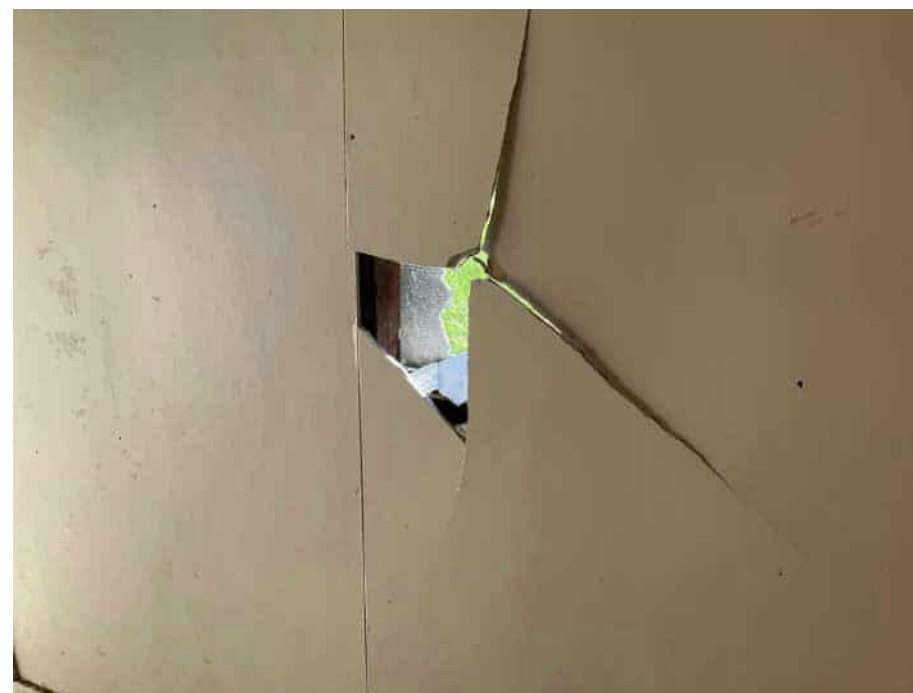
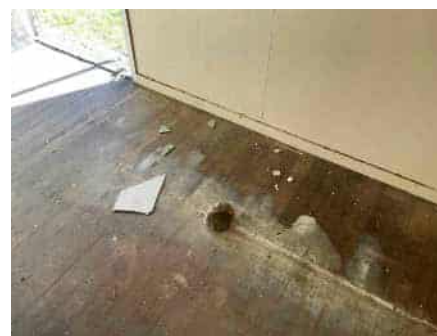
ACM debris within room from external damage to wall cladding

Damage to wall where ACM debris has entered room

ACM debris on ground

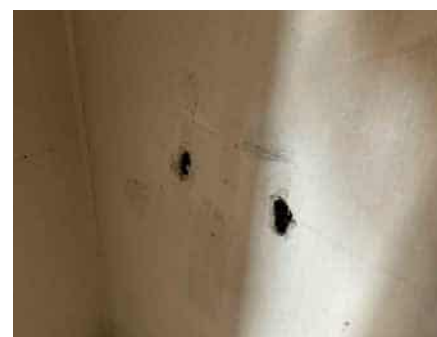
Damage to partition/ cubicle walls

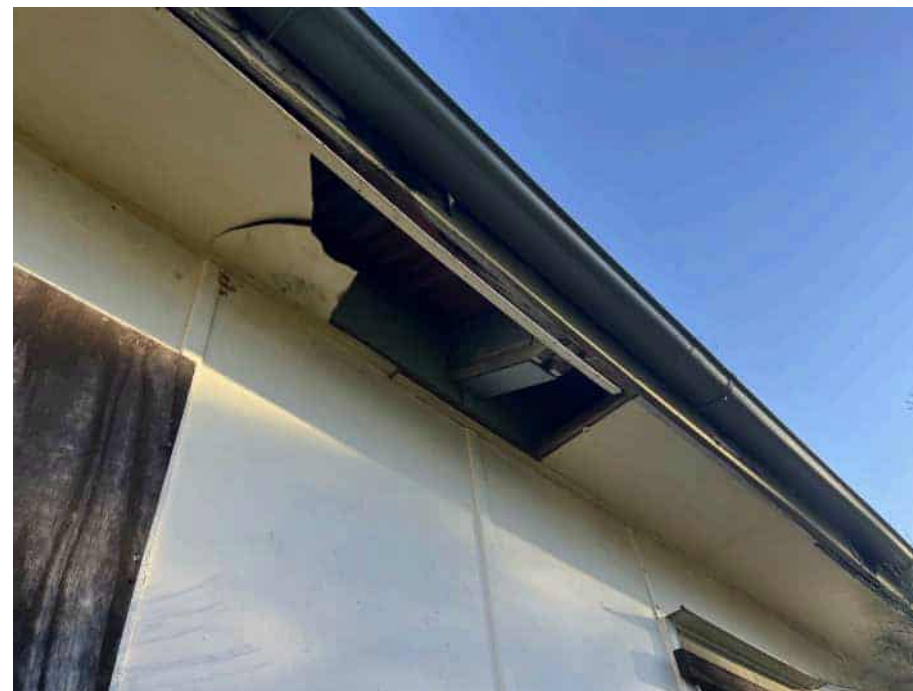
Damage to soffit sheeting

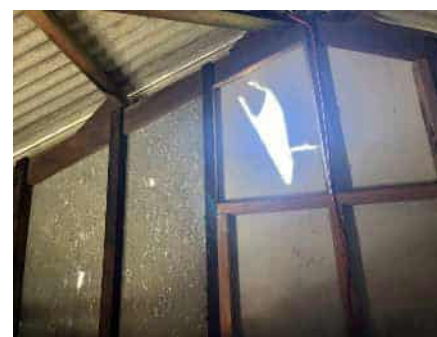
Debris from damaged roof and gable sheeting present in ceiling void. This would be removed during roof removal process as part of standard asbestos decontamination procedures.

Debris in roof void presumed due to damage to external cladding

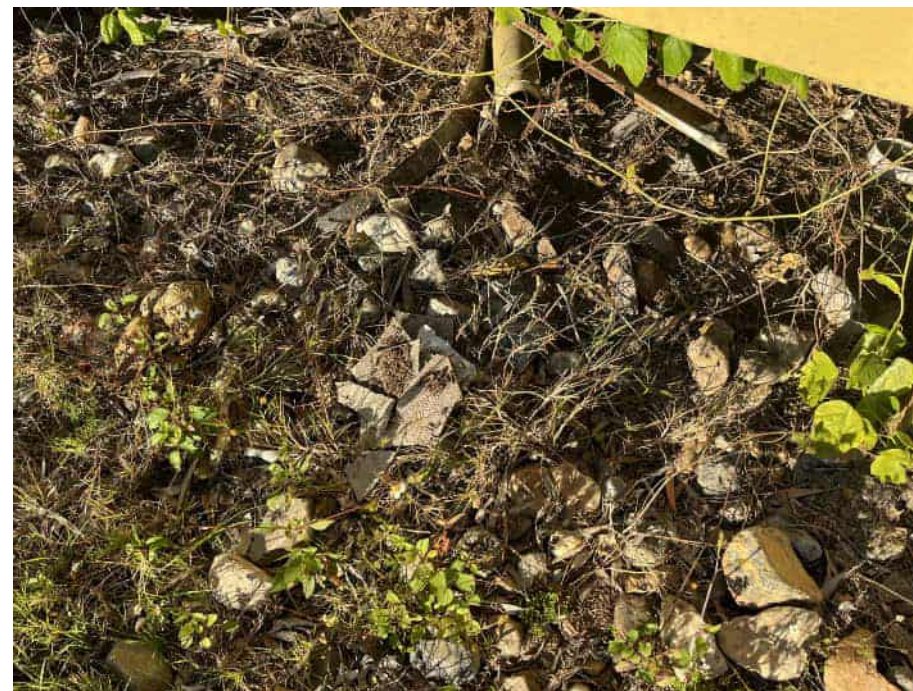
Various debris spread throughout undercroft and surrounding building from damage caused to roof, soffit and cladding. Recommended hand pick or scrape of ground when building removed.

Debris on ground

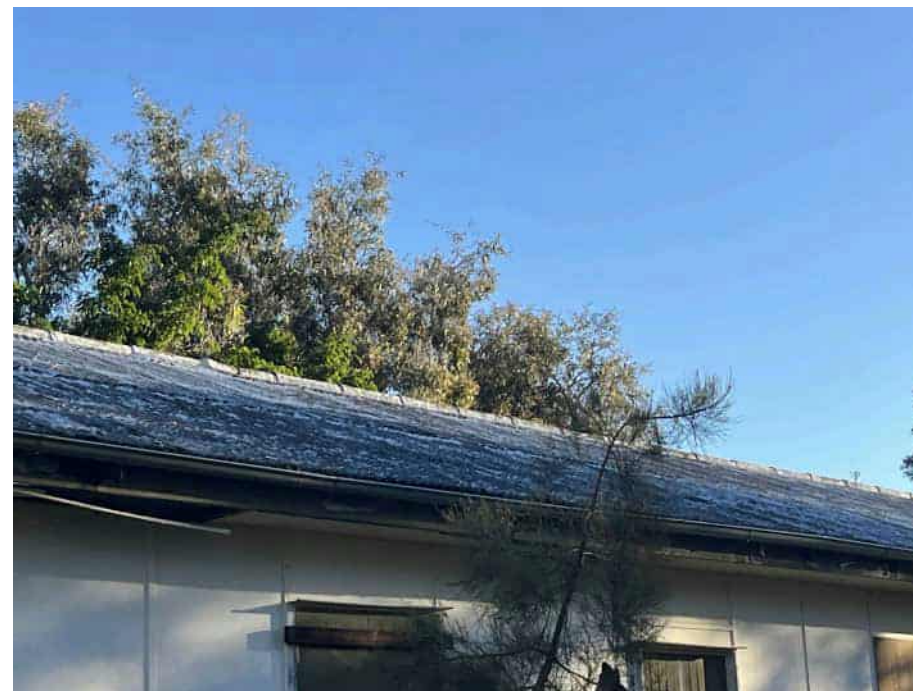
Roof sheeting is degraded, contamination of the gutters from the roof sheeting is presumed and would be removed during asbestos roof removal.

Roof sheeting
