22 June 2023

**“Mimosa”; 33 Balfour Street, New Farm – Application No. A006264903
Information Request response in relation to Heritage issues raised.**

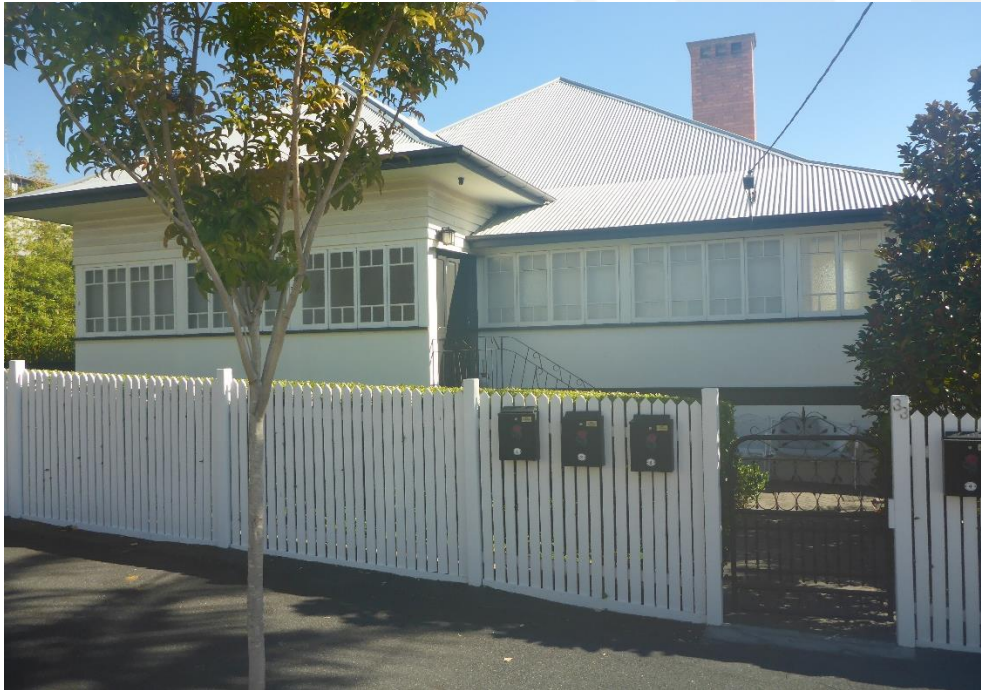
Figure 1: Oblique Street view of the subject heritage residential building, “Mimosa”, as viewed from the Balfour Street site frontage and indicating the low-set, timber picket fence extant across that frontage. (Source: VAULT)

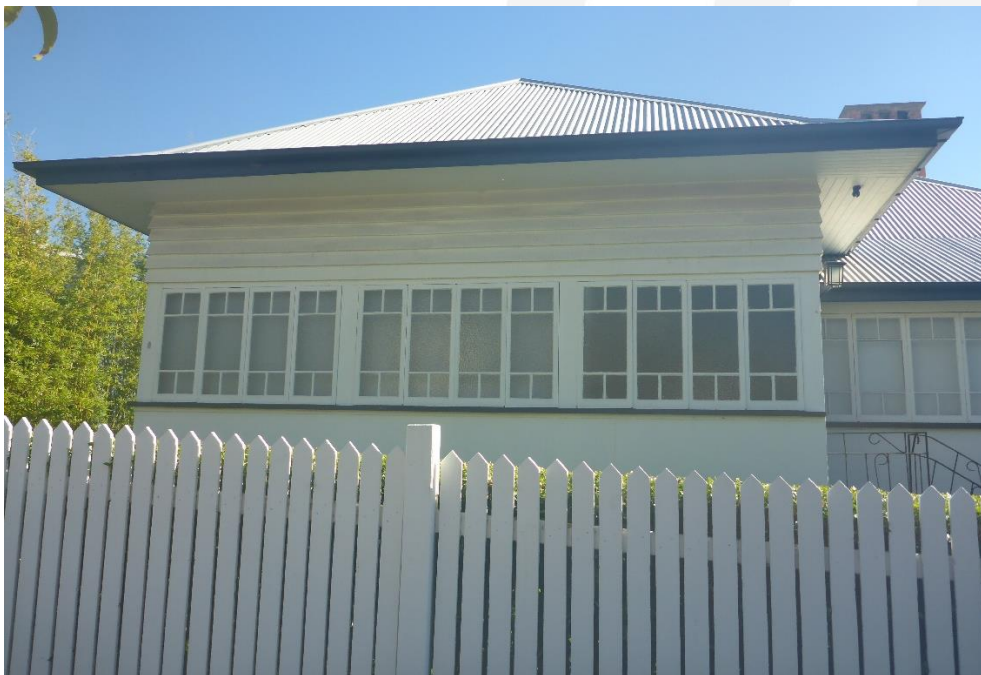
Figure 2: A more detailed view of the southern portion of the “Mimosa” street façade focused upon the projecting, hipped roof component of that façade, which originally comprised an open verandah (now enclosed). (Source: VAULT)

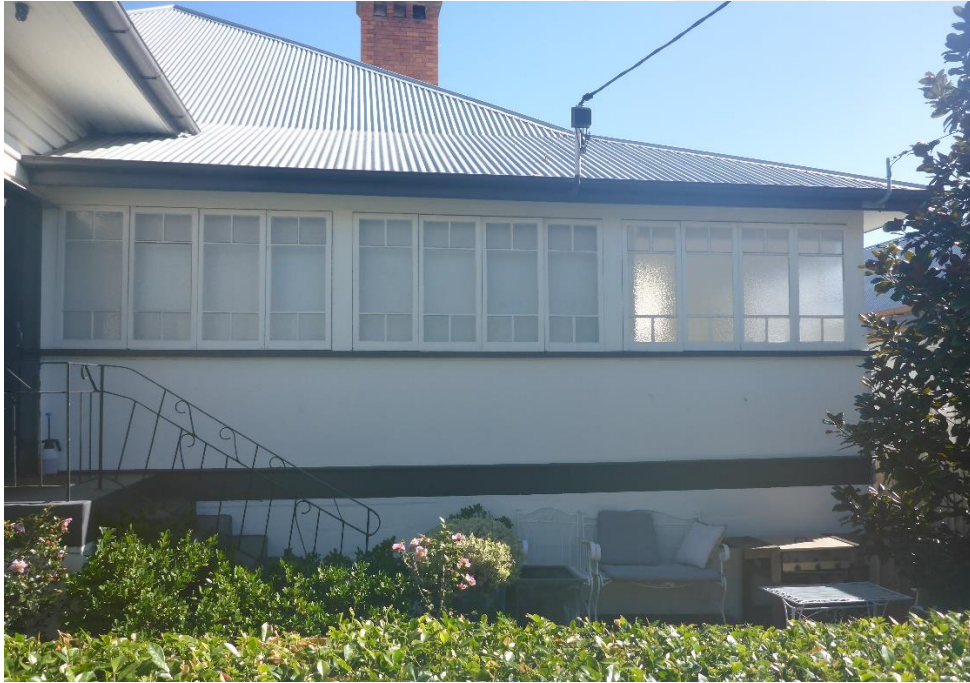
Figure 3: A more detailed view of the balance of the “Mimosa” street façade focused upon what was originally a wraparound verandah beneath a “broken back” roof line, which has now been fully enclosed. (Source: VAULT)

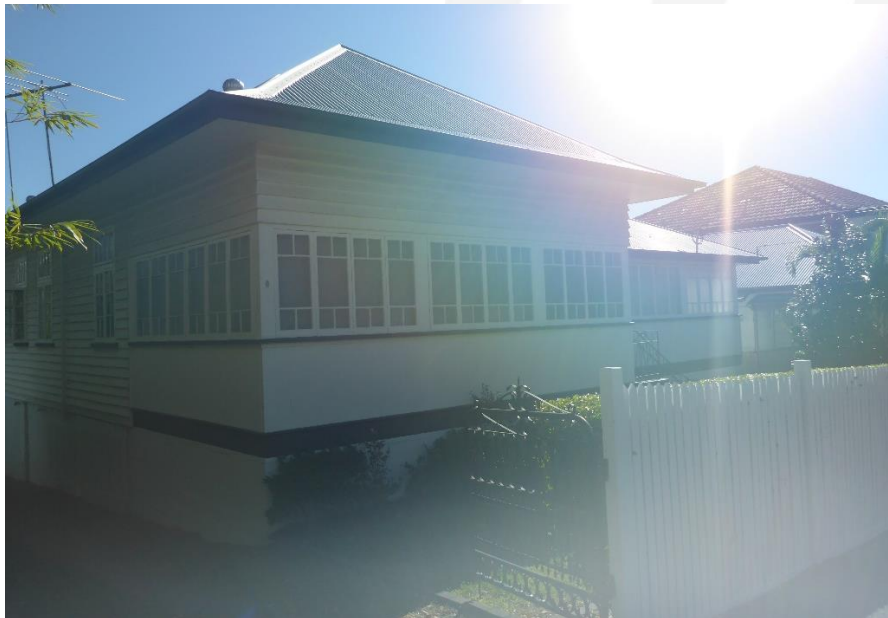
Figure 4: The reverse oblique street view of the subject heritage residential building, “Mimosa”, as viewed from the southern (front) corner of the subject site. This view reveals the stepped street façade and various “broken back” and hipped roof forms over. (Source: VAULT)

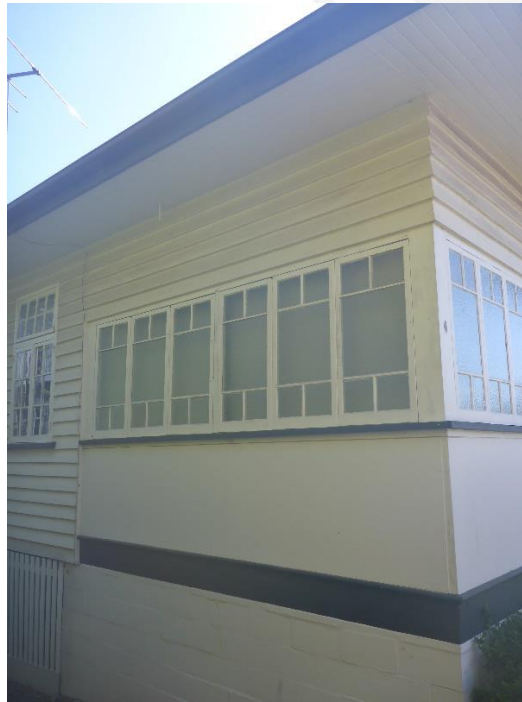
Figure 5: A detailed view of the south-eastern (front) corner of the subject heritage residential building showing how the original open verandah space has been subsequently enclosed with a combination of sheet asbestos balustrade cladding with an array of multi-paned, casement windows over. (Source: VAULT)

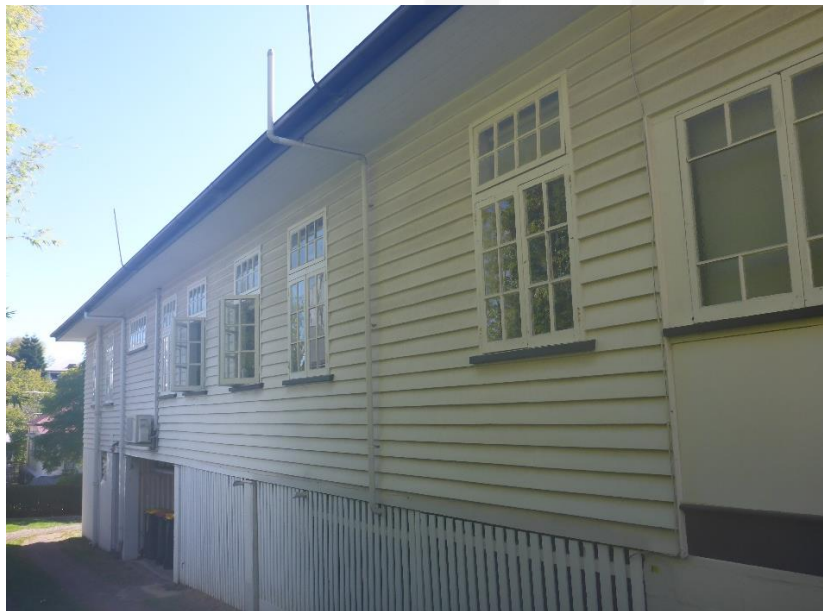
Figure 6: The view down the southern side elevation of the subject heritage building looking rearwards from the return end of the verandah enclosure (at image far right) and showing the array of original windows set into this weatherboard-clad façade of the building. (Source: VAULT)

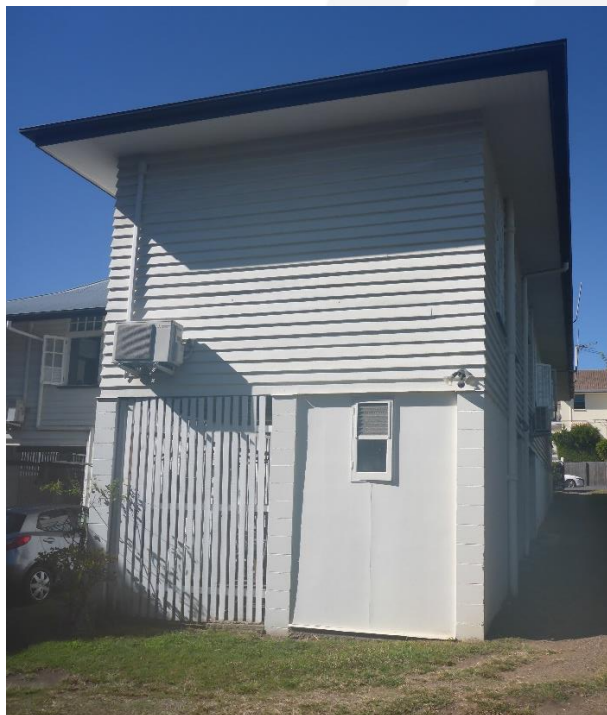
Figure 8: The western (rear) elevation of the subject heritage residential building, which comprises the remnant of the original Kitchen wing projecting behind the core of this building. (Source: VAULT)

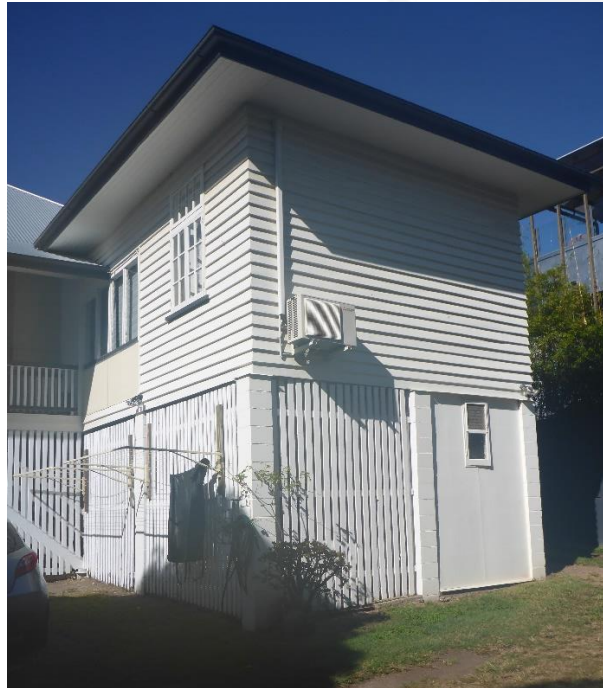
Figure 9: An oblique view of the rear wing projection of the subject heritage residential building, which originally comprised the Kitchen wing of “Mimosa” connected to the core of the residence by an open verandah. (Source: VAULT)

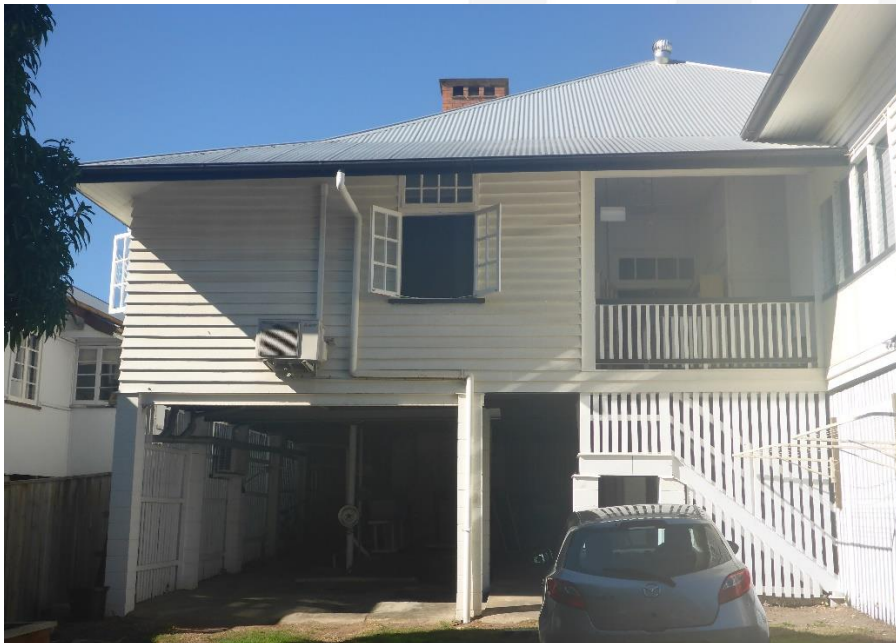
Figure 10: The balance of the rear elevation of the subject heritage residential building showing the rear verandah space and access staircase (at image right) and the rear wall of the house’s core with a hipped, “broken back” roof line over same. Also noted is the solid rear wall at image left, which was originally an open verandah return. (Source: VAULT)

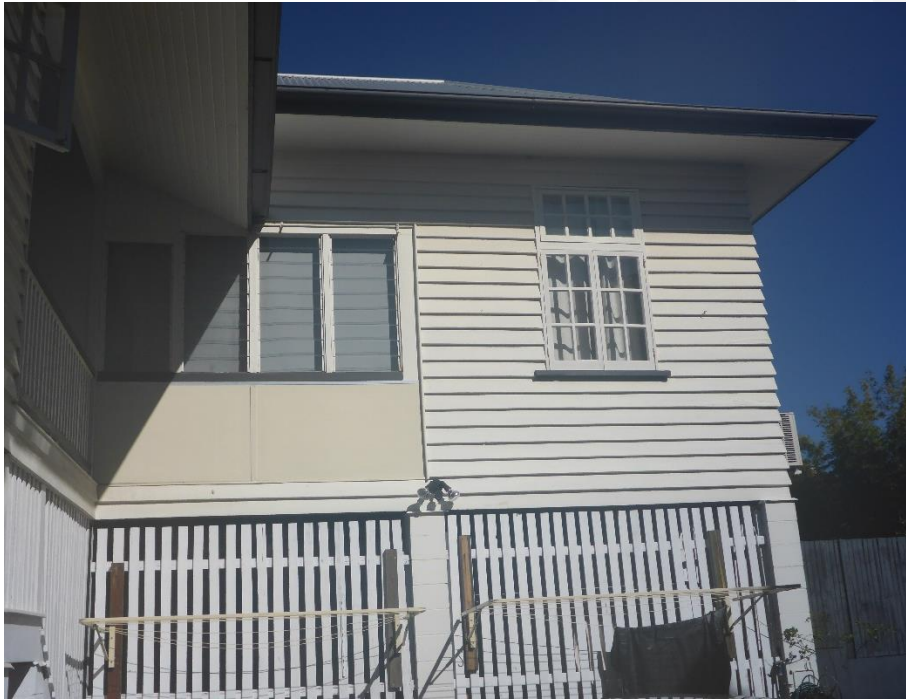
Figure 11: A more detailed view of the internal elevation of the rear Kitchen wing, which shows the more recent enclosure of what was originally an open verandah connection into that Kitchen wing. (Source: VAULT)

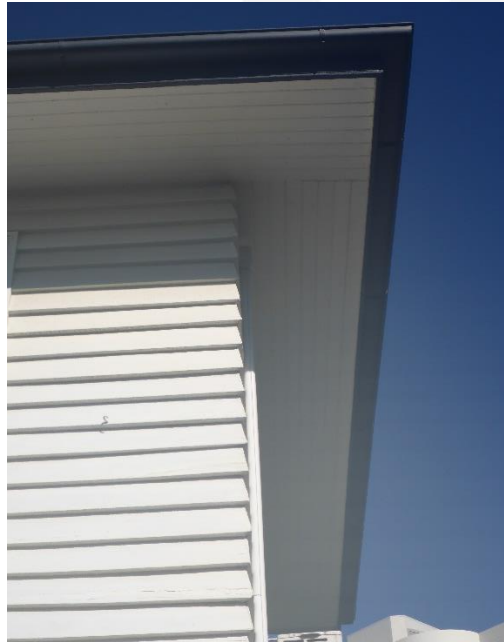
Figure 12: A detailed view of the eave soffit detailing on the projecting Kitchen wing at the very rear of the building. It is noted that the timber soffit lining is butt-jointed, rather than mitred at the corner, and the soffit panel itself is flat, rather than raked in profile (as per the front section of *“Mimosa”*). (Source: VAULT)

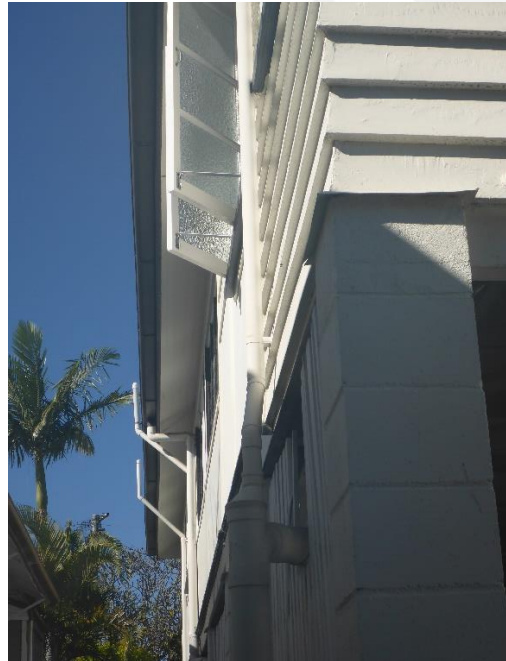
Figure 13: The view from the rear corner of the building looking forward along the northern (side) elevation of the subject heritage residential building, “Mimosa”. This side of the building was originally an open verandah return but has subsequently been fully enclosed as additional habitable space. (Source: VAULT)

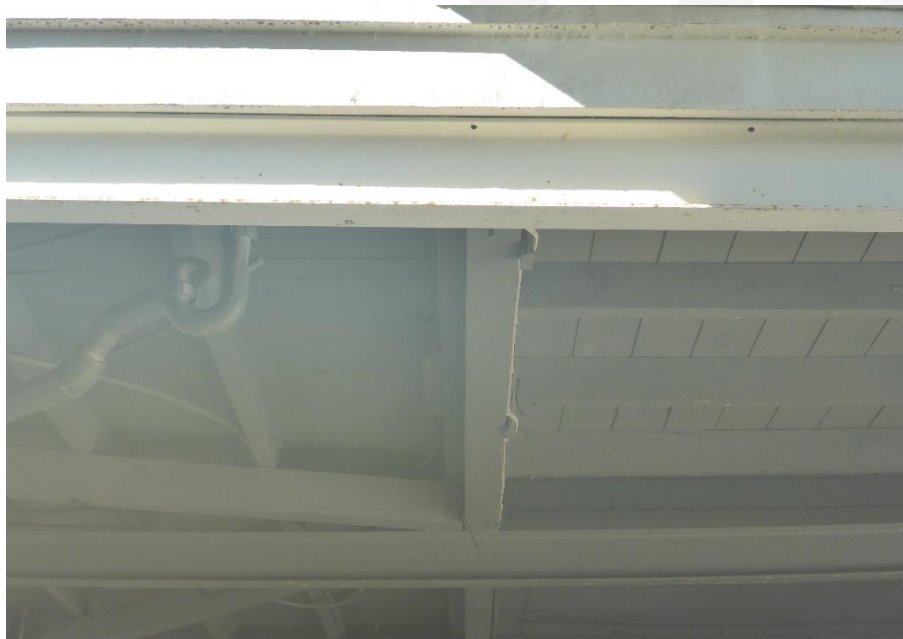
Figure 14: The view into the undercroft space situated immediately below the rear corner of the subject building; as per the preceding image. Note the differential between the sub-floor framing and decking / boarding over same between the solid core of the house (at image right) and the subsequently enclosed side verandah (at image left). (Source: VAULT)

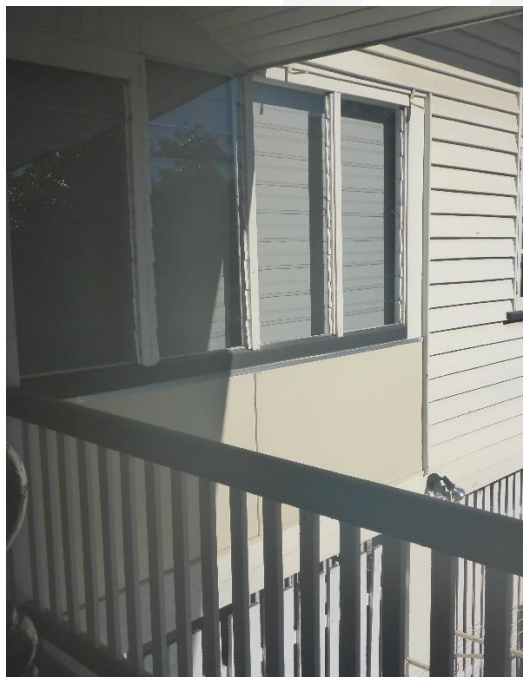
Figure 20: The rear wing of the subject heritage building incorporates a more contemporary enclosure of what was originally an open verandah walkway – indicated by the glass louvres and panelled spandrel upstand. (Source: VAULT)

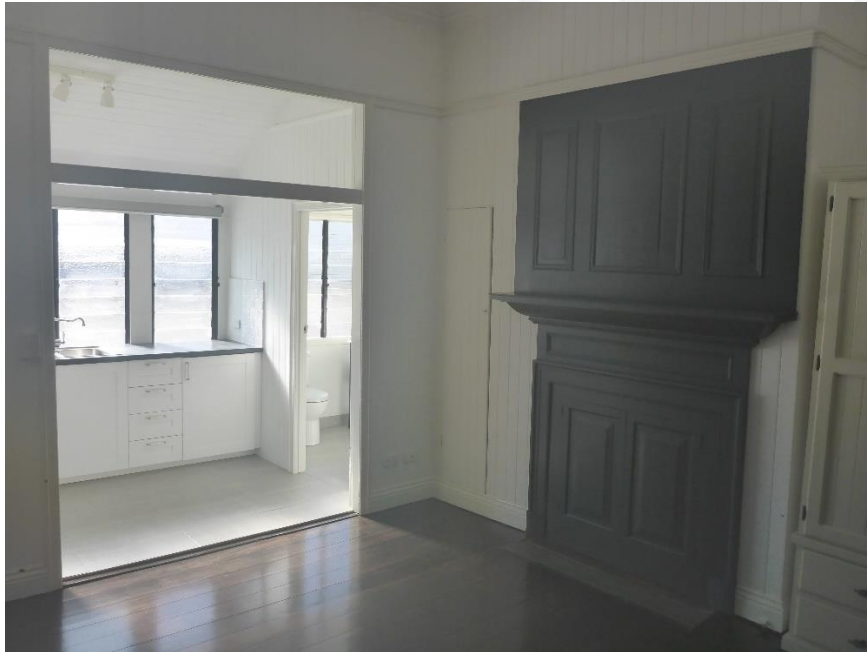
Figure 37: An interior view of Unit 3 showing the intact fireplace assembly (with enclosing panel over fireplace) and showing the removed French door assembly (at image left) that connects this core space with the enclosed verandah beyond and the kitchen installation integrated into that space. (Source: VAULT)

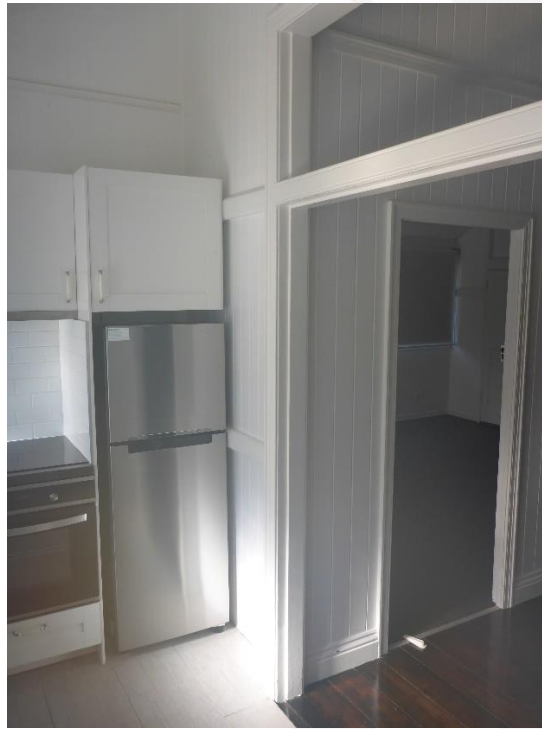
Figure 49: Another interior view from the kitchen space within Unit 1 looking back into the core of the heritage residence and showing the remnant framework of a removed French door assembly and the view through to the bedroom space within that tenancy (in background at image right). (Source: VAULT)

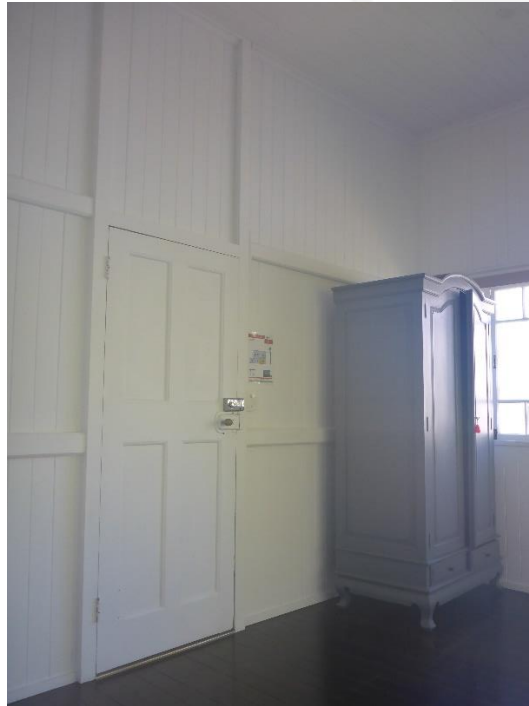
Figure 55: Another interior view from within the bedroom of Unit 2 showing the single skin construction of the infill wall that has enclosed this part of the original front verandah and the entrance doorway set within same. (Source: VAULT)

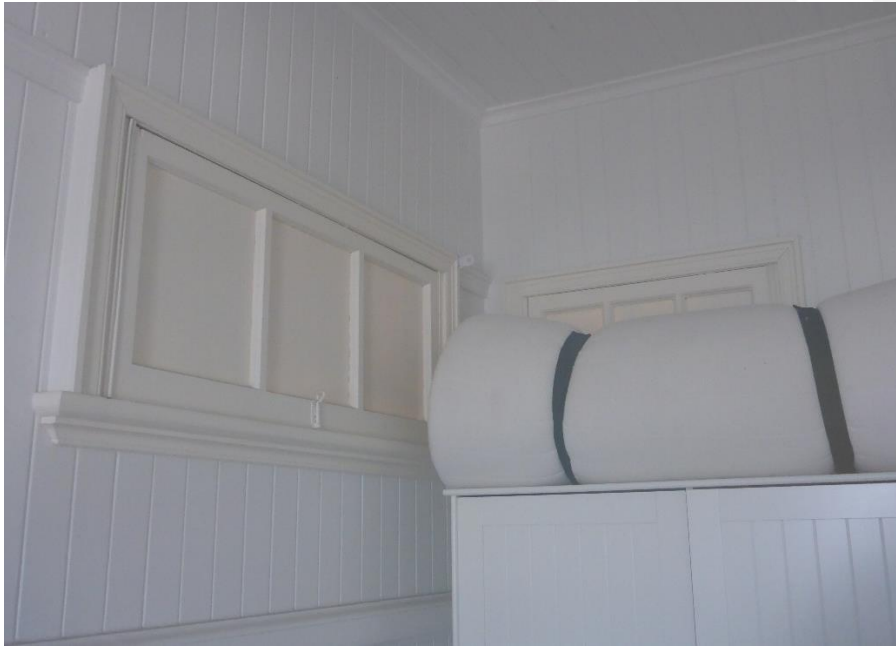
Figure 63: In the corner of the bedroom space within Unit 4, there are a pair of high-set, multi-paned awning windows that have now become internalised by later additions to the building. The glazing panels within both of these windows have subsequently been painted out for the privacy purposes. (Source: VAULT)

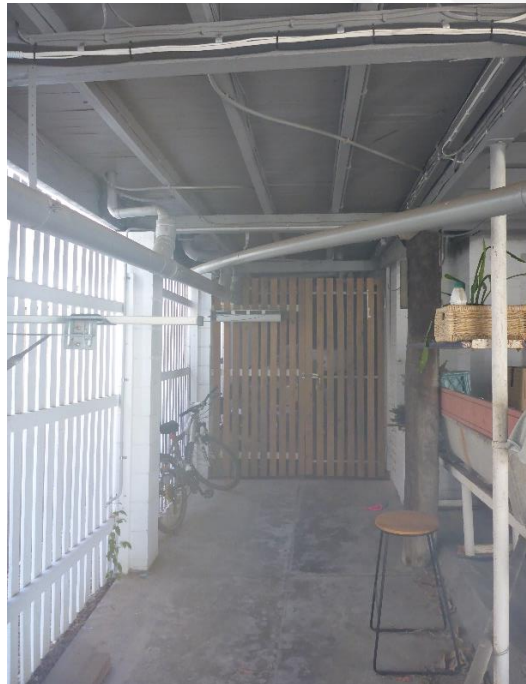
Figure 67: The view through the undercroft space extant beneath the side verandah enclosure situated along the northern side of the building core. The differential in sub-floor framing direction between the core of the building and the side verandah is readily identifiable in this image. (Source: VAULT)

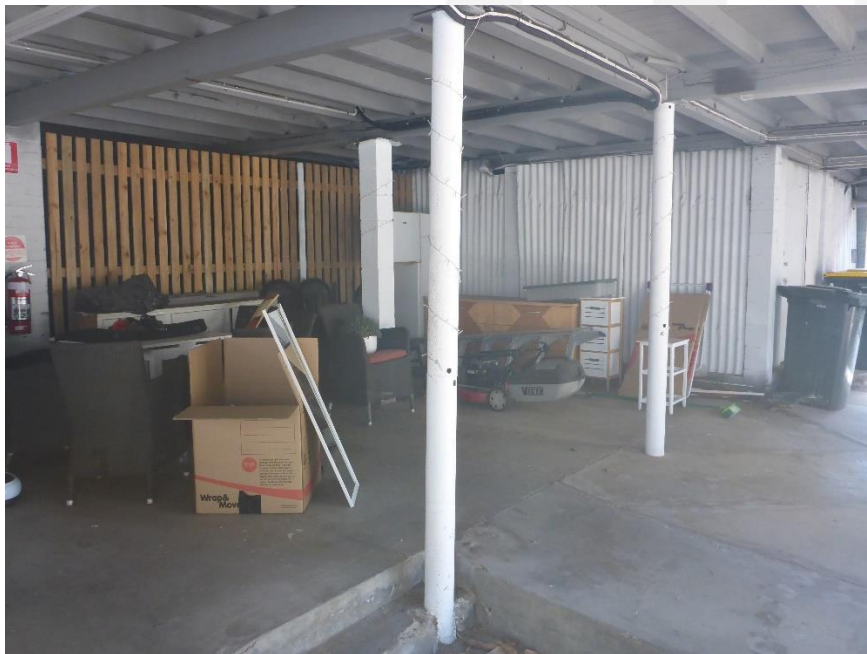
Figure 68: A broader view across the extant undercroft space beneath the heritage building, which shows the varied array of non-original support structures (i.e. steel posts or concrete columns) that are extant within this space. (Source: VAULT)

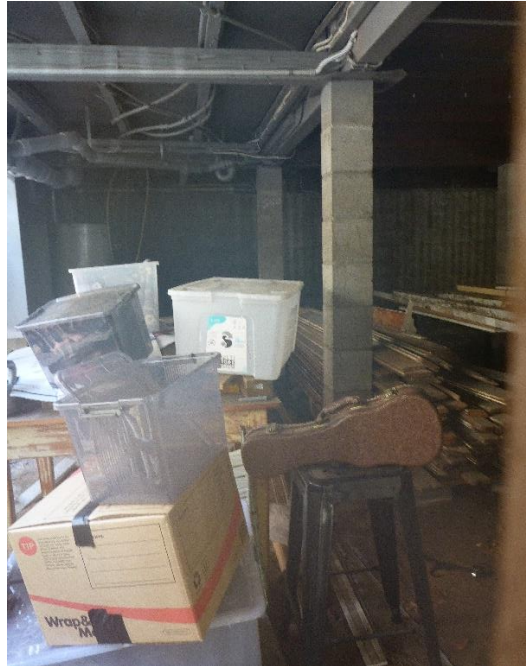
Figure 69: Another view through a different portion of the undercroft space beneath the heritage building showing how some of the supporting columns have been constructed from a vertical stack of concrete blocks. (Source: VAULT)

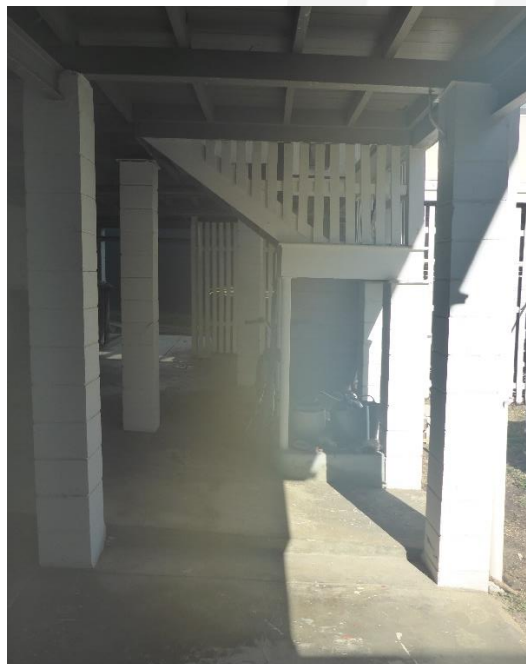
Figure 70: Another view through the extant undercroft space; this time proximate to the rear staircase and looking laterally across the rear portion of the building, which again shows the mixture of steel and concrete blockwork columns utilised as support structures beneath the heritage building. (Source: VAULT)

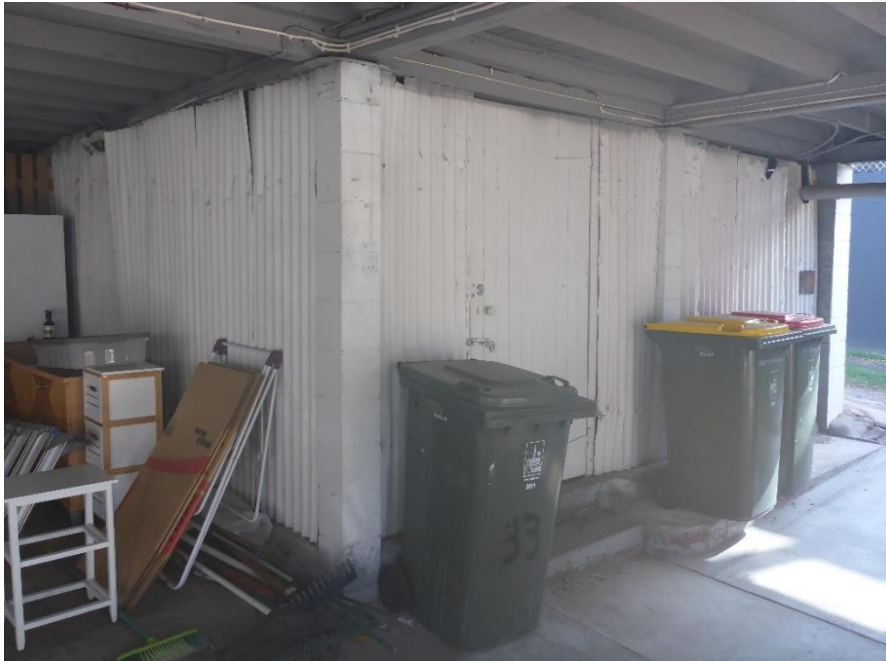
Figure 71: The undercroft space beneath the heritage building also incorporates a “lock up” enclosure that has been formed up within a series of the non-original concrete blockwork columns and has been clad in recycled corrugated iron sheeting. (Source: VAULT)

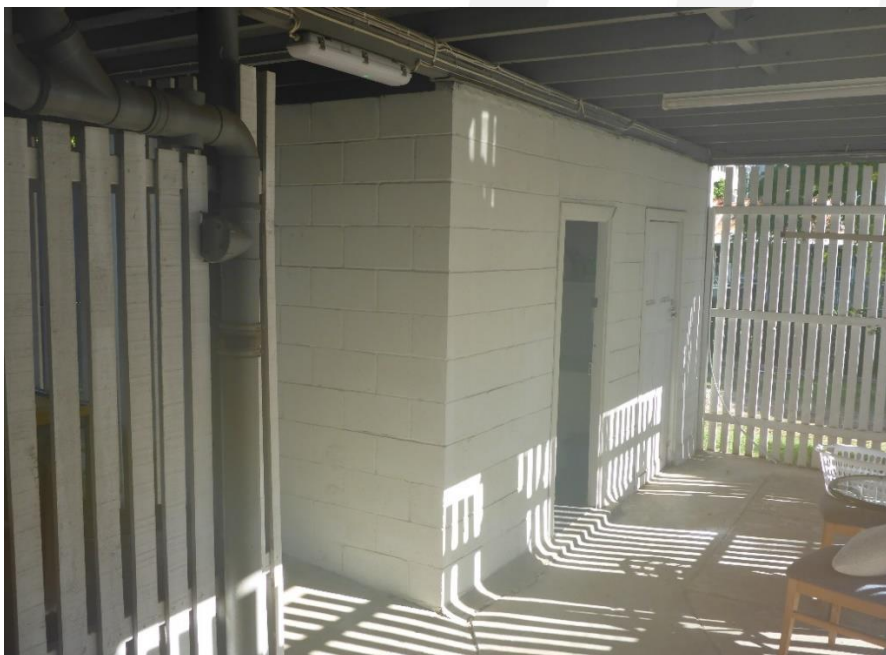
Figure 72: The undercroft space beneath the heritage residential building also incorporates a more contemporary laundry enclosure that has been constructed with concrete blockwork. (Source: VAULT)

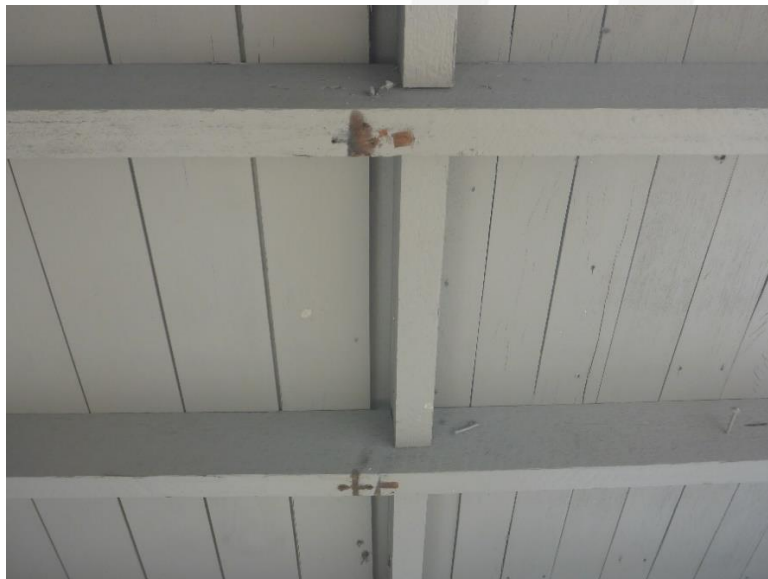
Figure 74: A more detailed view of the sub-floor framing (and associated floor linings) showing the differential in the gauge of the timber flooring lining what was the original core of the heritage residence, "Mimosa" (at image left) and the transition to narrower gauge decking boards (at image right) where the open side verandah space has been enclosed and integrated into the habitable areas of the building. (Source: VAULT)

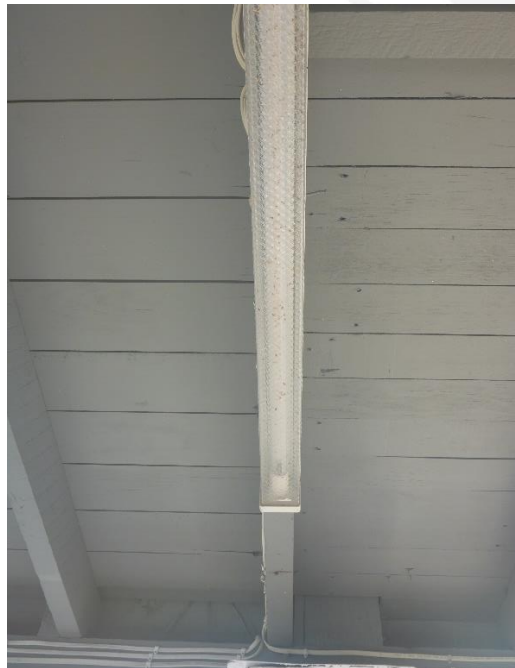
Figure 75: Another detailed view of the differentiation in floor lining that can be readily observed from within the undercroft space showing the wider gauge of interior timber flooring (at image left) and the narrower and lower grade species of the decking boards used where the original verandah spaces have subsequently been enclosed (at image right). (Source: VAULT)

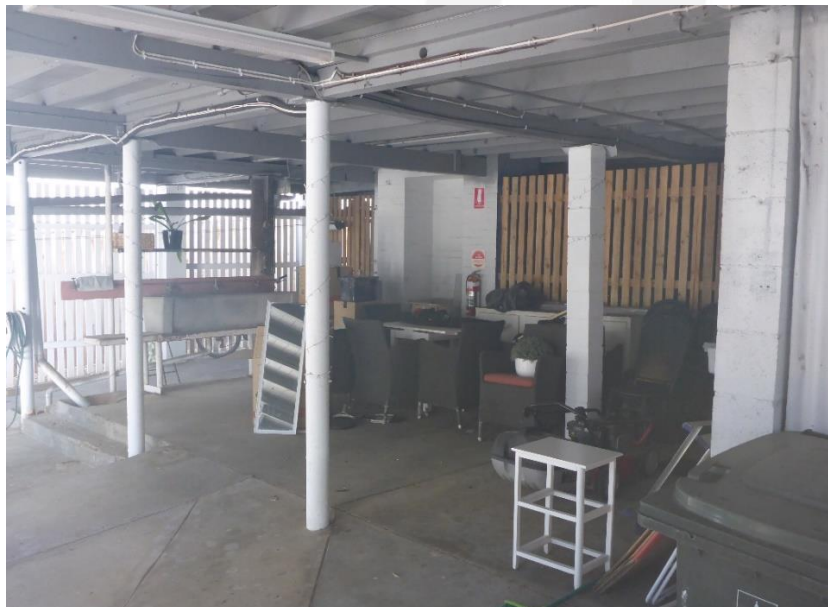
Figure 76: The reverse view across the extant undercroft space beneath the heritage building – taken from the opposite end of this space to that shown above in **Figure 68**, which again shows the varied array of non-original support structures (i.e. steel posts or concrete blockwork columns) that are extant within this space. (Source: VAULT)
