76-84 KING AVE, WILLAWONG –VEGETATION MANAGEMENT PLAN – COVER LETTER

Vegetation Management Plan

Level 3 / 12 Commercial Road Newstead Qld 4006 Ph 3505 3053 www.s5consulting.com.au	Issue	Description	Date	Client	Project Name	Project No.
		B	Vegetation Management Plan - Minor Change	29/05/2026	A1 Global Autoparts	76 & 84 King Avenue, Willawong	S521156
		Drawing Name	VEGETATION MANAGEMENT PLAN				VMP001

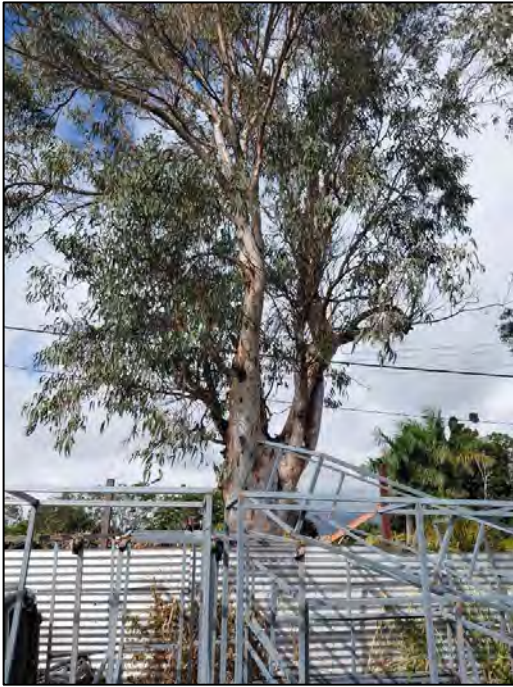
A site inspection was undertaken on the 14th of May 2026 by S5 Environmental Ecologist to assess the status of the additional trees proposed for removal. All 6 trees and stag were ground-truthed as present, with two (2) trees (Tree 30 and 28) located offsite, adjacent to the existing fenceline (refer to **Plates 1 to 5**).

Plate 1 Tree 30 – *Eucalyptus seeana* (Offsite)

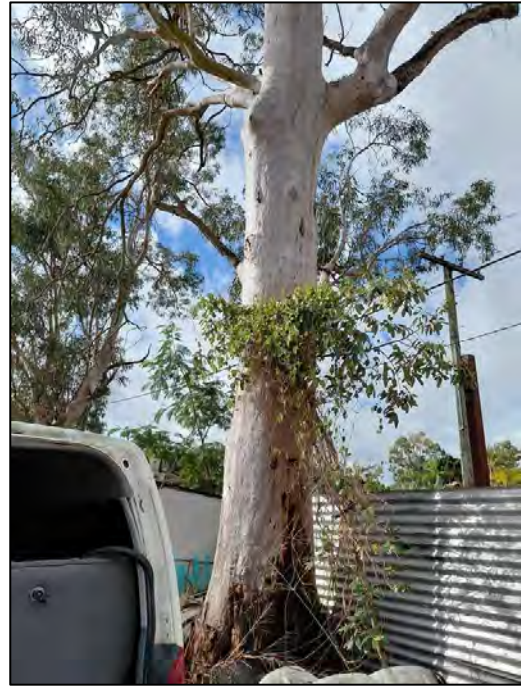
Plate 2 Tree 29 – *Eucalyptus seeana* (Onsite)

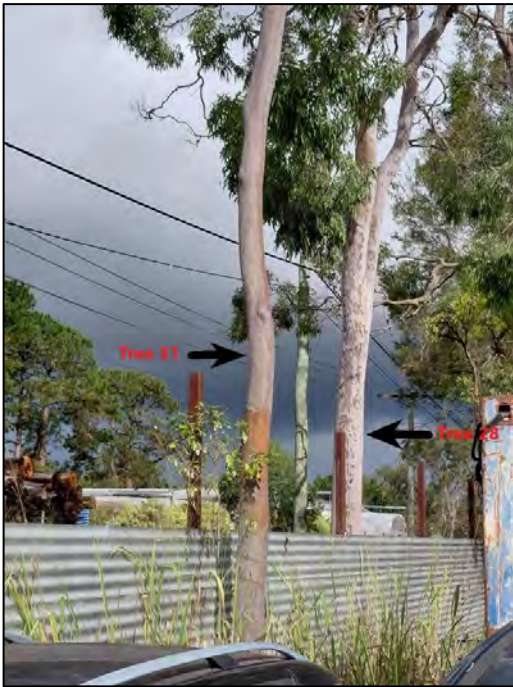
Plate 3 Trees 31 - *Angophora leiocarpa* (On-site) &
Tree 28 *Angophora leiocarpa* (Offsite)

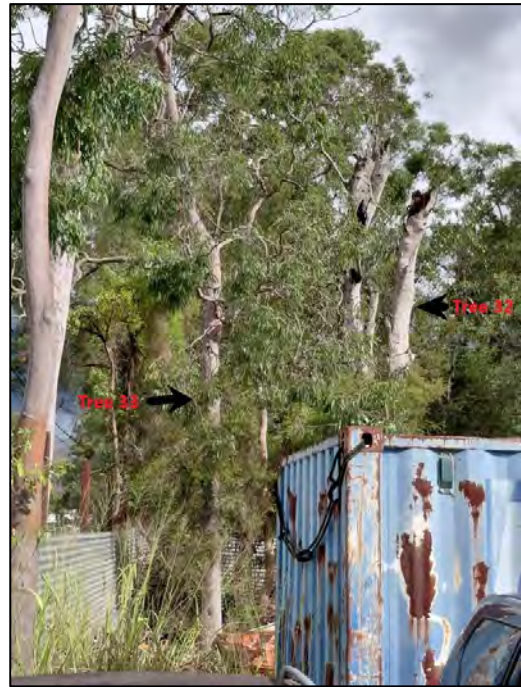
Plate 4 Tree 33 - *Angophora leiocarpa* (On-site) &
Tree 32 – Stag (On-site)

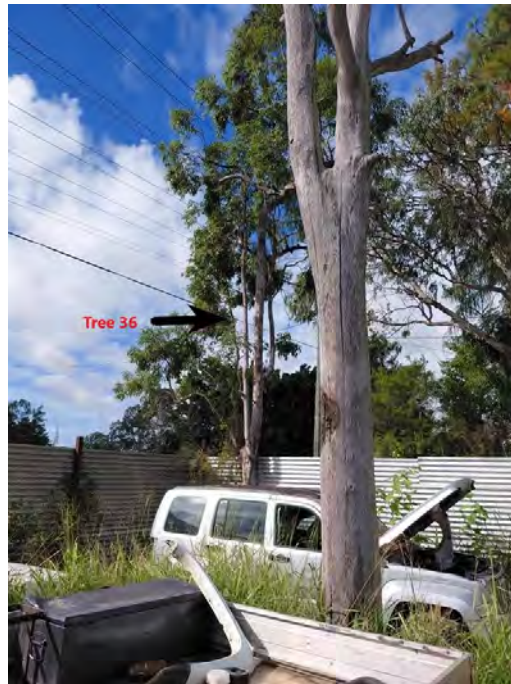
Plate 5 Tree 36 *Angophora leiocarpa* (On-site)

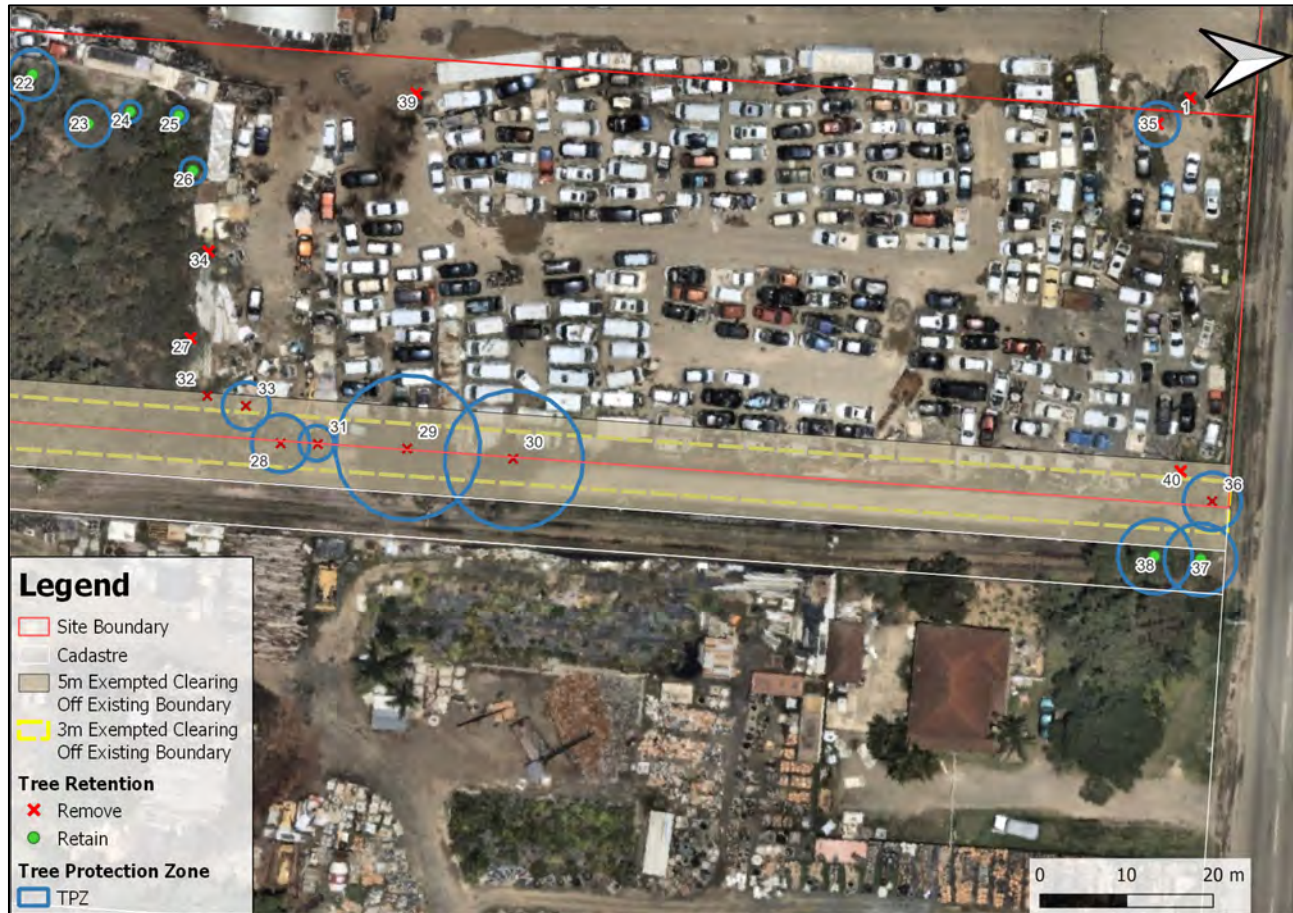
Therefore, S5 Environmental understands that the Lot owner holds the right to utilise exempted development for clearing up to 5m off a boundary fence line, which include Trees 28 – 33 and Tree 36 (refer to **Figure 1** below).

Figure 1 Clearing Exemption Distances Applied to Existing Boundary

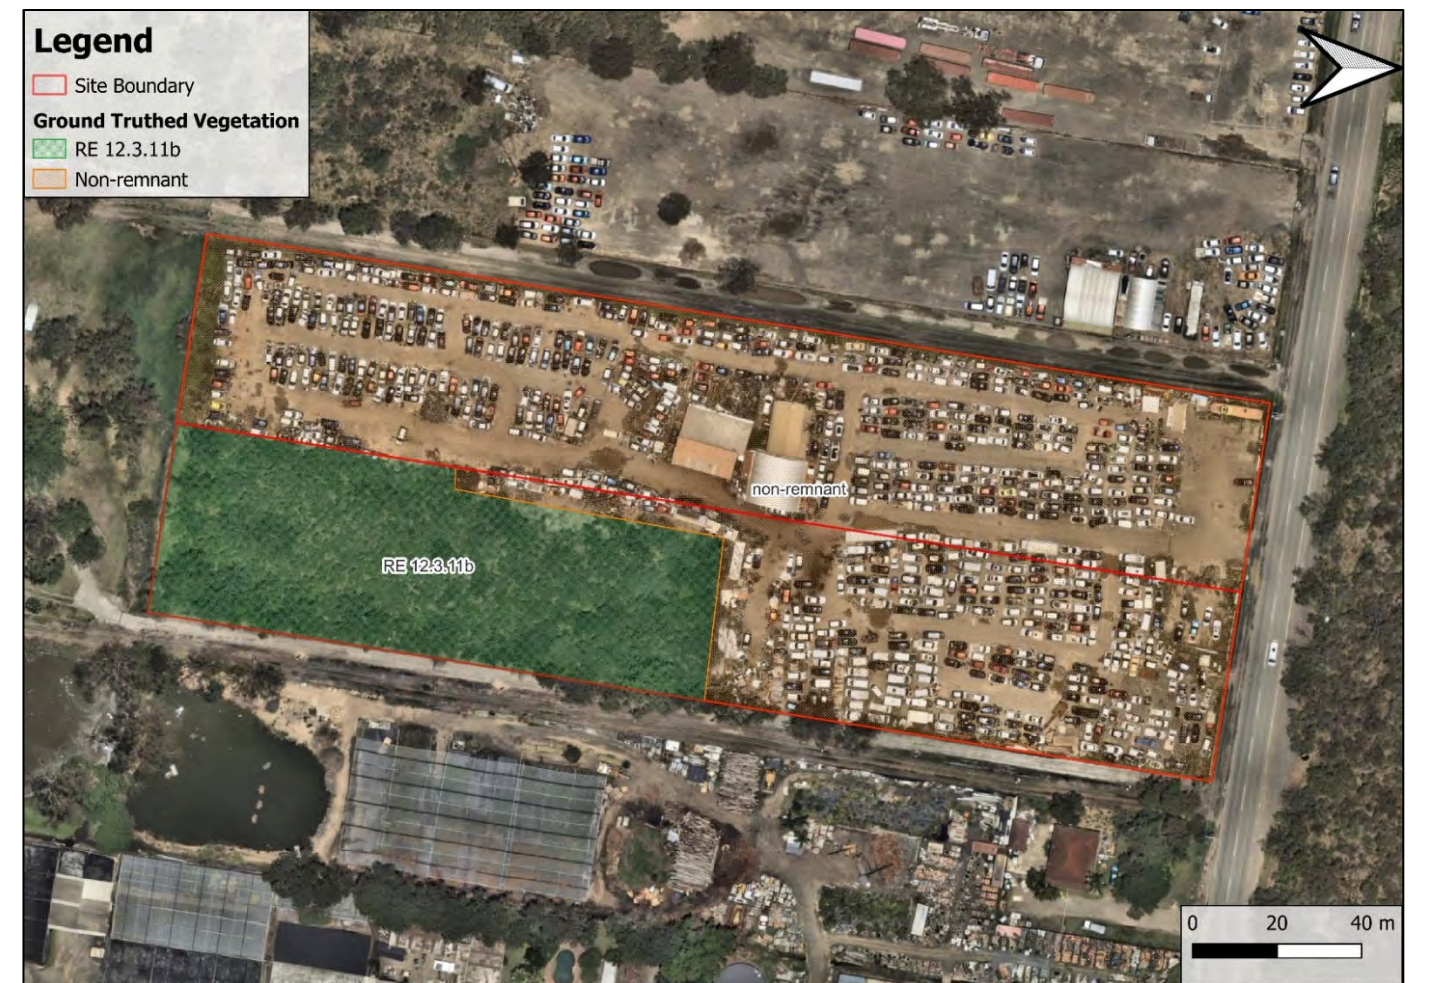
RE	Description
RE 12.3.11b	<p>The Regional Ecosystem for the area was identified as RE 12.3.11b, and dense vegetation is present within the south-eastern portion of the site. RE 12.3.11b is described as containing <i>Eucalyptus tereticornis</i> and/or <i>E. racemosa</i> subsp. <i>racemosa</i> +/- <i>E. siderophloia</i>, <i>Lophostemon suaveolens</i>, <i>E. seeana</i>, <i>E. fibrosa</i> subsp. <i>fibrosa</i>, <i>E. propinqua</i> and <i>Angophora leiocarpa</i> open forest, usually with a dense shrub layer dominated by <i>Melaleuca nodosa</i>.</p> <p>The observed tree species in the south-eastern area (Lot 17) included narrow-leaved red gum (<i>Eucalyptus seeana</i>), rusty gum (<i>Angophora leiocarpa</i>) black she-oak (<i>Allocasuarina littoralis</i>), red ash (<i>Alphitonia excelsa</i>), hickory wattle (<i>Acacia disparrima</i>) as trees with a canopy height between 8-16m along the site-facing perimeter of the remnant area and Sieber's paperbark (<i>Melaleuca sieberi</i>) dominating the smaller trees under 8 metres, also around the site-facing perimeter.</p> <p>Weed trees observed through the vegetation included Jacaranda (<i>Jacaranda mimosifolia</i>), Cadaghi (<i>Corymbia torelliana</i>), Chinese celtis (<i>Celtis sinensis</i>), umbrella tree (<i>Schefflera actinophylla</i>), Cocos palm (<i>Syagrus romanzoffiana</i>), broad-leaved pepper (<i>Schinus terebinthifolia</i>) and Easter cassia (<i>Senna pendula</i> var. <i>glabrata</i>).</p> <p>The shrub and ground cover layer was weed infested with species including lantana (<i>Lantana camara</i>), blue billy goat (<i>Ageratum houstonianum</i>), cobbler's pegs (<i>Bidens pilosa</i>), Rhodes grass (<i>Chloris gayana</i>), red natal grass (<i>Melinis repens</i>), fireweed (<i>Senecio madagascariensis</i>), signal grass (<i>Urochloa decumbens</i>), guinea grass (<i>Megathyrsus maximum</i> var. <i>maximus</i>), Johnson grass (<i>Sorghum halepense</i>), purple succulent (<i>Callisia fragrans</i>), climbing asparagus fern (<i>Asparagus africanus</i>), basket</p>

Figure 1: Ground-truthed Regional Ecosystems

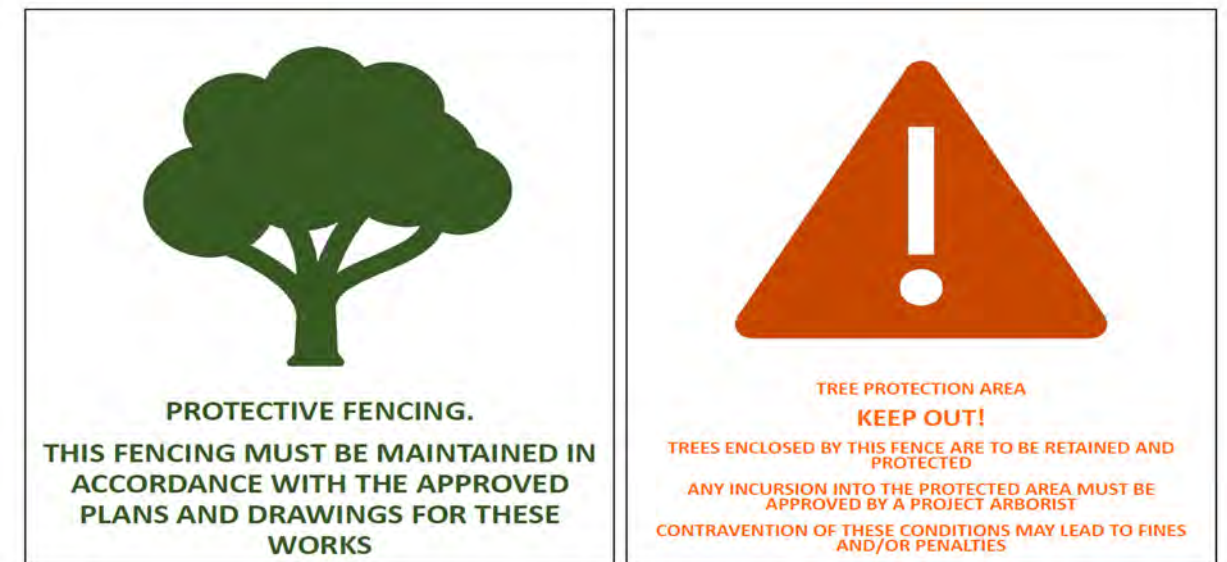
Suitable signage must be attached to the Tree Protection Fencing at suitable intervals. Tree Protection Signage should clearly identify the nature and purpose of the fencing and clearly indicate that all activities are excluded from within the fenced area. Examples of suitable TPZ Exclusion Signage are shown below.

Figure 2: Tree Protective Fencing Signage, Image source: AS 4970-2009
