Issue	Description	Date	Client	Project Name	Project No.
B	Vegetation Management Plan - Minor Change	29/05/2026	A1 Global Autoparts	76 & 84 King Avenue, Willawong	S521156
Drawing Name	VEGETATION MANAGEMENT PLAN				VMP001

This VMP has been developed to reflect the minor change request lodged and satisfy Condition 16(a) of the parent DA A005942878. The VMP details the management and mitigation measures to be followed prior to and during the clearing of vegetation for a for a shop, warehouse, and car storage areas at 76 and 84 King Avenue, Willawong. The property is further described as Lot 17 on RP 80241 and Lot 18 on RP 80241, herein referred to as the 'subject site' and has a total area of 23,016m².

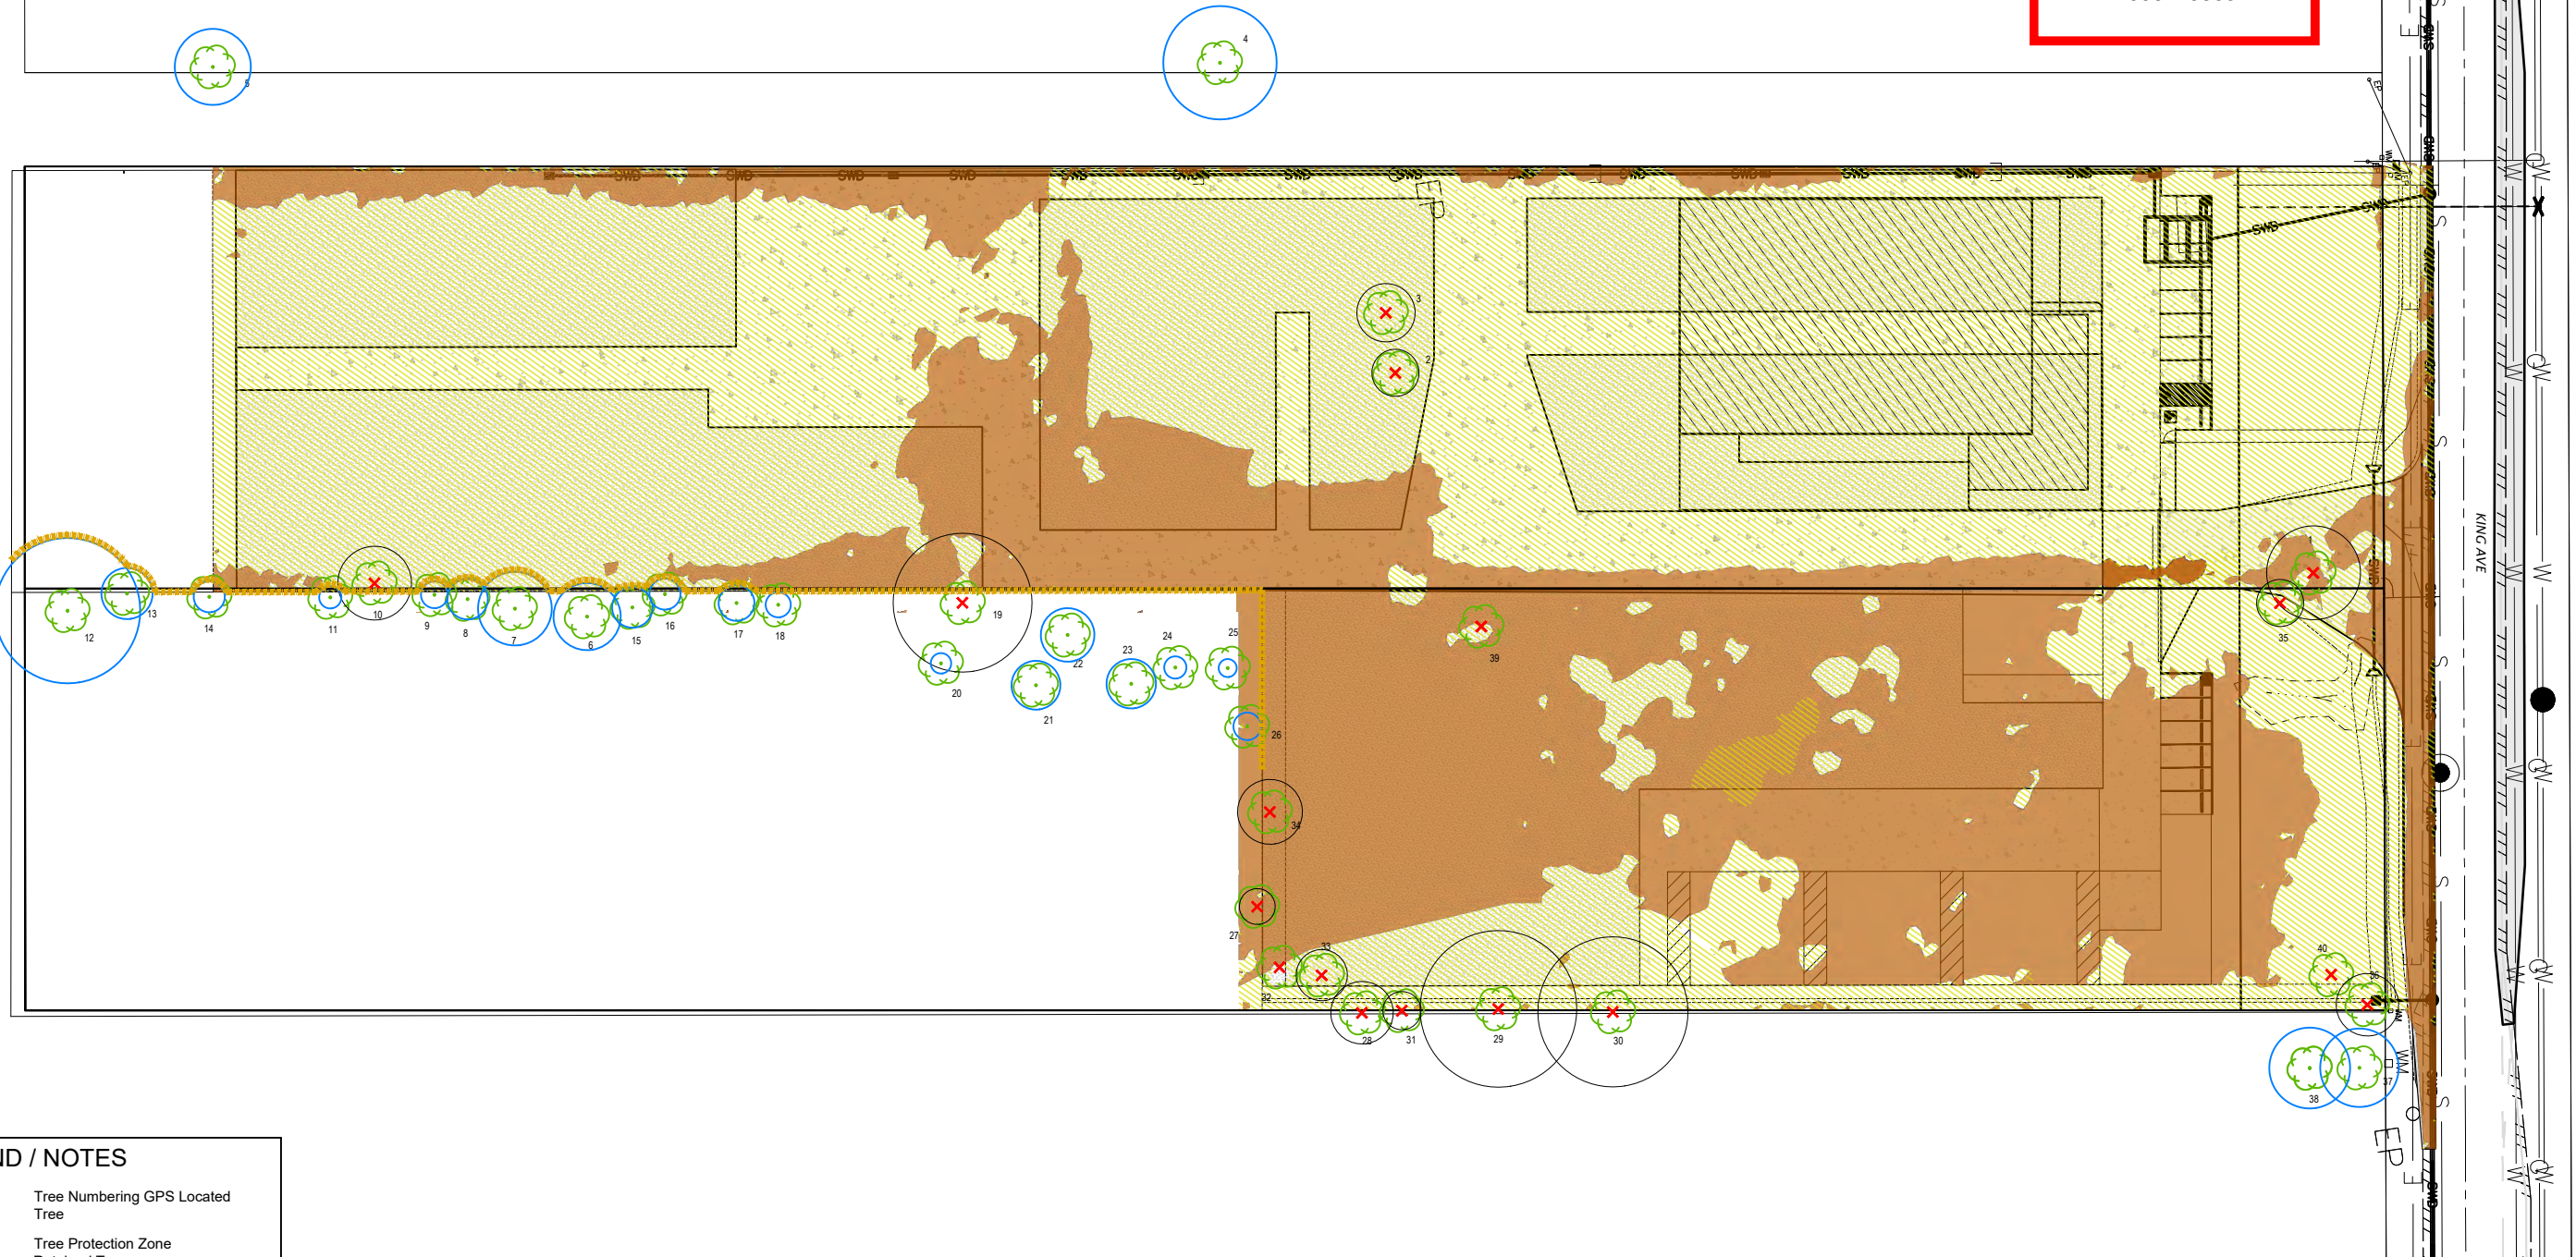
LEGEND / NOTES	
	Tree Numbering GPS Located Tree
	Tree Protection Zone Retained Tree
	Tree To Be Removed
	Tree Protection Fencing
	Proposed Earthworks - Fill
	Proposed Earthworks - Cut
	Proposed Stormwater

- Tree retention is to be in accordance with the cover page of this VMP and the Tree Schedule at the rear of this VMP;

- Trees to be retained outside of the subject site boundary include trees 4, 5, 37 and 38.
- Trees to be retained within the development area are trees 6-9, 11-18 and 20-26 around the northern and western perimeter of RMU2.
