Arboricultural Impact Assessment

Prepared For: SEQ Development 11 Pty Ltd

92 Eugenia Street
Inala QLD 4077

IAS21539

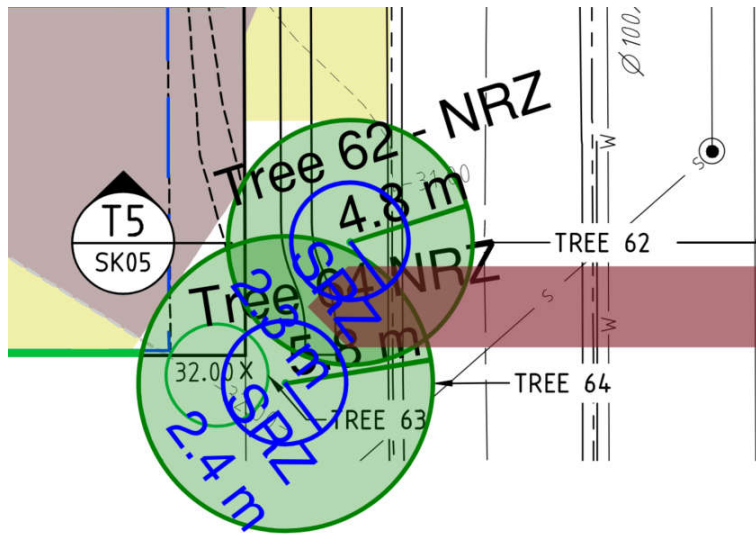
Tree 62 Impacts:

Tree 62: *Melaleuca quinquenervia* (Common Paperbark)

TPZ: 4.8 metres (radius), **DSH:** 400mm

Incursion: Major

Impact: Major impact from footpath.

Recommendation: Retain & Protect the *Subject Tree*

- All required pre-start meetings and regulatory permissions to be in place.
- Undertake vacuum excavation along the proposed cut line for footpath on the extent closest to the *Subject Tree*. Roots under 50mm in diameter can be clean cut. All other roots are to remain in situ.
- Where roots for retention are identified, methodologies such as ramping of roots or a floating slab is to be incorporated. Plastic formwork chairs and reinforced mesh to be laid (if required) and concrete poured on top. TripStop® may be required where ramping is undertaken.
- Organic fill may be required to modify the road reserve profile and support battering from the footpath. Fill is prohibited around the collar of the *Subject Tree*.
- Facilitate a plant health care program to mitigate the negative impacts of construction quarterly for 12 months post footpath construction where root severance has occurred.

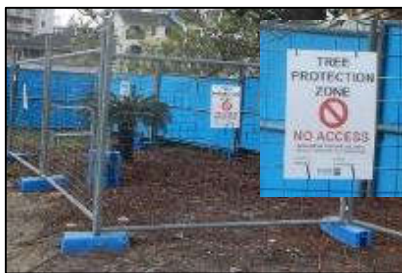
Figure 4

Example of Fauna Friendly Rigid Style Temporary Fencing

An exclusion zone is to be established along the perimeters of retained trees and cordoned off with a physical barrier of wire mesh fence, 1.8m in height, which is securely anchored. The role of these fences is to prevent any damage to the complete tree including root system (SRZ & TPZ), stem and branch structure as well as the crown or canopy. Alternatively, and on approval of a minimum AQF5 Project Arborist, plastic mesh fencing, 1.2m in height, secured with star pickets and caps with straining wire can be utilised. All TPZ fencing will require appropriate signage to signify the relevant protection zones. This will require audit and sign off prior to operational works onsite.

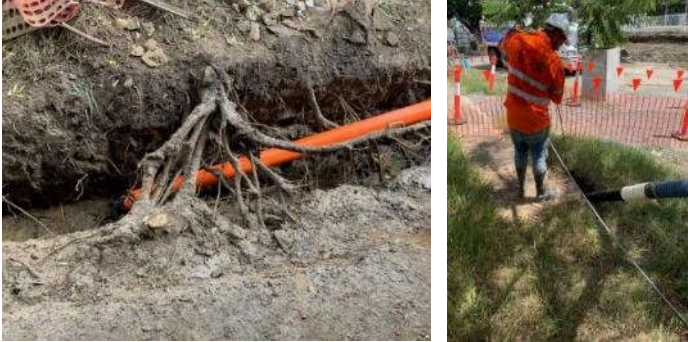
Examples	Photos
<p>The use low pressure water excavation for the installation of conduits</p>

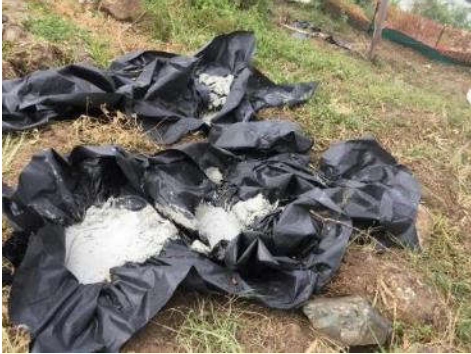
<p>The use of black plastic to line pier holes</p>

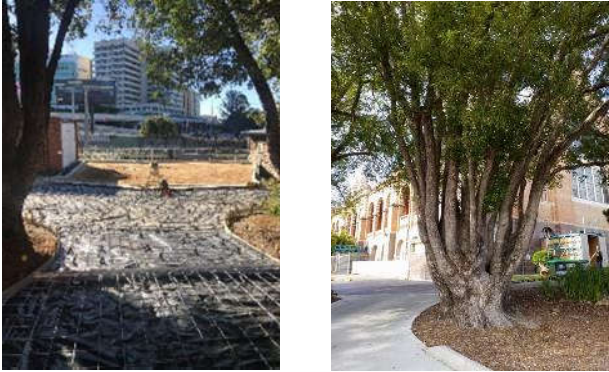
<p>The use of black plastic to line concrete</p>
