RE: BCC Information Request – 45 Portal Street, Oxley (A006814396)

45 Portal Street, Oxley
(Lot 9 on RP84473)

Concept Rehabilitation Plan -
existing conditions

TYPE: Concept Rehabilitation Plan

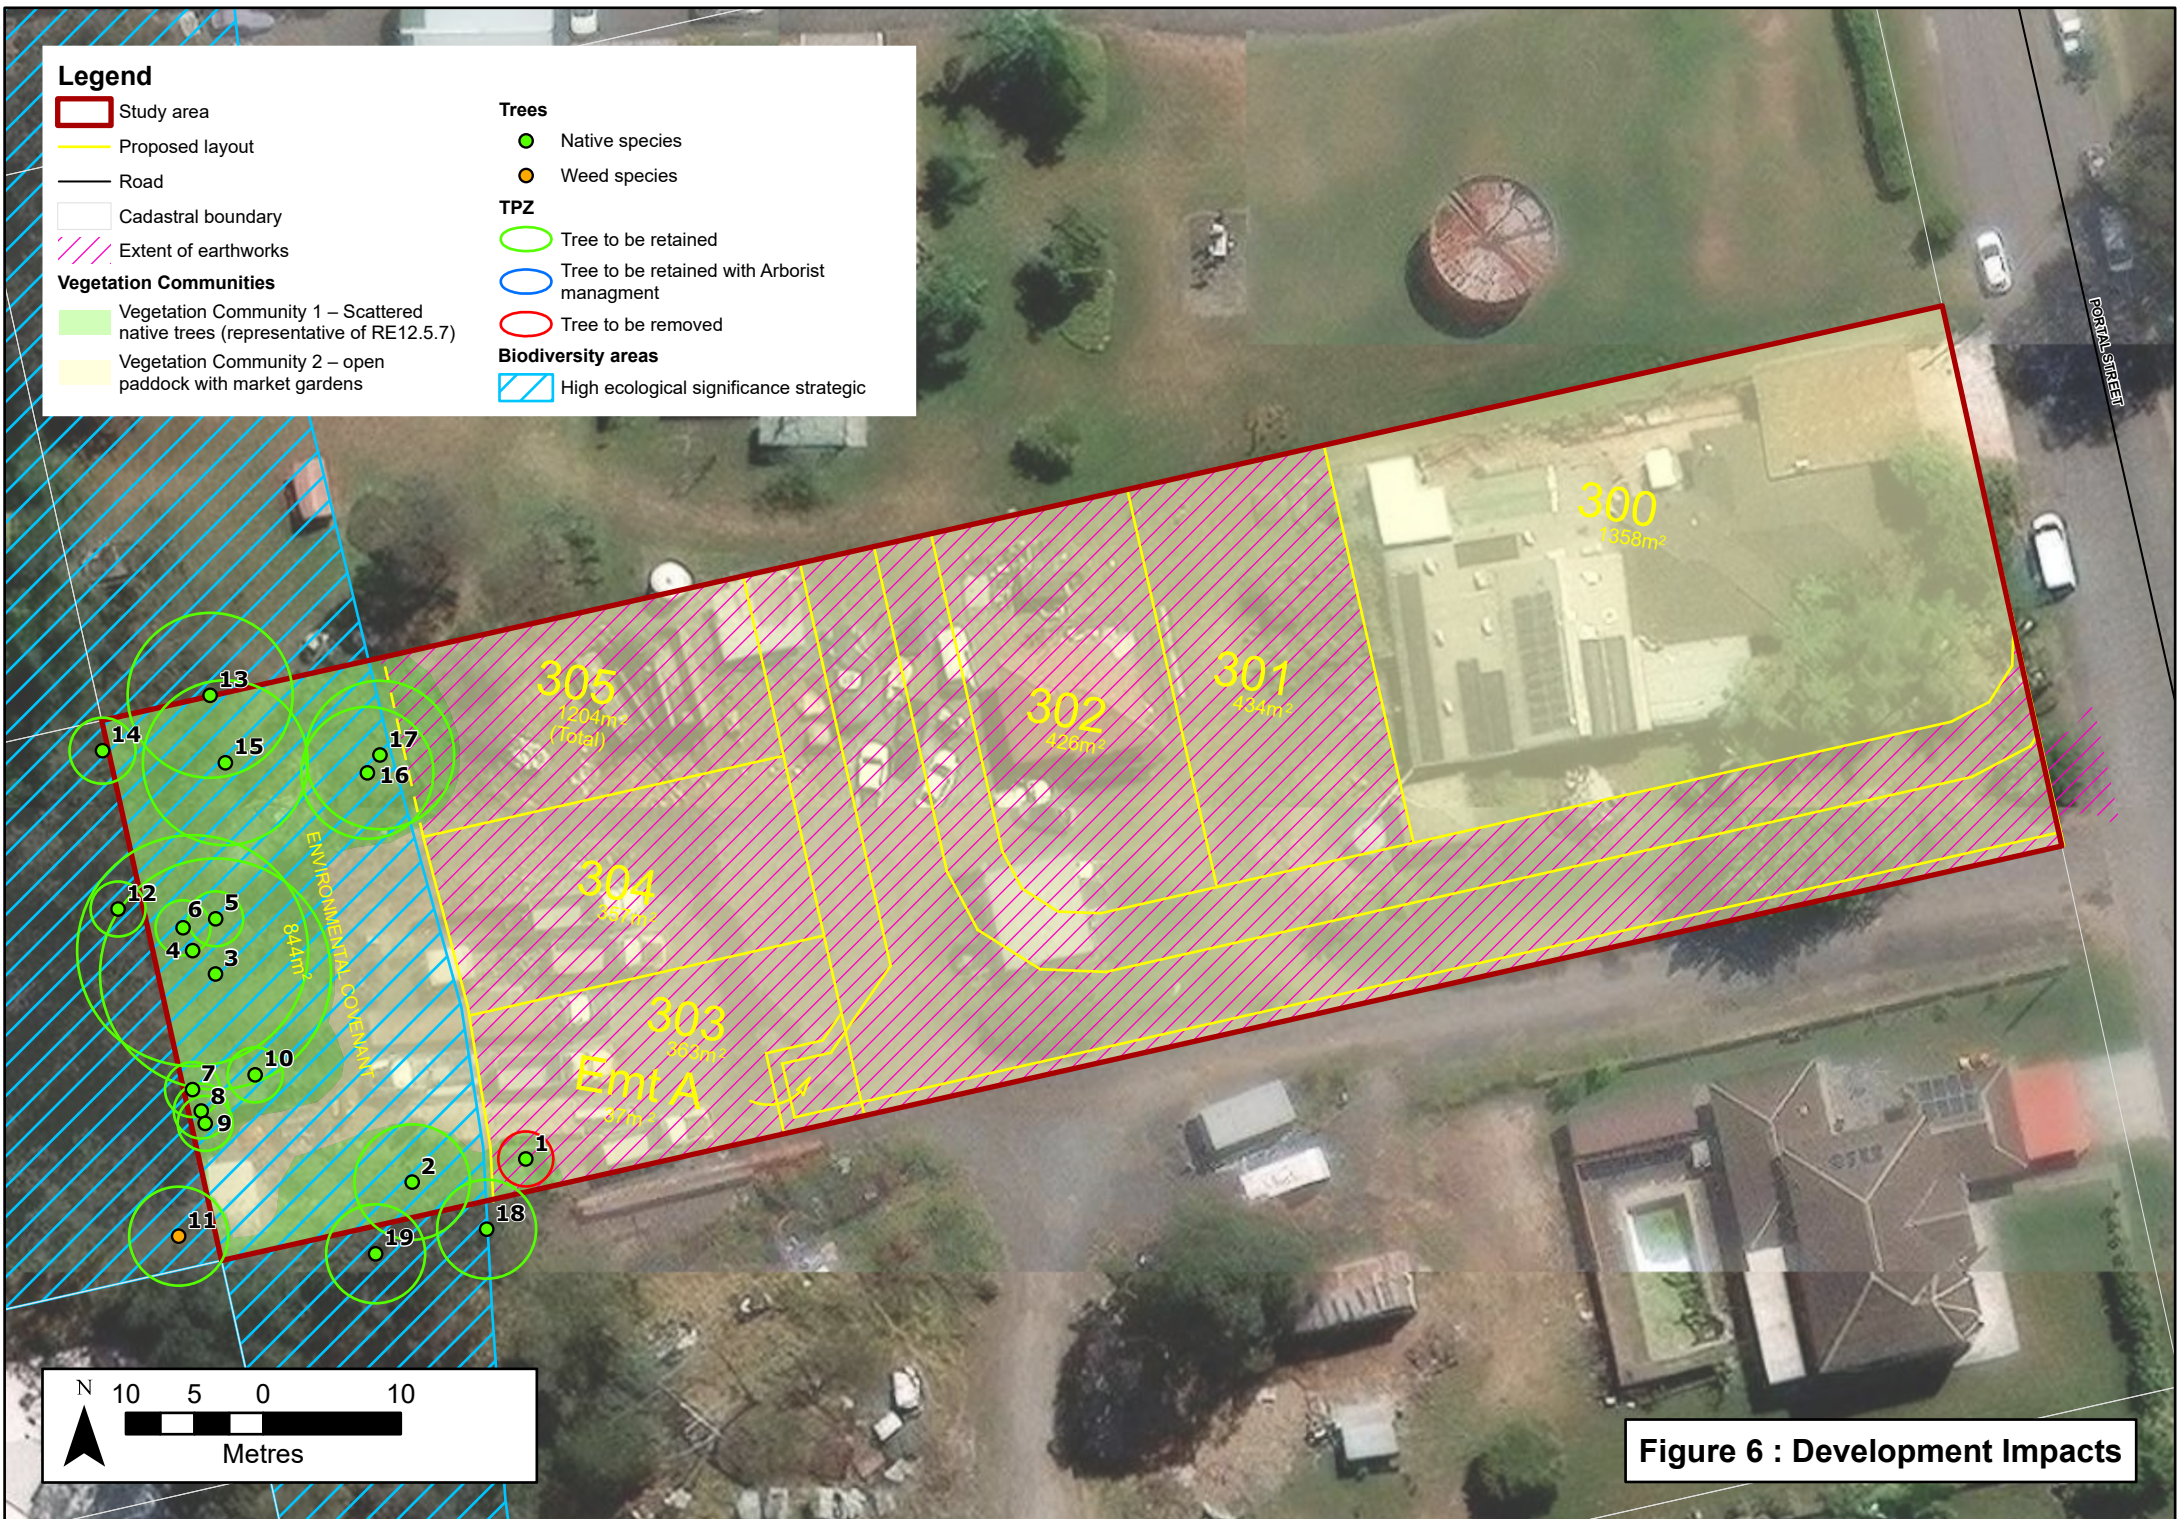
Figure 6 : Development Impacts

Figure 6 in the EAR provides an updated layout and the relevant civil works plans overlaid onto ecological values, including the tree survey. No native trees (>10cm DBH & 4m high) will be removed in the environmental covenant area. One native tree will be removed as a result of the development.

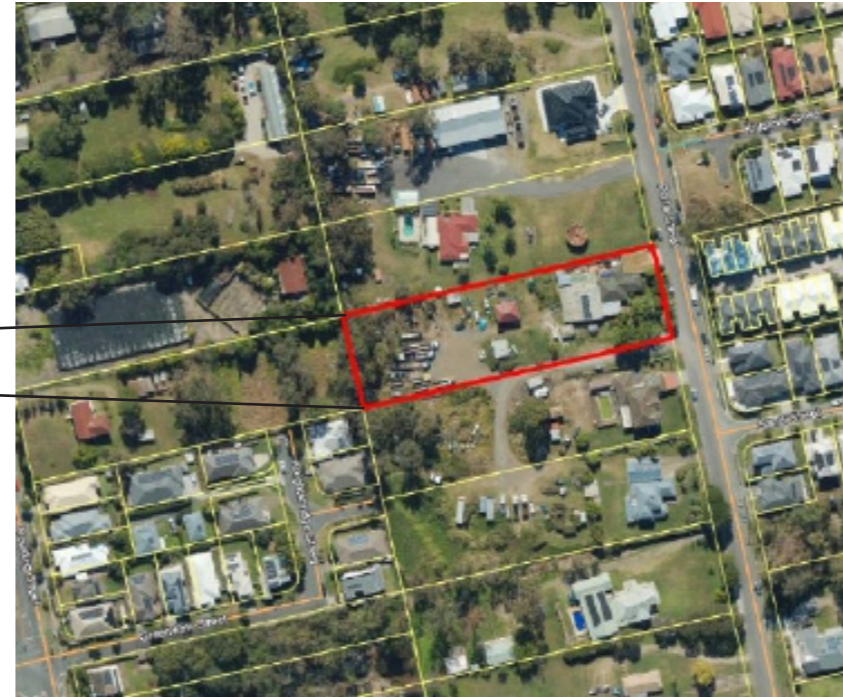
LOCATION PLAN

The development application will involve the creation of an additional 5 lots (creating 6 lots in total) on the subject site. There will be one large lot (>1,200 m²) with road frontage to retain the existing brick house and two smaller lots (> 400 m²) located on an access road that traverses the southern boundary before heading north and providing access to another three lots in the western extent of the subject site within the area zoned as 'emerging communities'. These rear allotments will have a developable area of around 360 m² each. The mapped HESS area in the west of the subject site will be retained in an environmental covenant area to be rehabilitated, within Lot 305 (making this lot >1,200 m²).

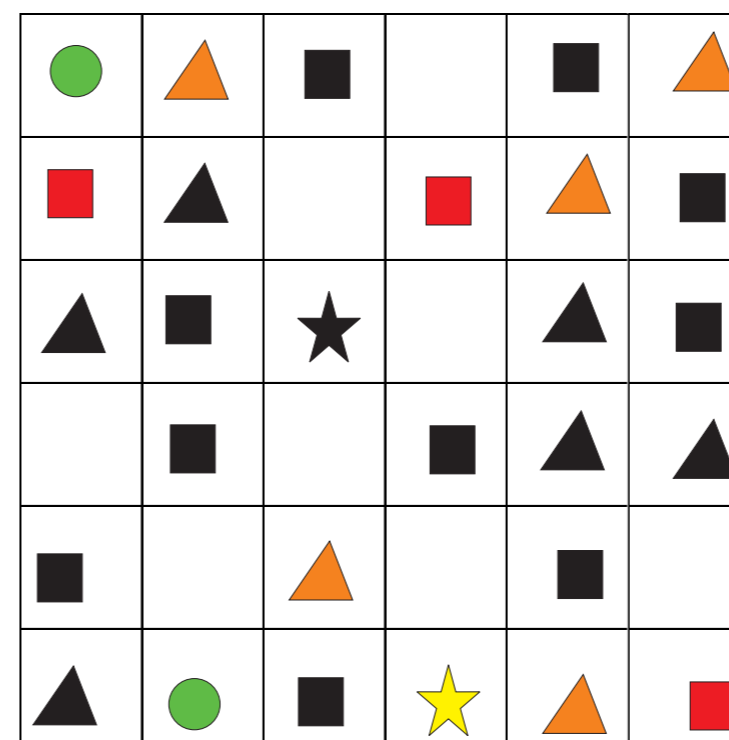
EXAMPLE PLANTING PALETTE VMU 1 - INFILL PLANTING

4.5m x 4.5m = 20.25 square meters
 Each square represents 0.75m x 0.75m

- ★ Existing canopy/ midstorey tree
- Existing shrub
- ▲ Existing groundcover
- ★ Canopy tree
- Mid-storey tree
- Shrub
- ▲ Groundcover

Planting of tube stock will be undertaken in areas that have been left with sparse native vegetation after weed removal. Planting will be undertaken as per Detail 1 (page 5). To plant tube stock within areas treated with stabilisation mat, a 10cm hole may be cut in the mat and planting procedures followed. The planting palette is to represent RE12.5.7 (*Corymbia citriodora subsp. variegata* +/- *Eucalyptus portuensis* or *E. acmenoides*, *E. fibrosa subsp. fibrosa* open forest) and incorporate the following species:

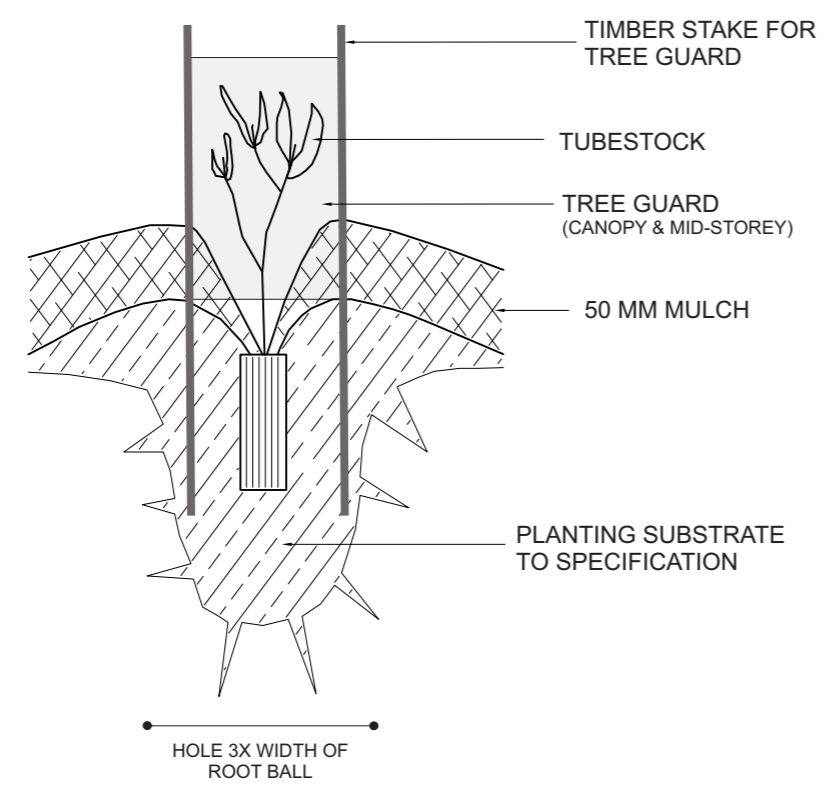
1 TUBESTOCK PLANTING DETAIL

1. Inspect plant for pests, disease and defects prior to planting.
2. Water plants in pots before planting.
3. Thoroughly wet holes before planting tubestock.
4. The top of the root ball should be level with the surrounding ground.
5. Berm (mound of mulch) should start at outer edge of the root ball.
6. Tree guards only necessary for canopy and mid-storey species.
7. Ensure timber stakes do not penetrate root ball.
8. Water and tamp plant after planting to settle.
9. Avoid planting in summer, due to heat stress on plants.
10. In the absence of rain, water plants once weekly for 6-8 weeks
