RE: Response to Information Request – 198 & 202 Gardner Road, Rochedale 4123

BCC Information Request Response

This Information Request (IR) response (Application References A006761597 and A006940193) has been prepared by BAAM Ecology, specifically responding to the ecological issues raised in two IRs, providing further information to the BAAM Ecological Assessment Reports for this proposed development.

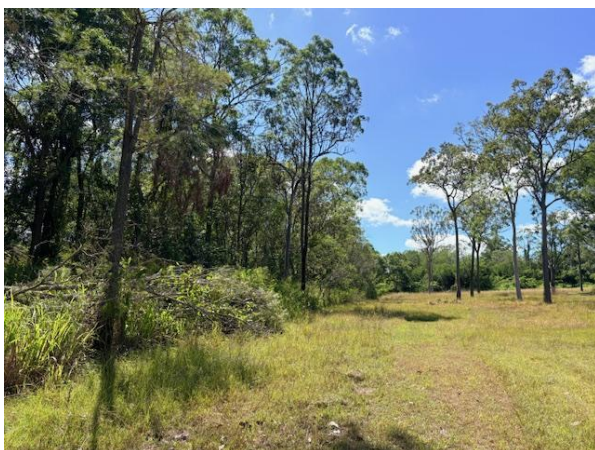
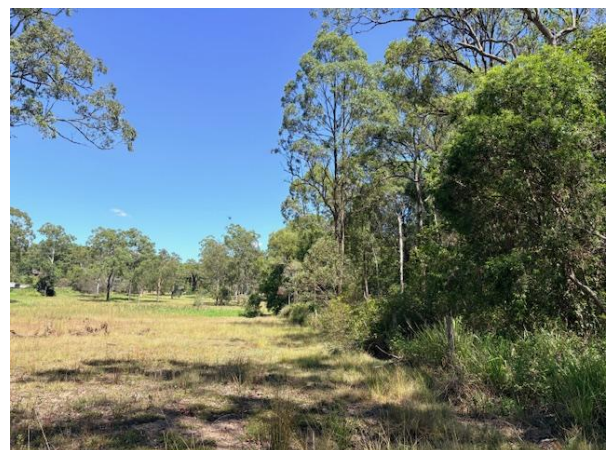
Photos 1 & 2 – Showing views along the northern boundary where the area is mapped as HESS with no native vegetation present.

There is also a narrow strip of HESS mapping that follows the northern boundary of lots 6 & 102 (**Figure 0**). This HESS mapping appears to be from aerial photo shadowing of native vegetation in adjoining bushland directly to the north of the site. Site inspection found this area to primarily consist of mown grassland with occasional native trees (**Photos 1 & 2**).

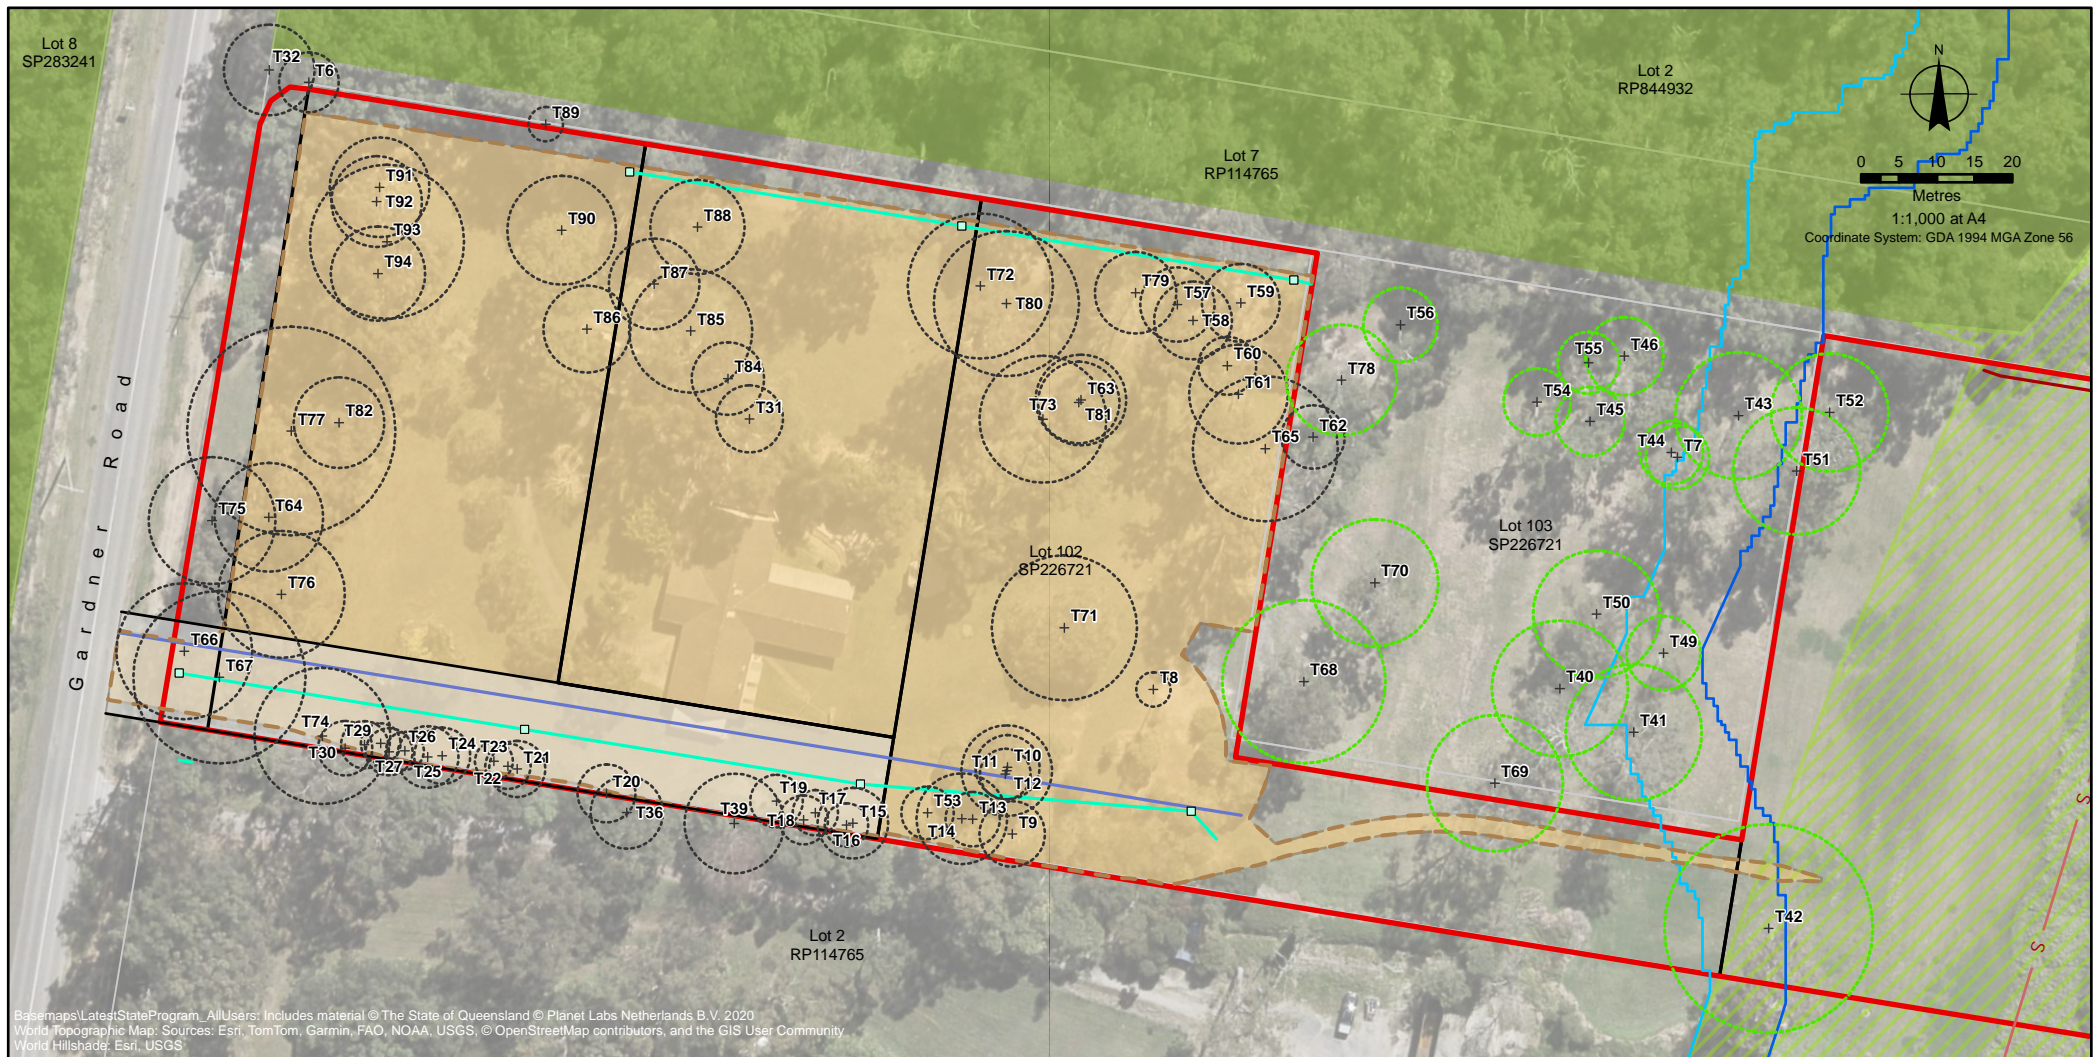
Figure: 0
Title: Vegetation Retention Plan - Overall
Project: 184, 198 & 202 Gardner Rd & 56 Farley Rd, Rochedale Qld (Lot 102 on SP226721, Lots 3 & 4 on RP114765, and part of Lot 6 on RP114765)
Client: Rochedale Development Partners

4a): A revised Vegetation Retention Plan is illustrated in **Figures 0 to 5**, showing all trees 100mm DBH or greater within the site. The figures also include the proposed development plan including services and the extent of all earthworks (cut/fill) required for construction of the development.

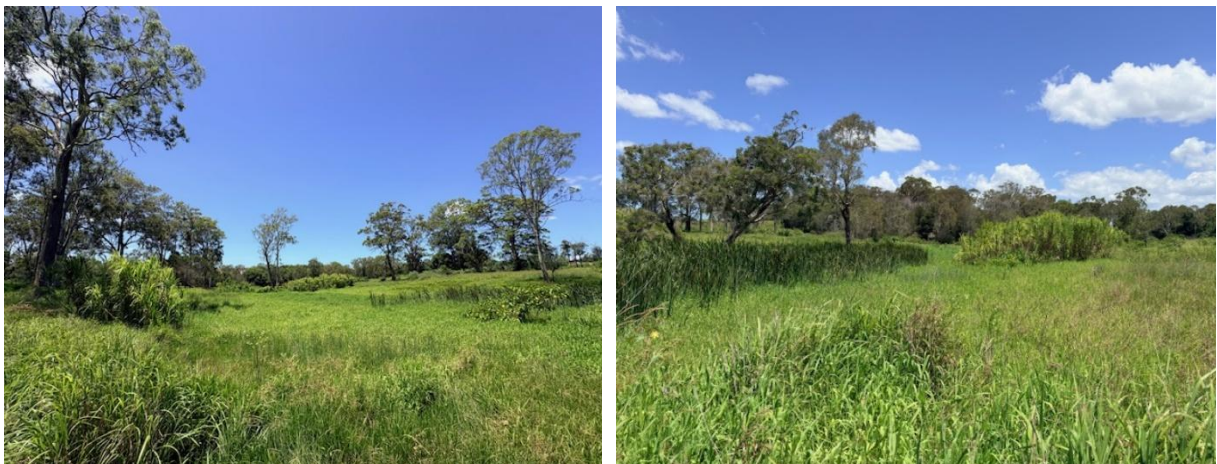
Photos 3 & 4 – Waterway corridor dominated by exotic grass

There is limited native vegetation currently growing in the waterway corridor which is generally limited to:

- Scattered native trees including *Eucalyptus tereticornis*.
- A small patch of native *Typha orientalis* (bullrush) with two mature *Melaleuca linariifolia* trees and one *Melaleuca quinquenervia* tree on the southern boundary of the site.
- A small patch of native *Typha orientalis* (bullrush) with a small number of young *Melaleuca quinquenervia* trees on the northern boundary of the site.

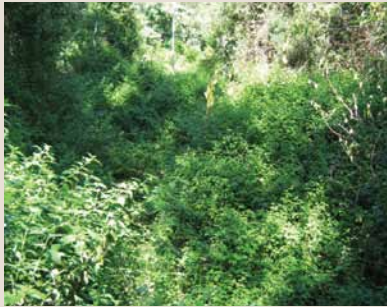
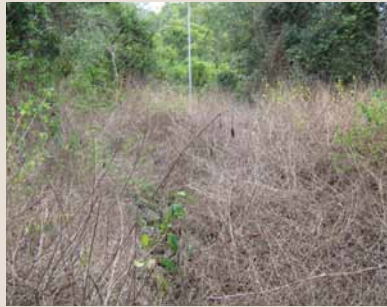
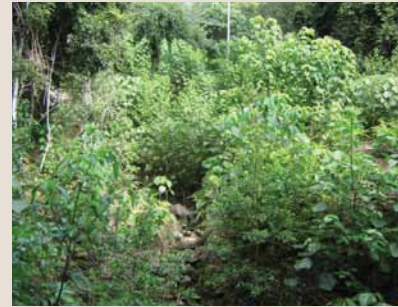
As of July 2010 after only 3 years effort of restoration, 55ha is under active management i.e. at maintenance level. This has been achieved by utilising a number of professional bush regeneration teams that work as a 3-4 person crew 1 day per week for two of the areas and one day a fortnight for the campground and high altitude forest. It is estimated that at this rate, all forested areas will be under a level of management within 10 years and the more open areas will be under reconstruction.

2008 - prior to work starting

2008

2010

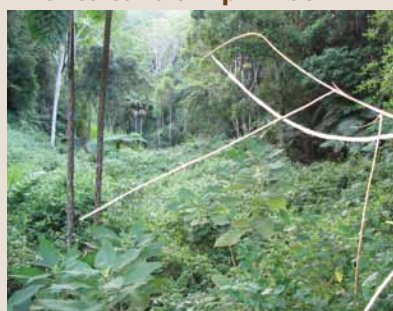
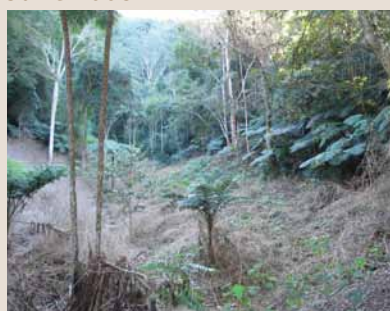
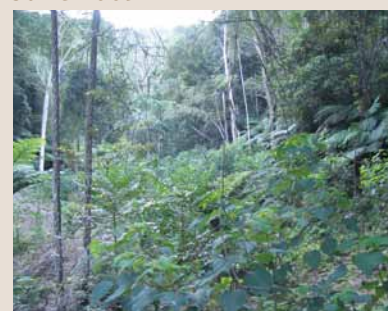
Assisted natural revegetation after control of Lantana

Prior to control April 2007

June 2008

June 2009
