**FW: Submission – Development Application A006923355 – 76 Queens Road, Everton Park**

**FORMAL SUBMISSION / OBJECTION**  
**Development Application – 76 Queens Road, Everton Park (MCU – Multiple Dwellings)**

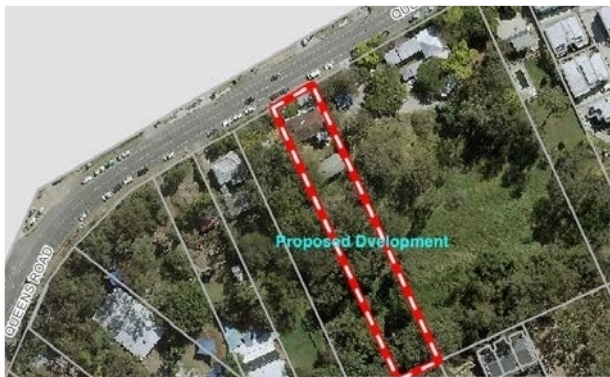
**Image 1**

- Image 1: Red: proposed development site,
- Image 2: significant overland and water catchment – see Section 7.5 for video evidence

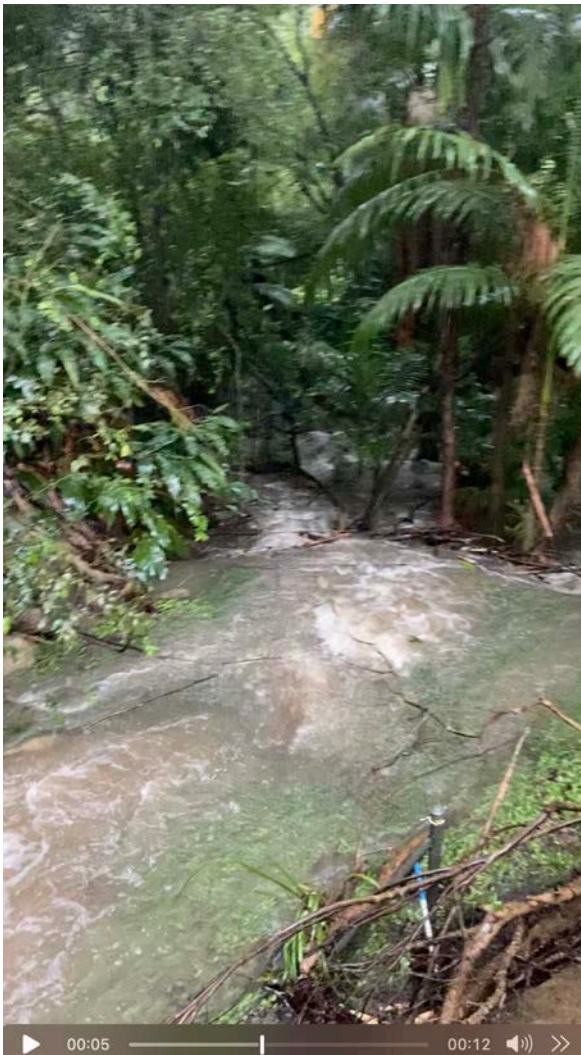
### Video 1: Vegetation Area

*Attached home videos from recent heavy rain (not flood events) showing the wetland area – screenshots below, full videos provided in submission*

- *Video 1: Vegetation Area*
- *Video 2: heavy overland flow*
- *Video 3: Overland flow from our property*
- *Video 4: Catchment area water passing through development site*

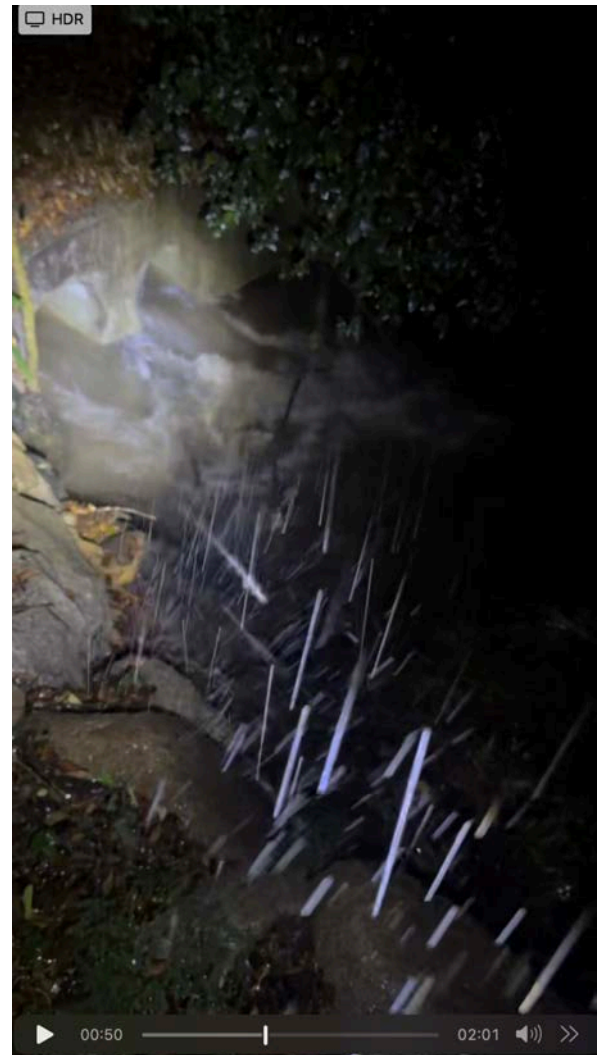
### Video 2: Overland Flow

Attached video evidence demonstrates the volume and movement of water through this corridor during **normal heavy rainfall events (not flood conditions)**.

- the intensity of flow through the area
- the reliance on existing vegetation for stability
- the sensitivity of the corridor to disturbance

- detailed stormwater management plan
- demonstration of **no increase in downstream flow volume or velocity**
- erosion and sediment control strategy
- protection of riparian vegetation
- modelling of overland flow paths under post-development conditions

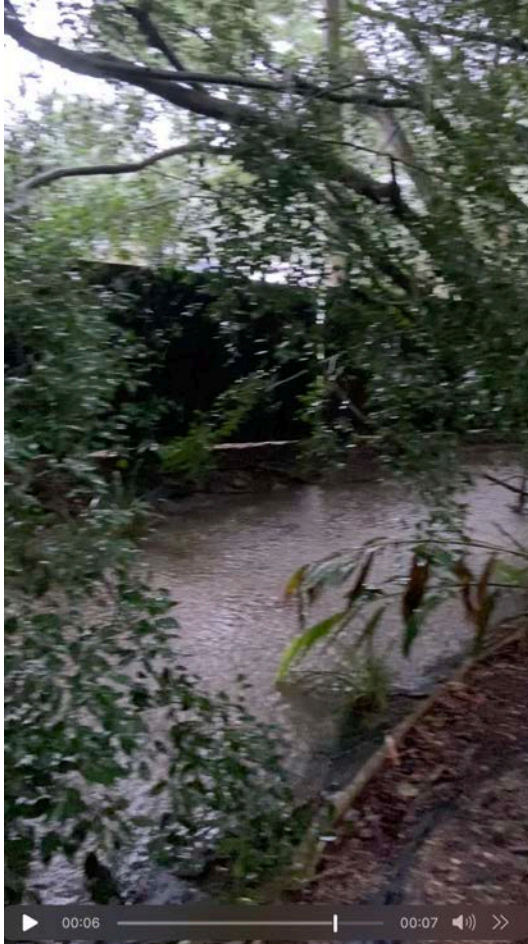
Video 3: Our property overland flow

Our property is located **downslope of the subject site**, meaning any changes in:

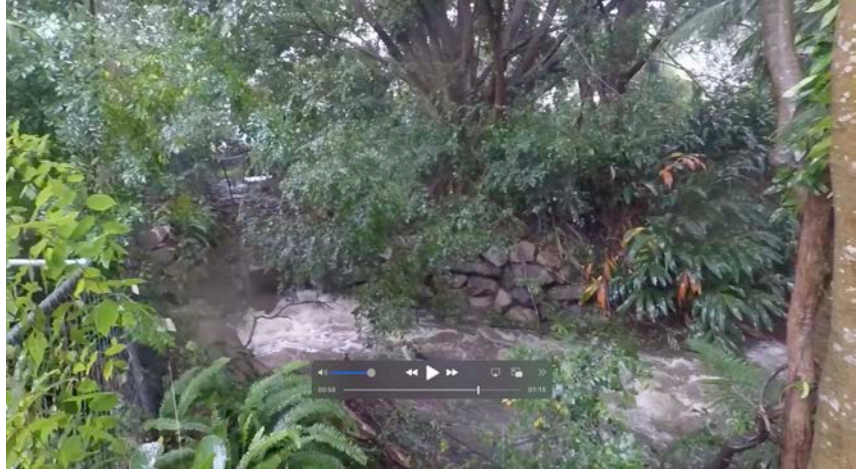
Video 4: flow of water from catchment

- the corridor carries **significant water volumes during rainfall events**
- the catchment extends beyond the subject site, including:
  - surrounding residential areas
  - Rogers Parade West
  - the adjoining school catchment
