# UTILITY MAP REPORT

<b>PROJECT LOCATOR</b>	Ryan Bradbury
<b>DATE</b>	25/05/2026
<b>SITE ADDRESS</b>	15 Villa Street, Annerley
<b>CLIENT</b>	Insight Planning Development
<b>SITE CONTACT</b>	Anthony Colwell
<b>CLIENT EMAIL</b>	anthony@insightplandev.com.au
<b>CLIENT NUMBER</b>	0413 608 612

CCTV investigation on stormwater assets conflicting with scope of works.

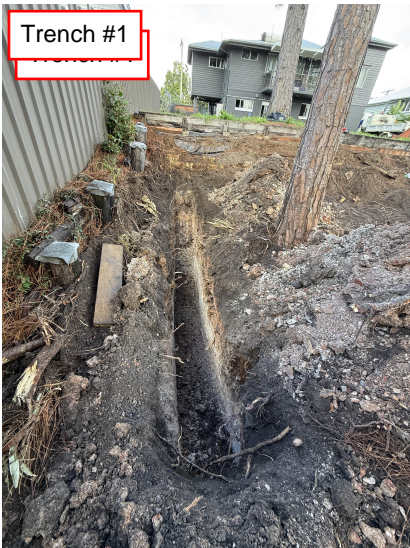
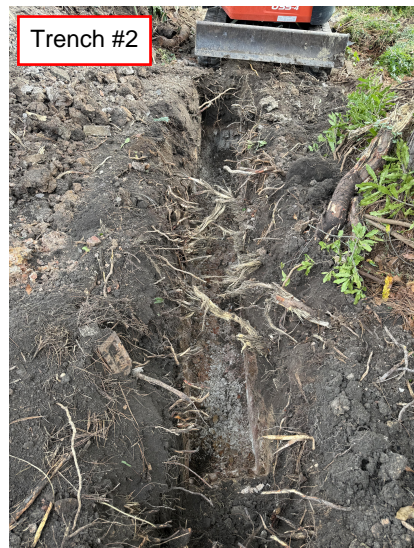
After today's investigations, it **appears possible** that the stormwater assets no longer exist.

Trench #1  
Trench depth approximately 1.4m to 1.6m  
Offsets:  
8.65m from the north western boundary fence.  
1.65m from the retaining wall.  
Please see photos on the following page.

HIGHLY RECOMMEND NON DESTRUCTIVE DIGGING SERVICES IN THIS AREA
