**RE: Structural Review of Relocation of Existing Heritage Listed Huts**

ALTERATION AND RELOCATION OF TWO EXISTING HERITAGE BUILDINGS  
UNITING CHURCH BRIGHTON CHILDCARE  
Structural Condition Report

December 2024  
Project No.: 24373  
Revision No.: B

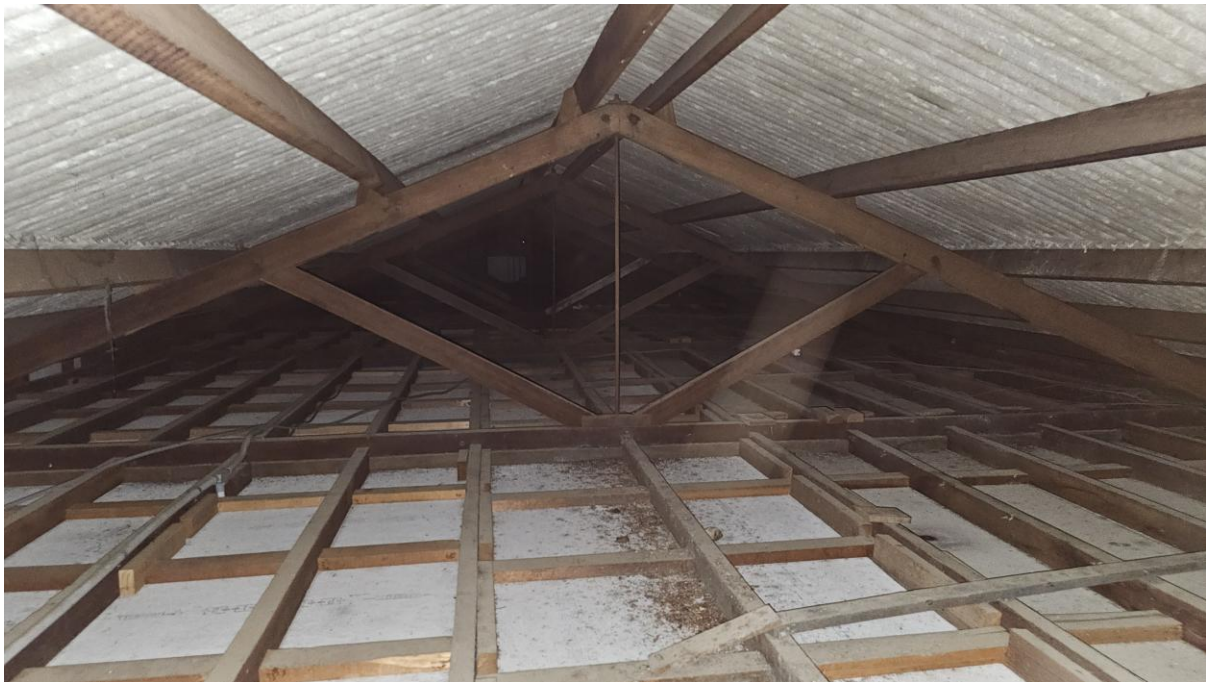
Photo 3: Roof Framing

Gable roof framing in Building 'A' and 'B' was configured using timber truss system. The roof trusses at Building 'A' are spanning from external wall to external wall at 6.8m, meaning the internal walls are not taking any roof loading. On the other hand, Building 'B' roof trusses is also spanning at 6.8m from external wall to internal wall and addition of 2.5m roof spanning to external wall as shown in Figure 1. The roof trusses spacing was measured at 3m centres. The ridge height of the roof truss from top of ceiling is 1.5m with 24° pitch approximately.
