# Management (Identification) Survey *Asbestos Survey Report*

**10059445-C1**

16 Twenty Fourth Avenue, Brighton QLD 4017

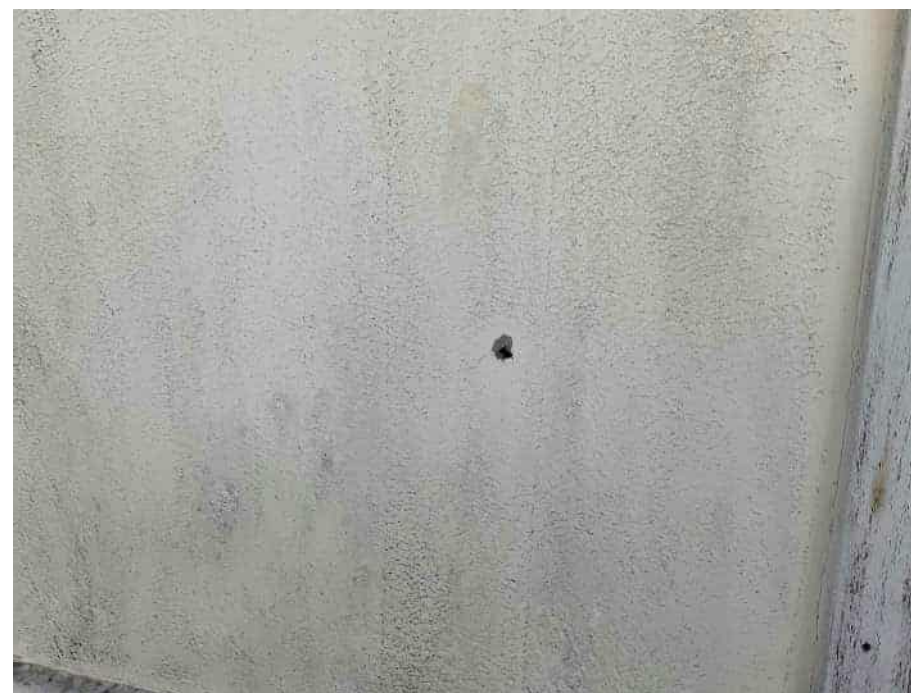
Sample location of wall cladding

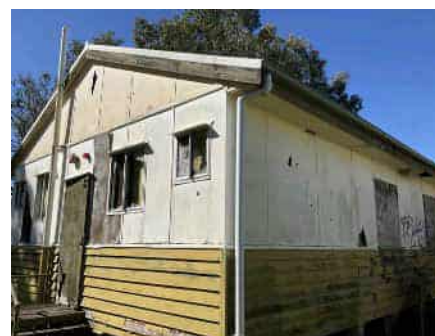
Wall and gable cladding - Overview

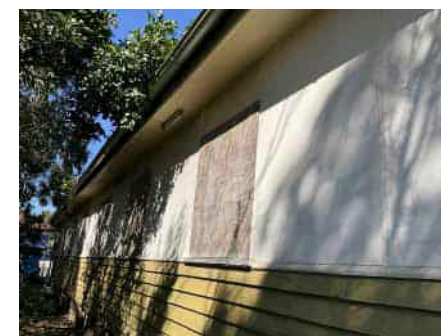
Wall and gable cladding - Overview

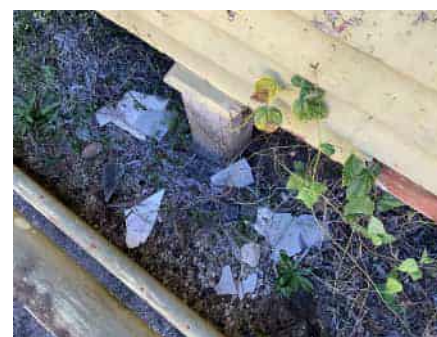
Damage to the external cladding and soffits has resulted in the accumulation of asbestos-containing debris on the ground surrounding and beneath the buildings. In some locations, ACM debris has also migrated into internal areas and roof void spaces through openings created by vandalism and the throwing of objects into the structures. Beneath the southern building, this includes stockpiled and unused ACM roofing materials, which will require removal. In addition, ACMs fixed to the ground will

ACM Debris adjacent building

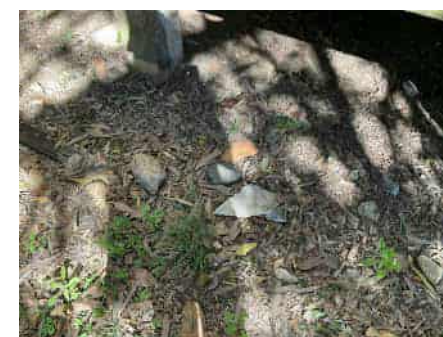
ACM Debris adjacent building

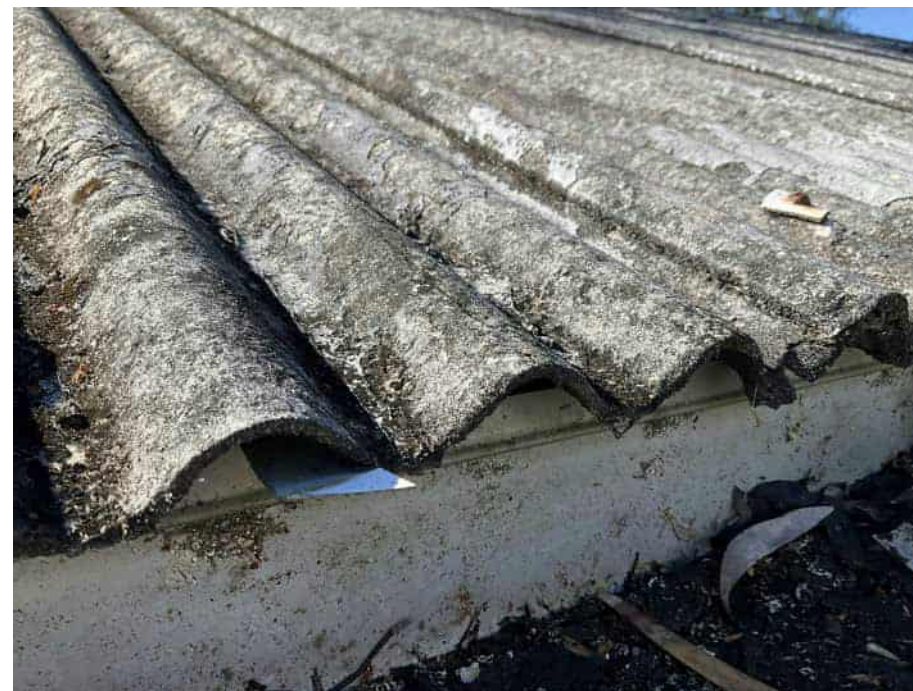
Roof sheeting - Overview

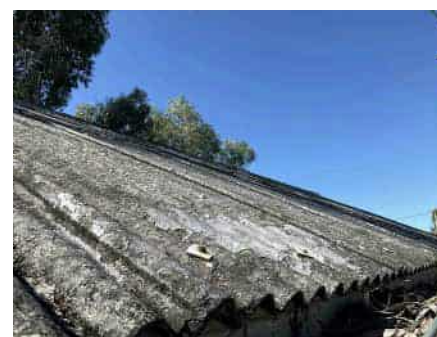
Roof sheeting - Overview

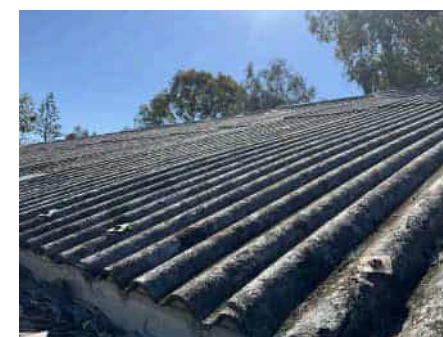
Roof sheeting - Overview

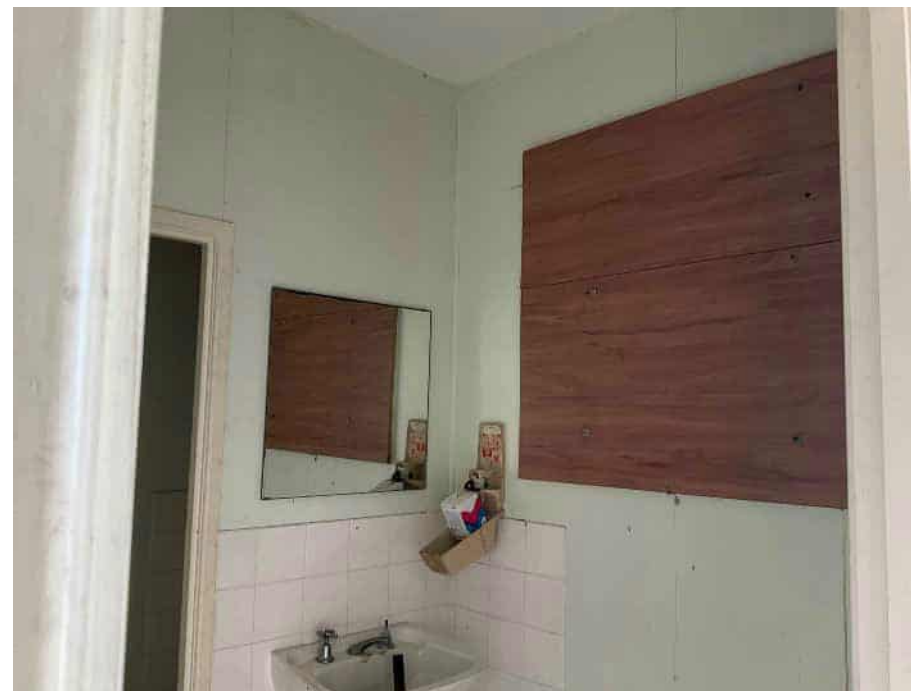
Male toilet walls

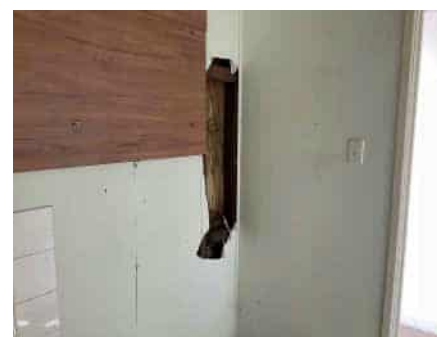
Male toilet walls

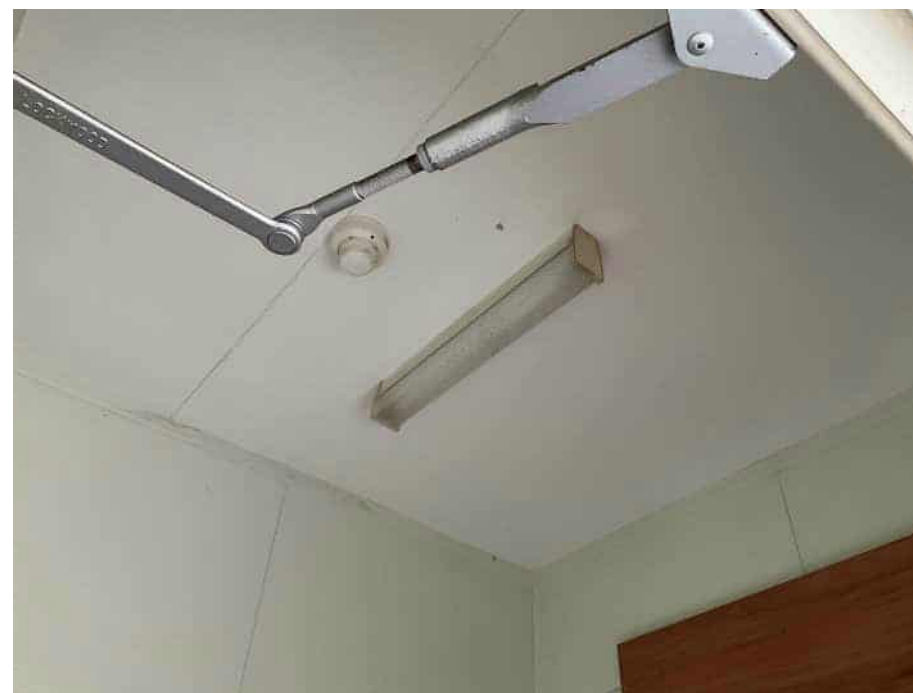
Male toilet ceiling lining

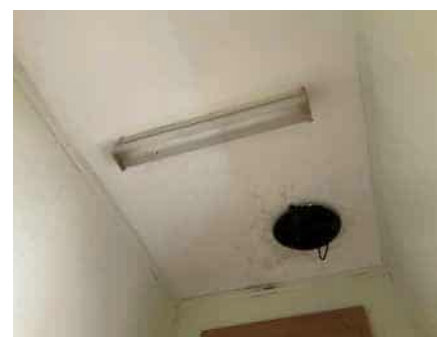
Male toilet ceiling lining

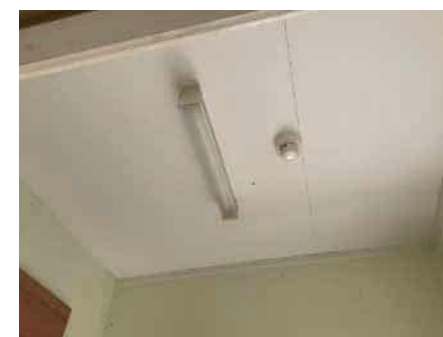
Male toilet ceiling lining

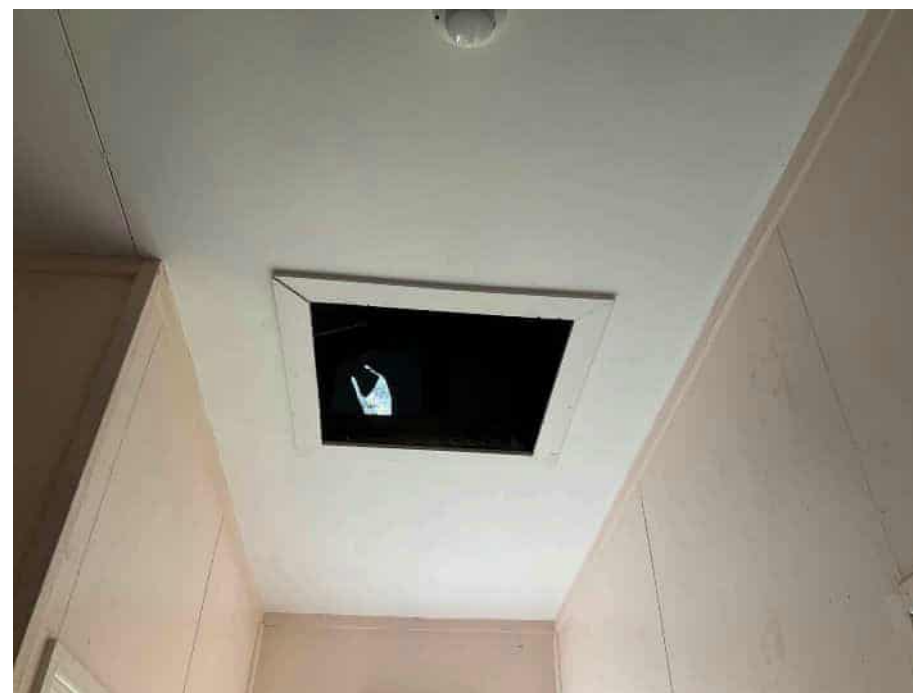
Entry foyer ceiling lining

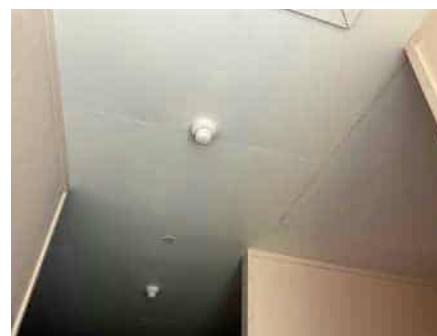
Entry foyer ceiling lining

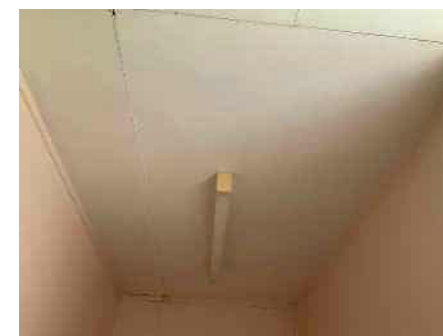
Entry foyer ceiling lining

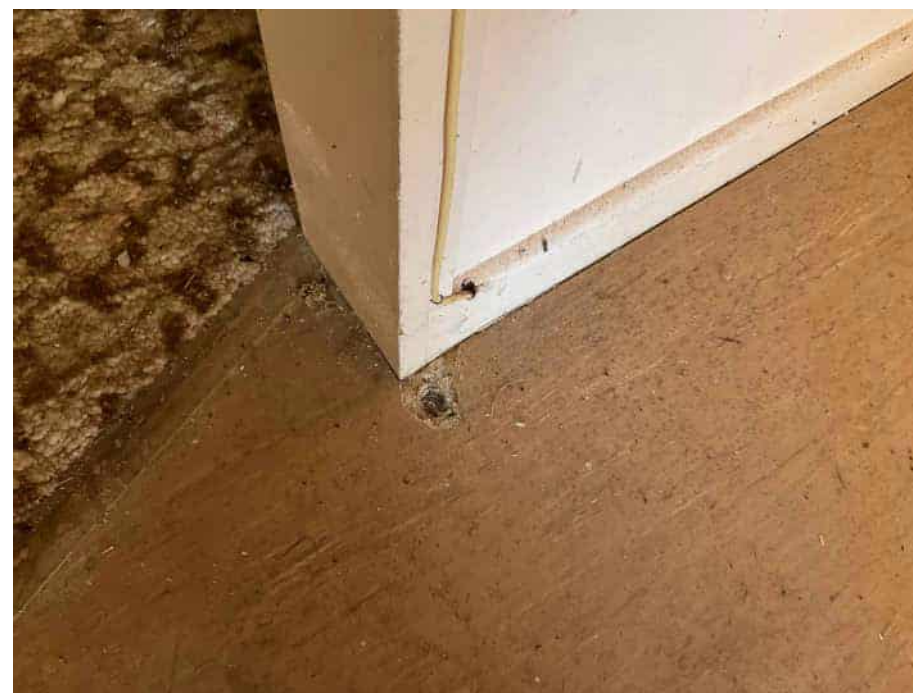
Floor where FC subfloor extends below vinyl

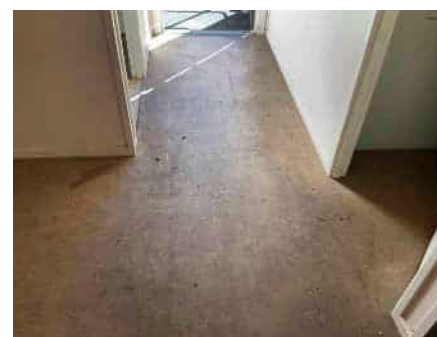
Floor where FC subfloor extends below vinyl

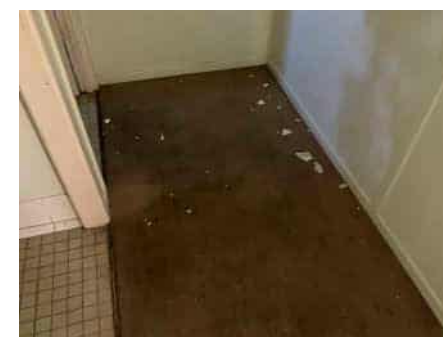
Floor where FC subfloor extends below vinyl

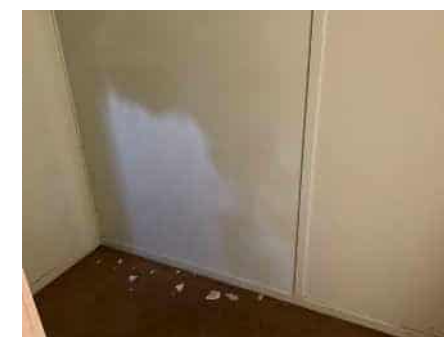
Women's toilet walls

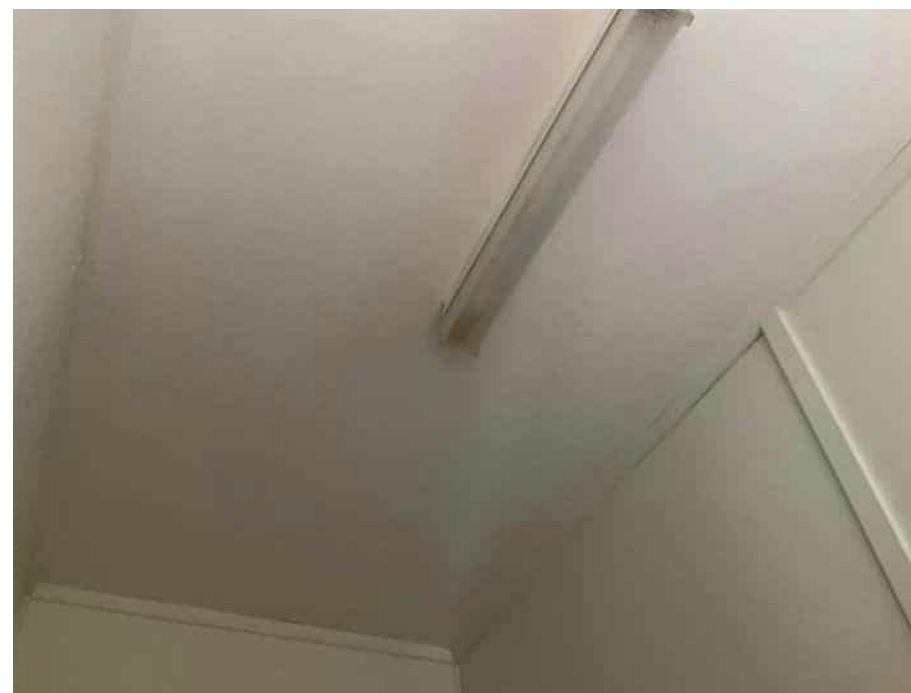
Women's toilet ceiling

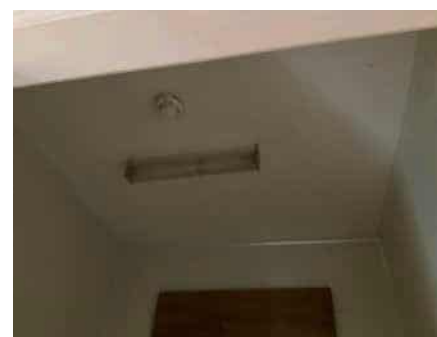
Women's toilet ceiling

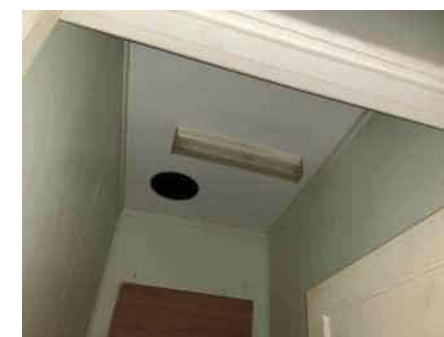
Women's toilet ceiling

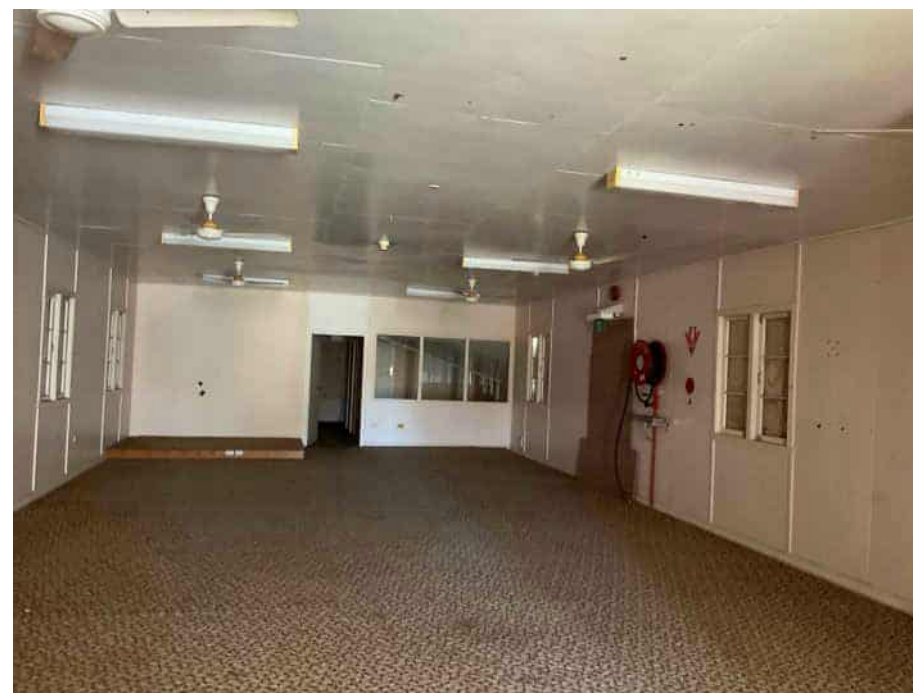
Main hall walls

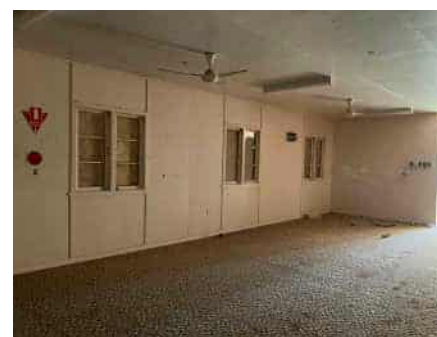
Main hall walls

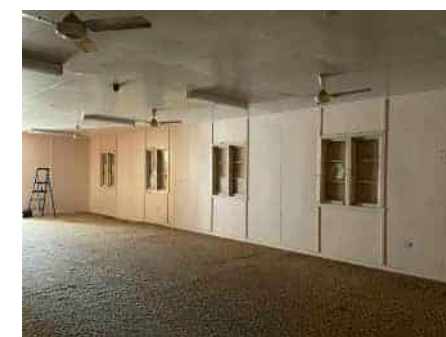
Main hall walls

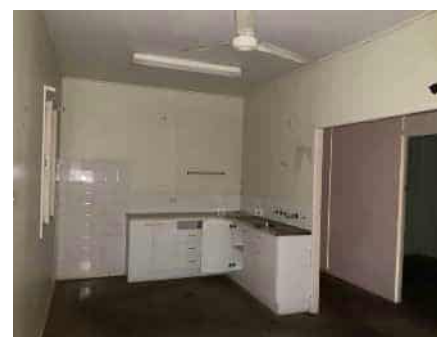
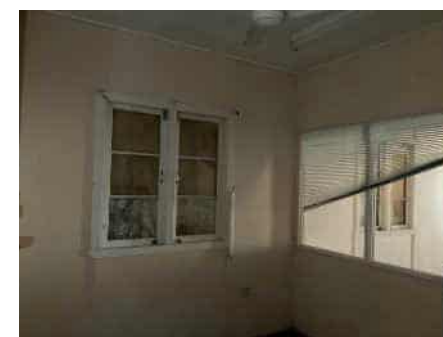
East rooms walls

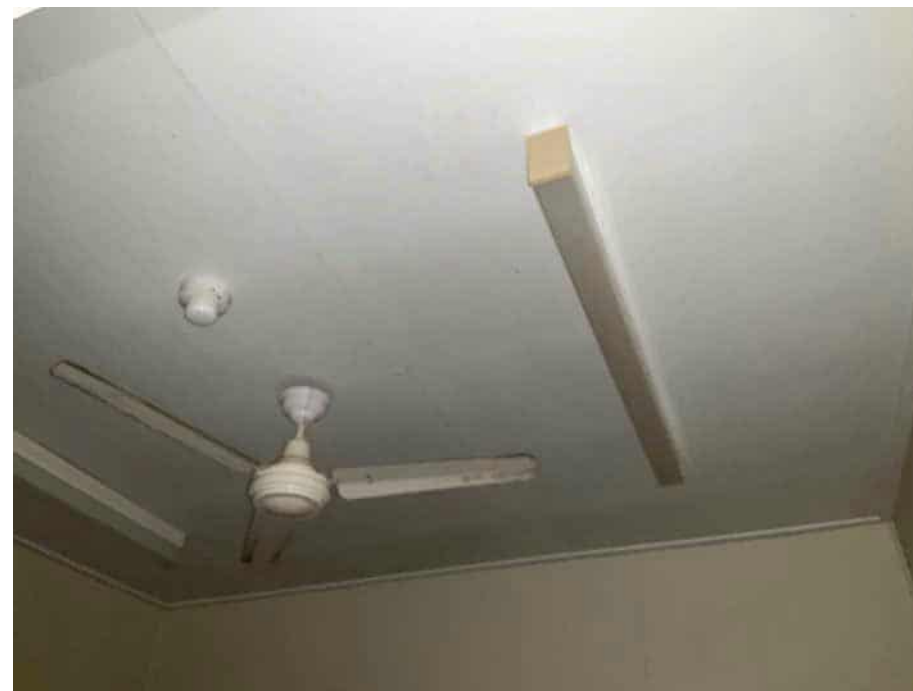
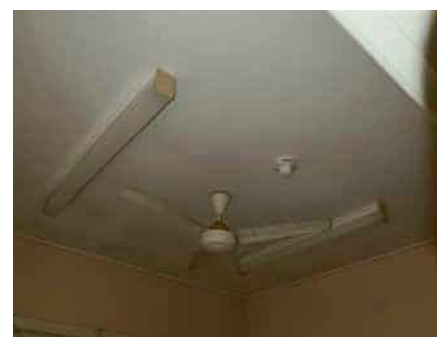
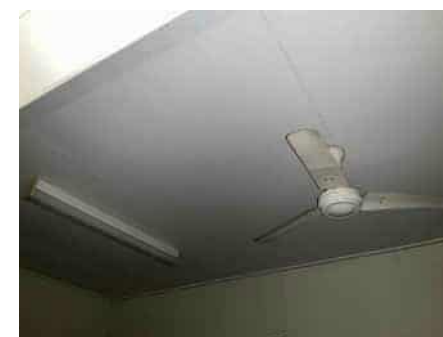
East rooms ceiling

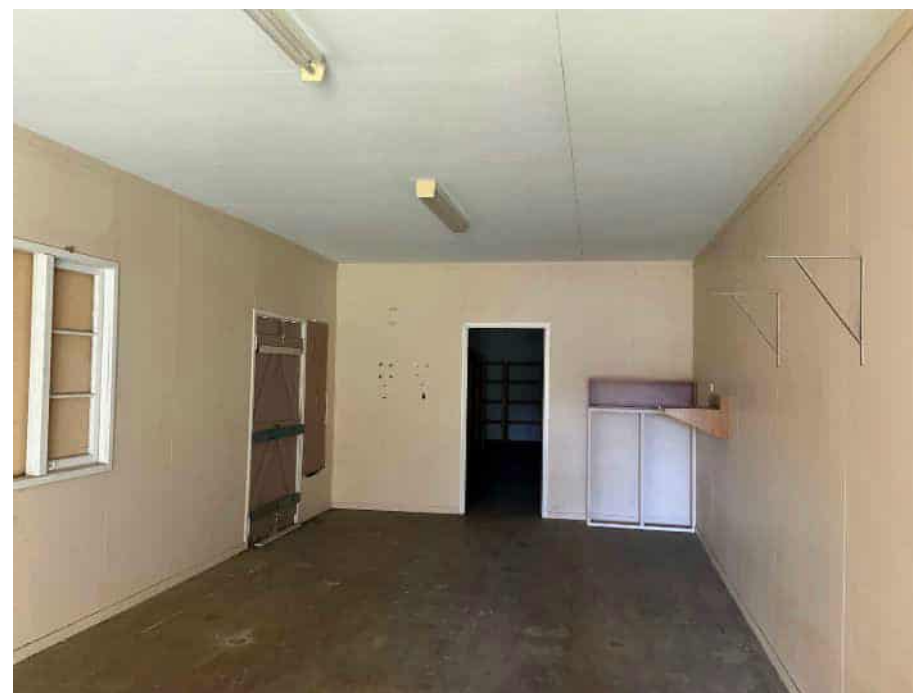
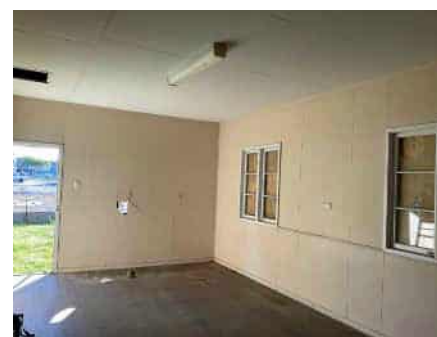
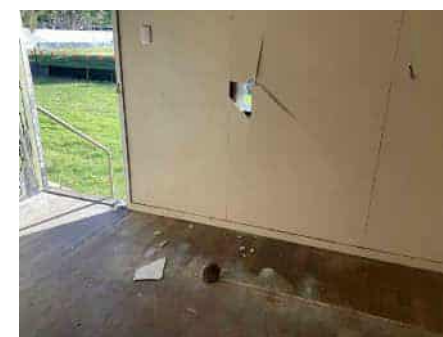
Northwest room walls

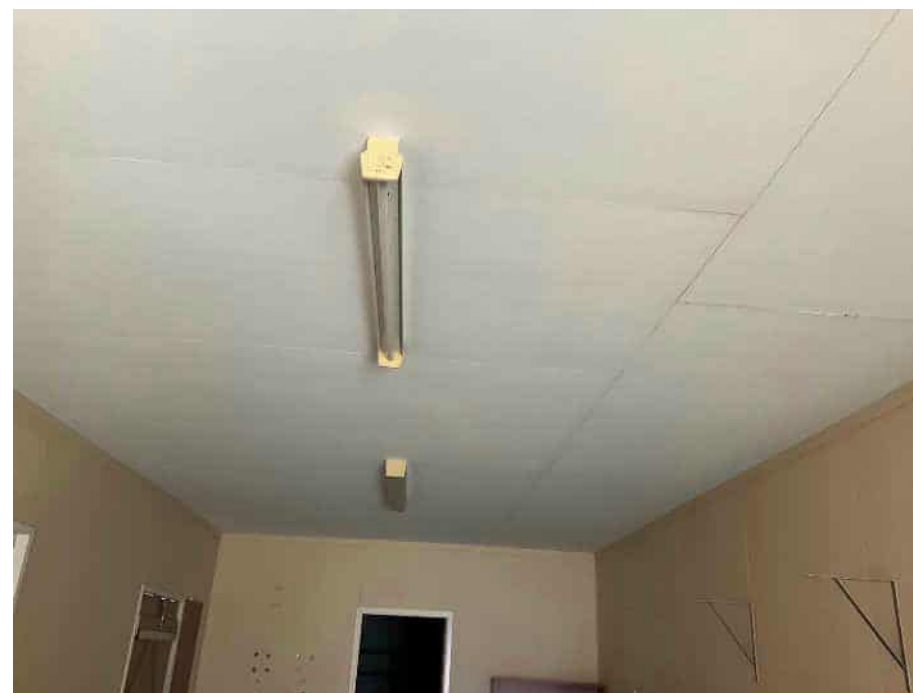
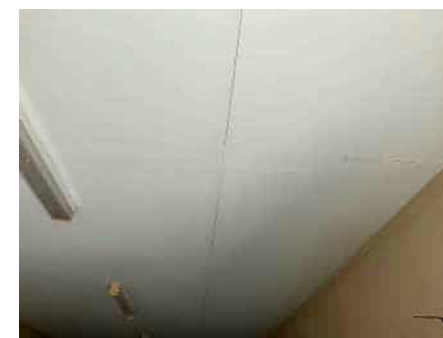
Northwest room ceiling

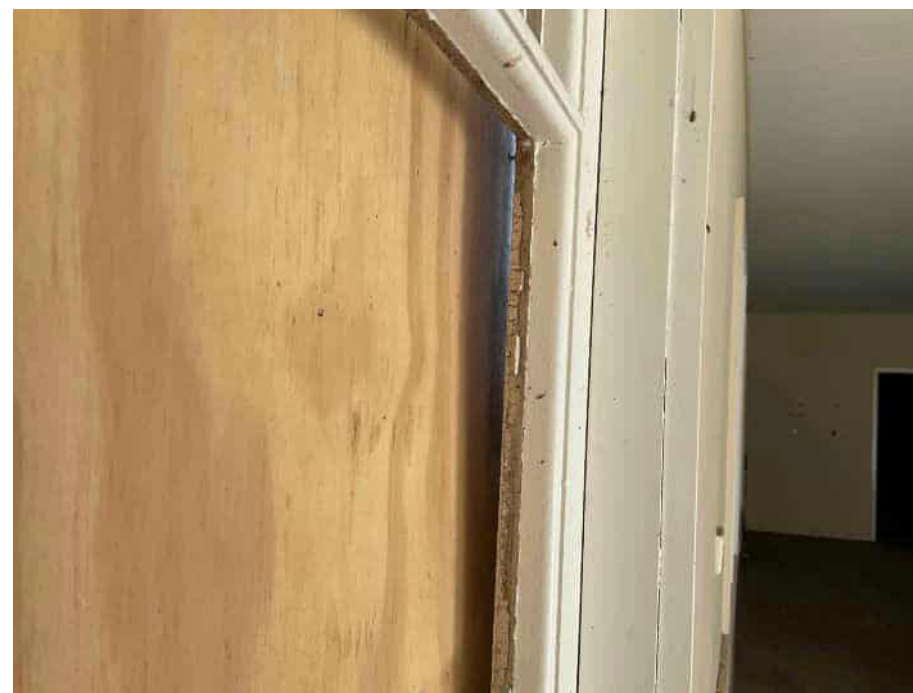
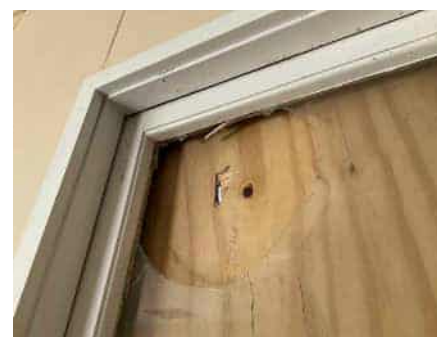
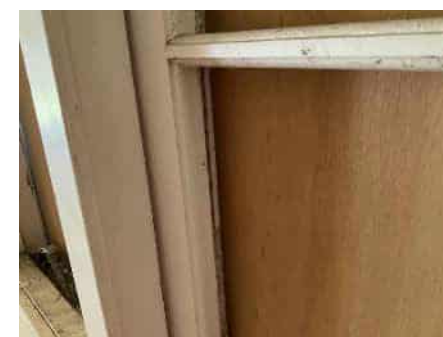
Representative samples collected where glass is missing and safe to do so.

Northwest and northeast rooms window putty

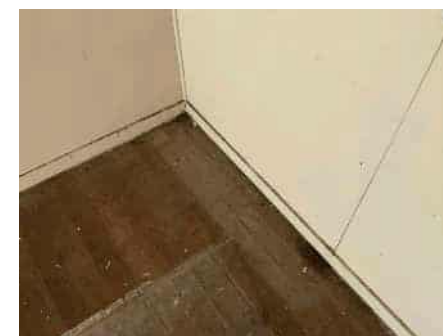
ACM debris within room from external damage to wall cladding

ACM debris on ground

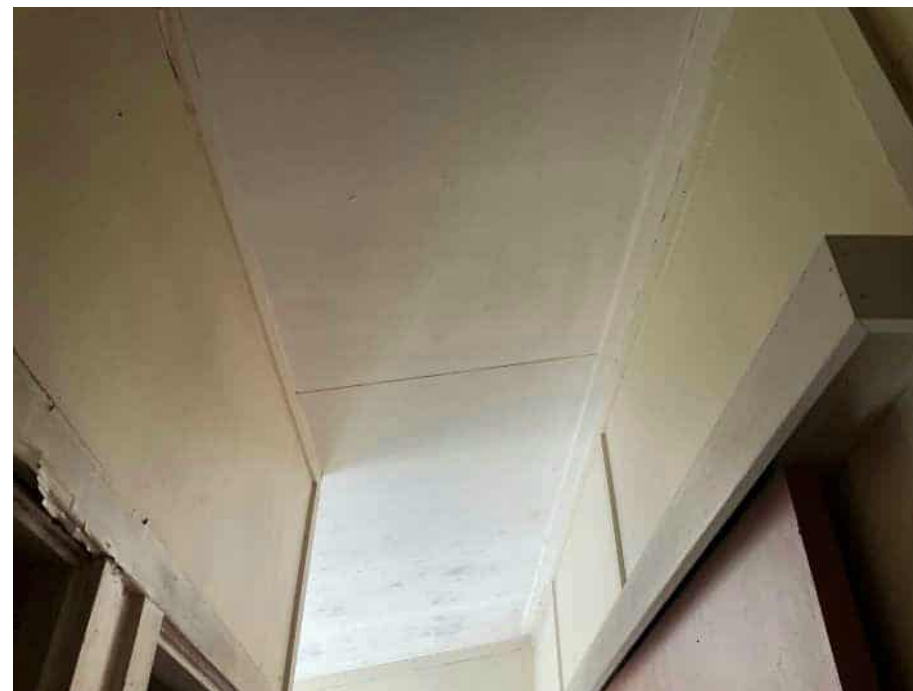
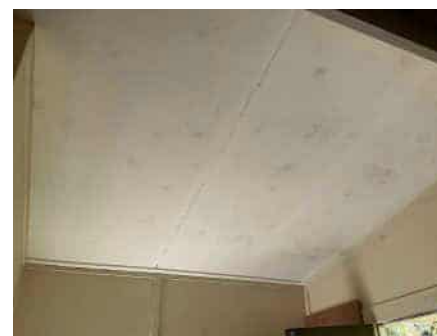
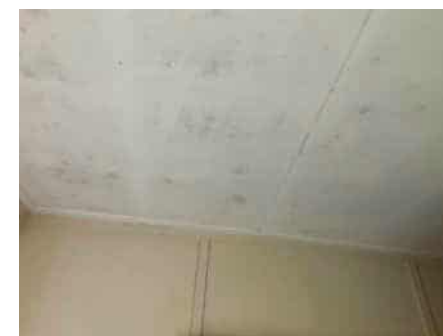
Southwest entry ceiling

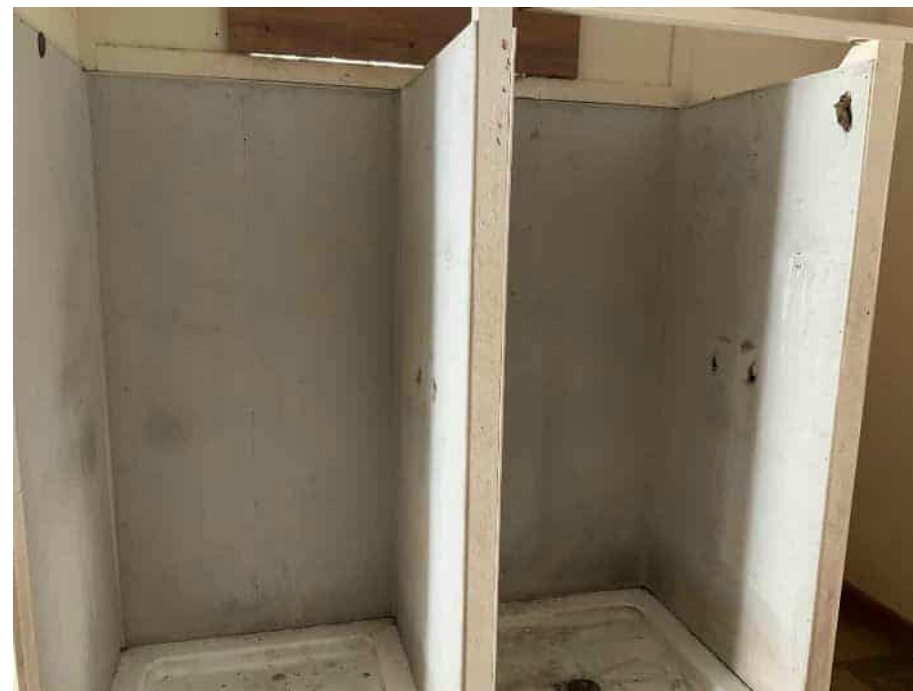
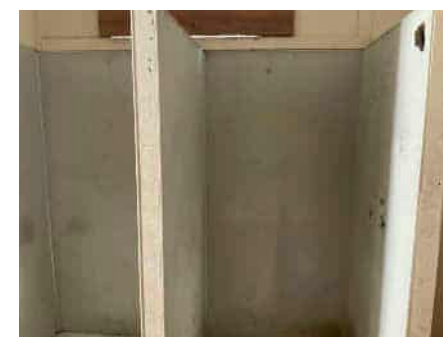
**Item Comments**  
Shower partitions

Shower room cubicle partitions

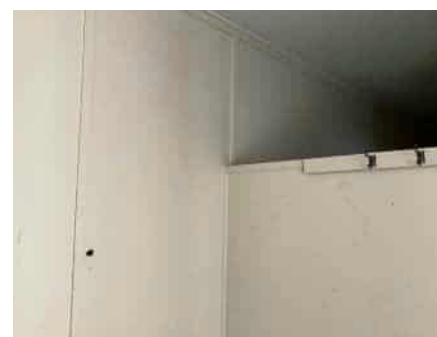
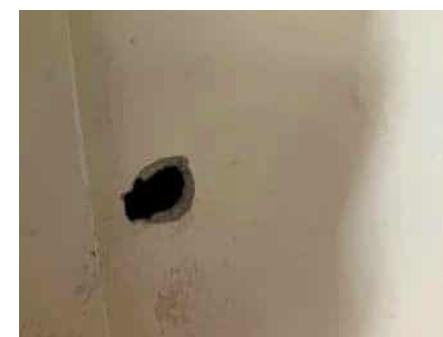
Shower room walls

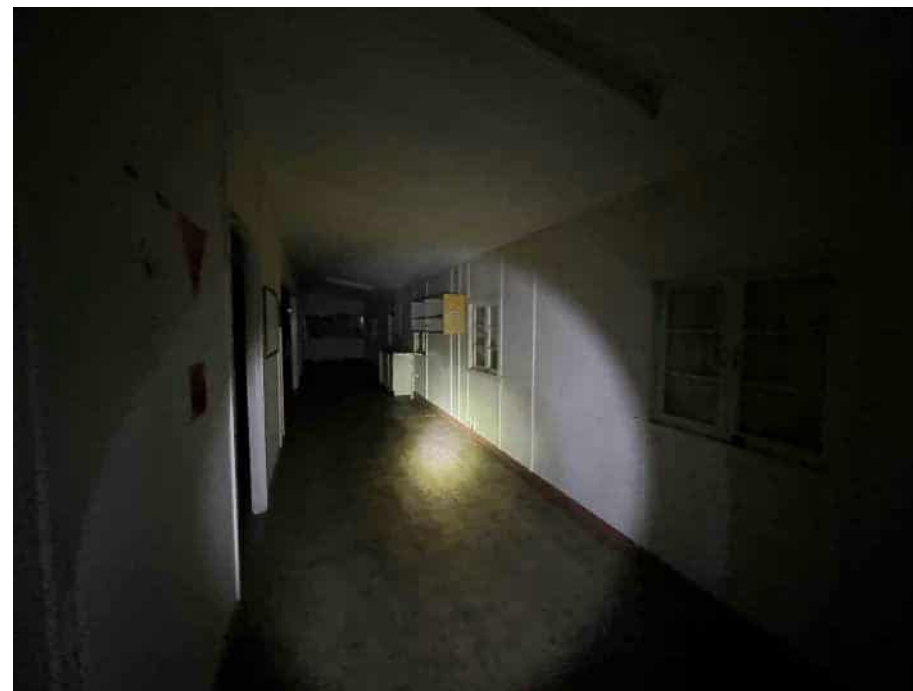
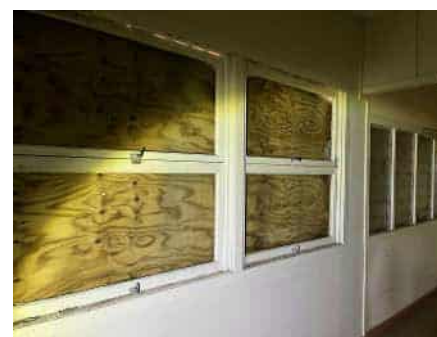
South rooms window putty

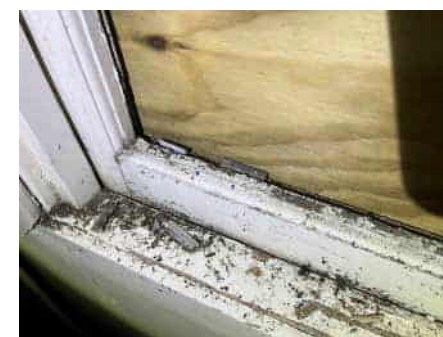
South rooms window putty

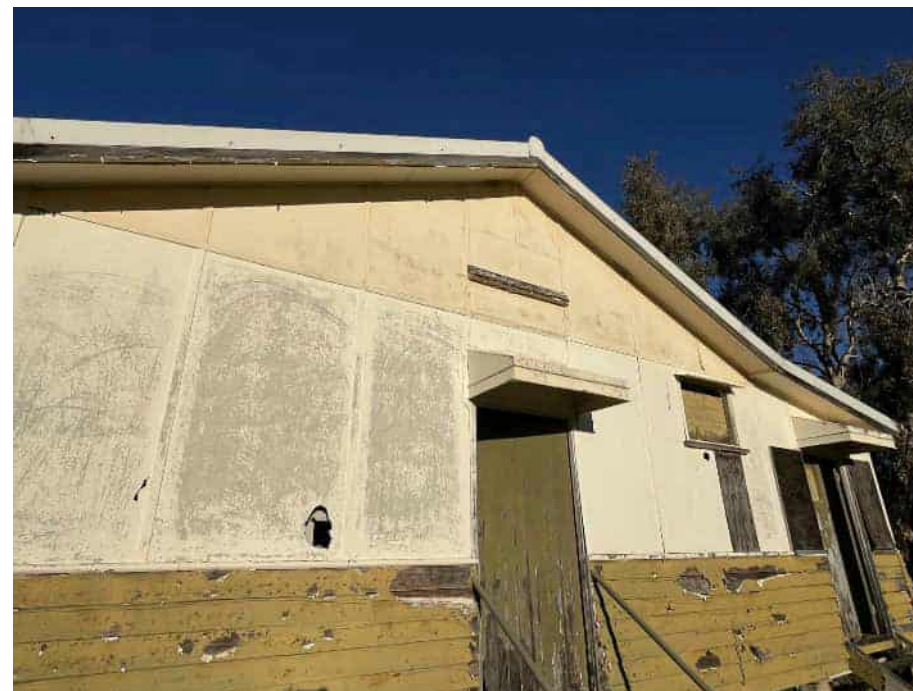
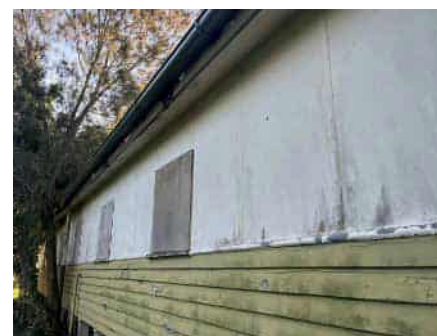
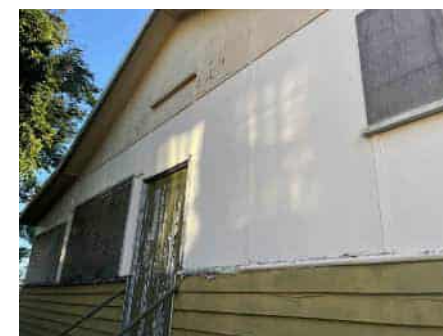
External cladding overview

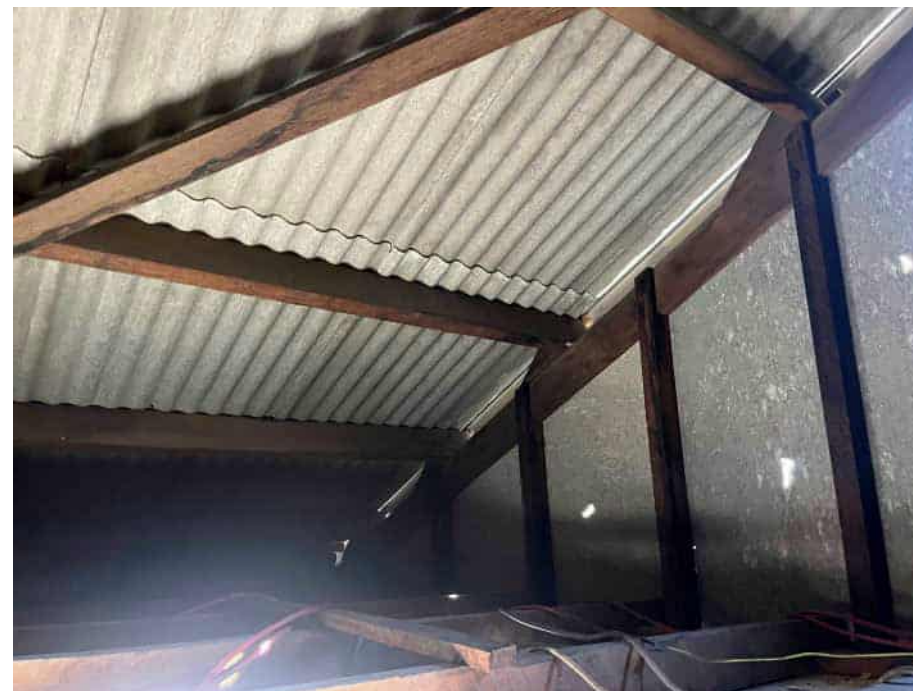
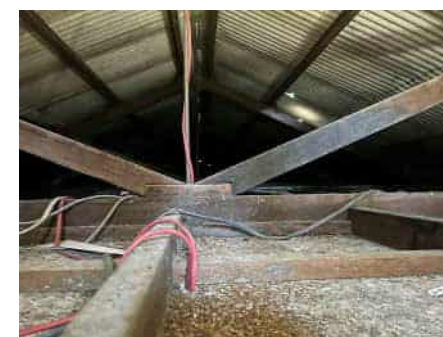
Debris from damaged roof and gable sheeting present in ceiling void. This would be removed during roof removal process as part of standard asbestos decontamination procedures.

Inner exposed side of asbestos roof, gable and ceiling sheeting is visible from ceiling void.

Roof void overview

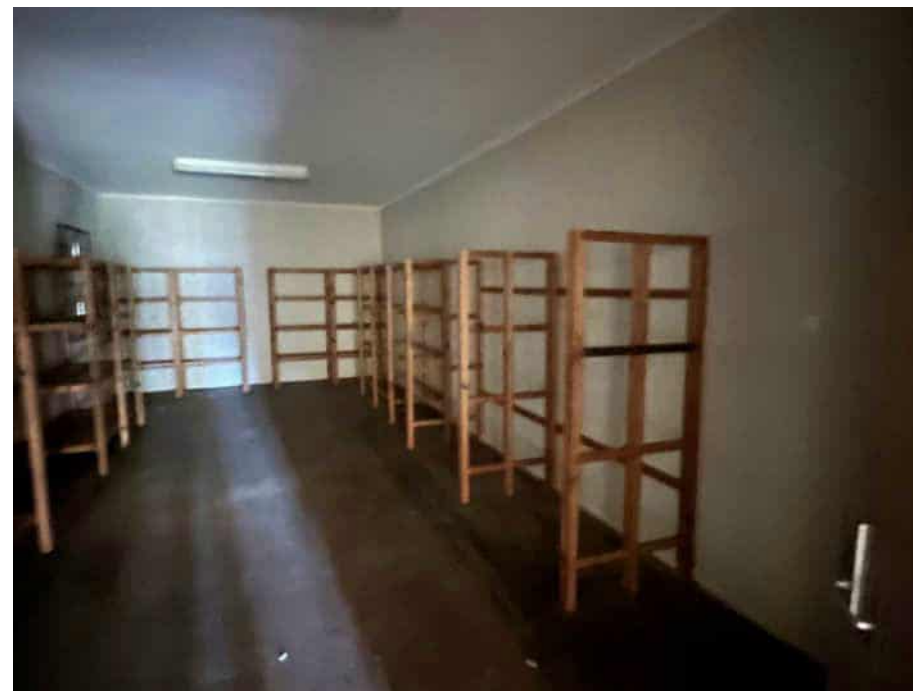
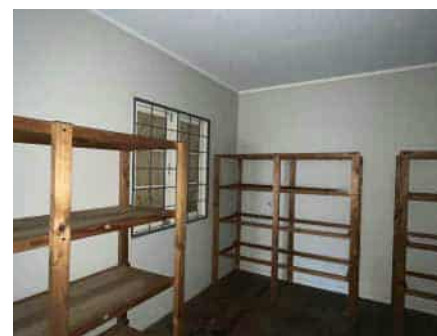
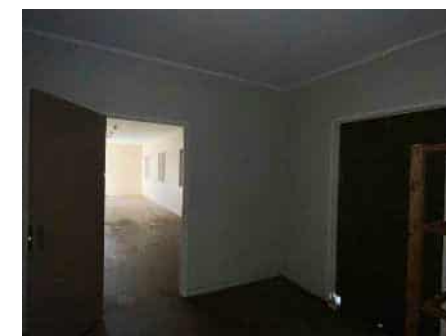
Northeast long room walls

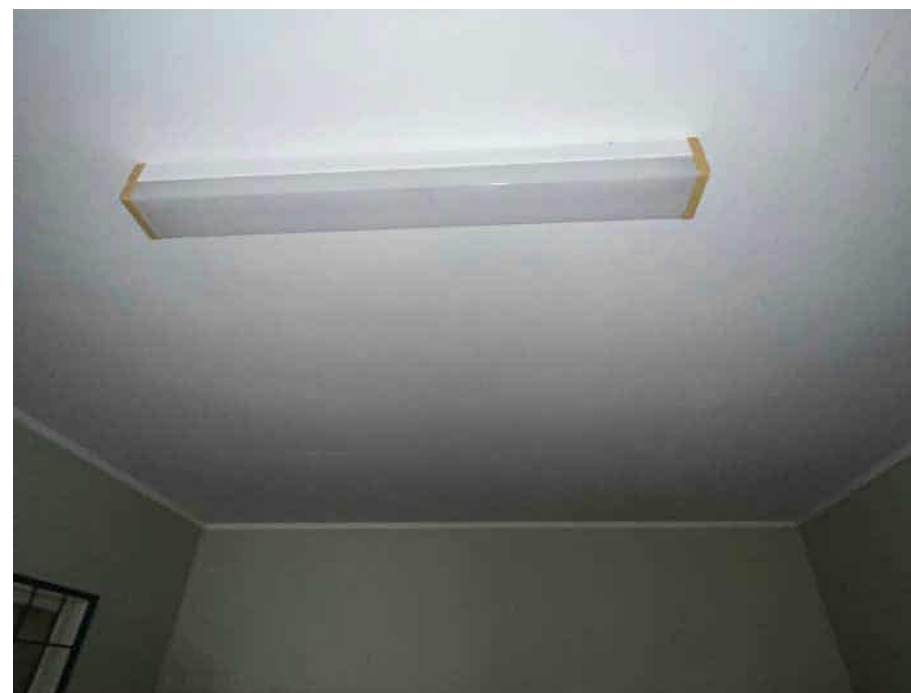
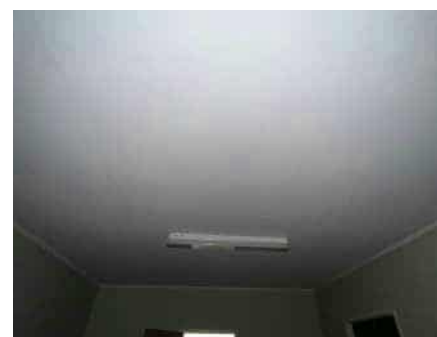
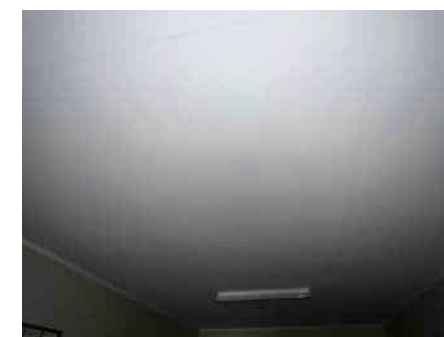
Northeast long room ceiling

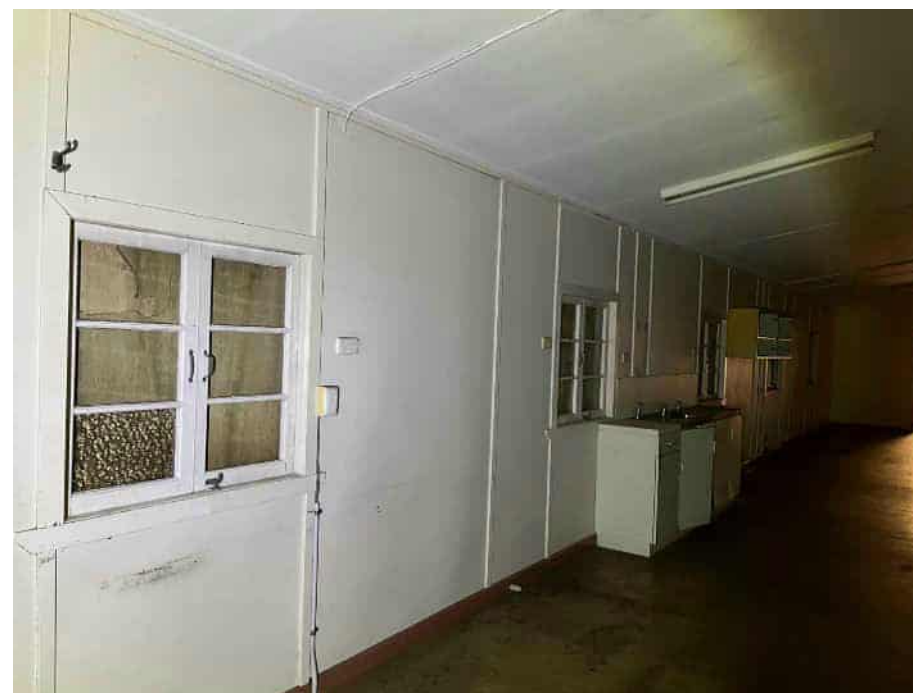
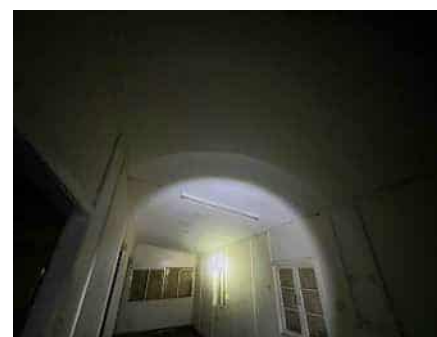
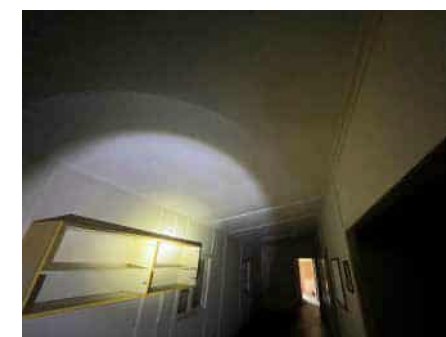
Enclosed sunroom ceiling

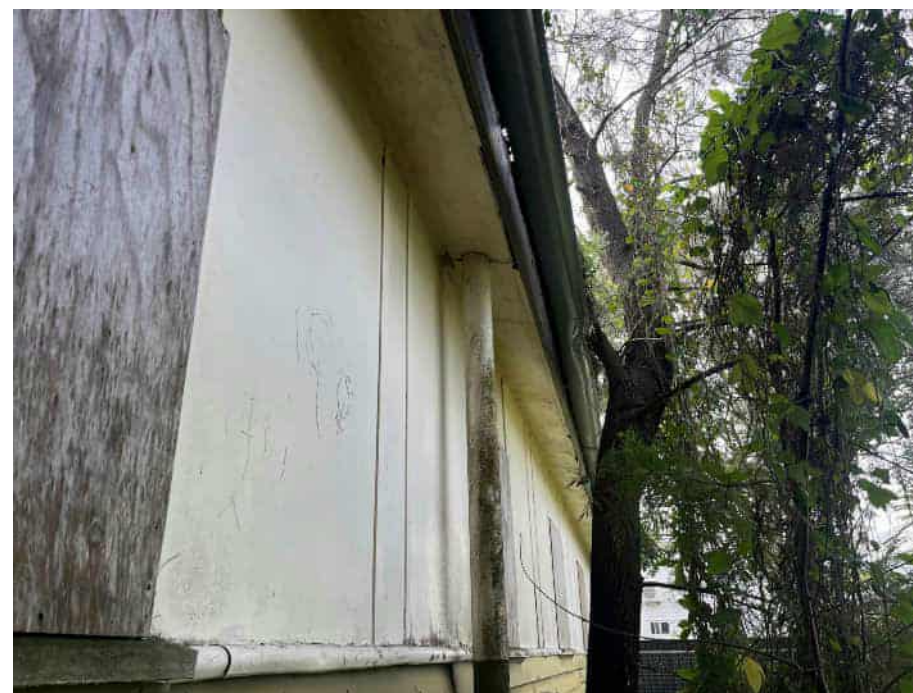
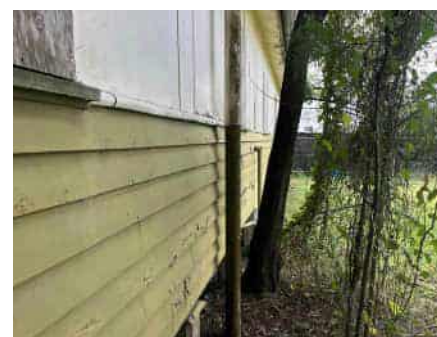
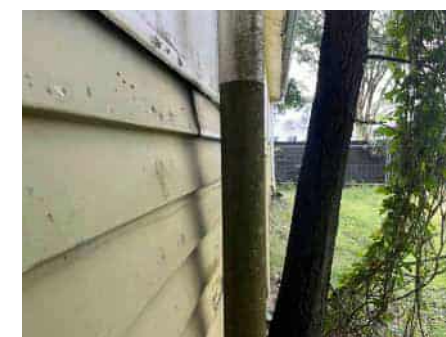
Waste vent pipe on south elevation

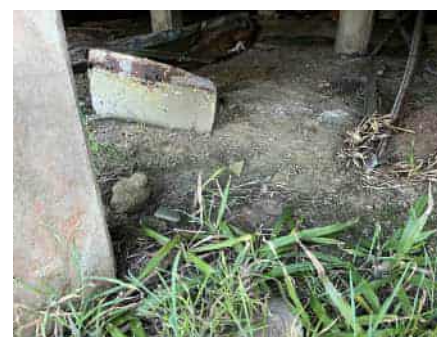
Various debris spread throughout undercroft and surrounding building from damage caused to roof, soffit and cladding. Recommended hand pick or scrape of ground when building removed.

Debris below building

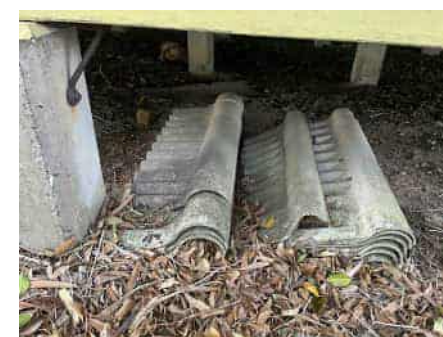
Stored ACM roof sheeting below building

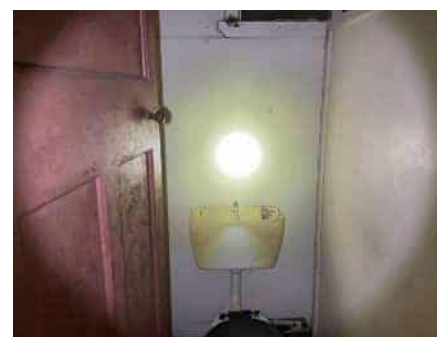
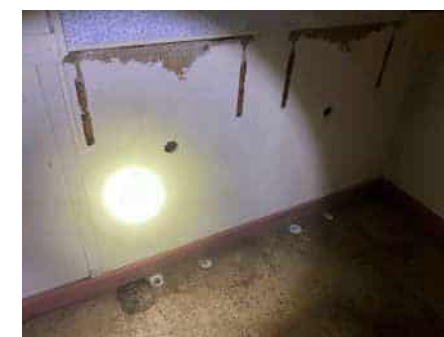
Infill panels behind toilets

Infill panels below removed sink

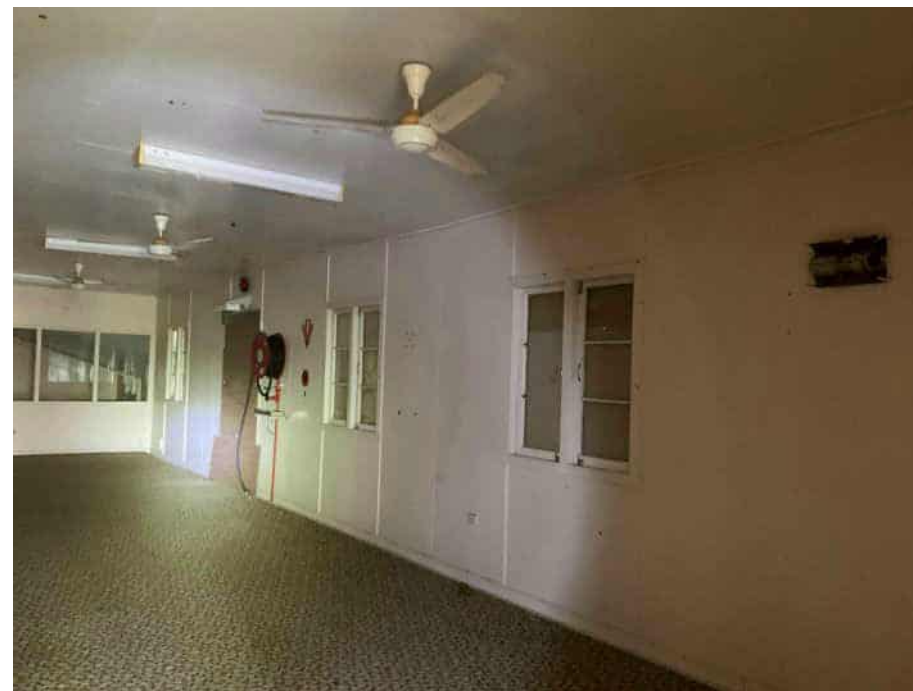
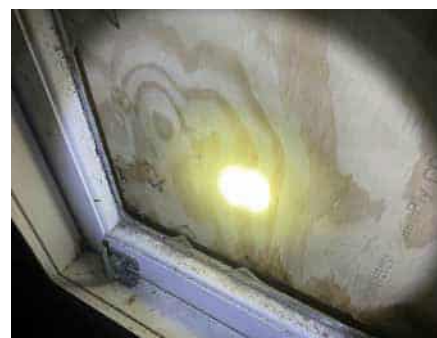
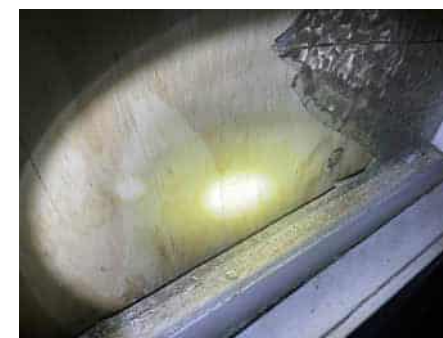
Windows with window putty

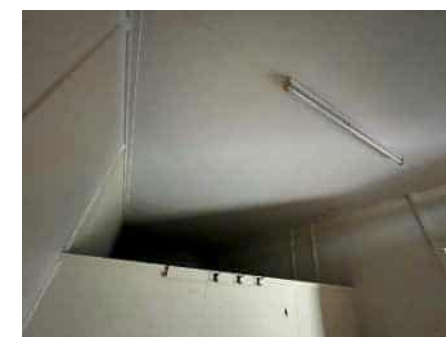
Shower rom ceiling
