# Management (Identification) Survey *Asbestos Survey Report*

**10059445-C1**

16 Twenty Fourth Avenue, Brighton QLD 4017

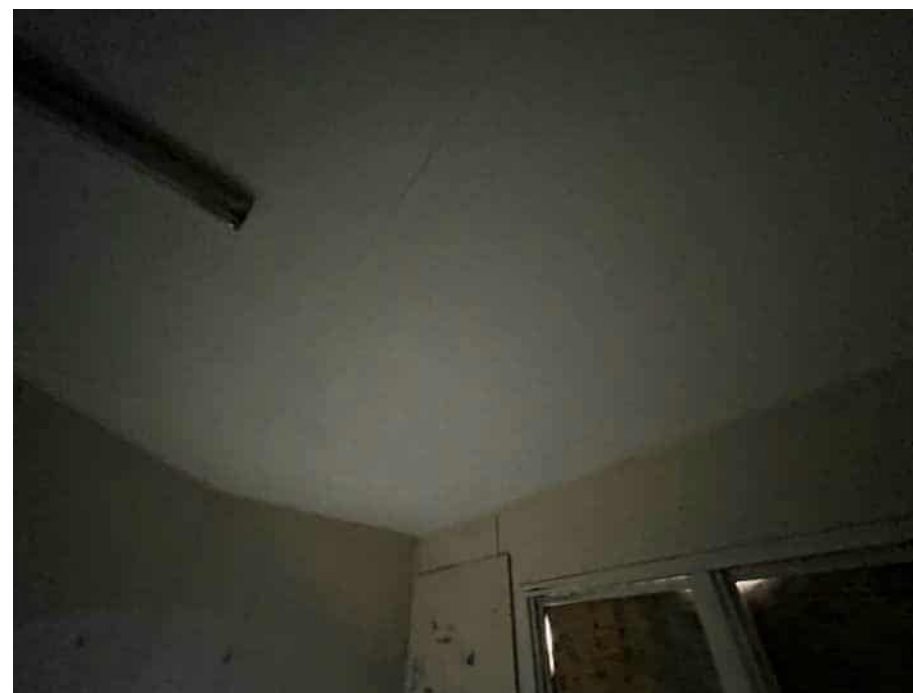
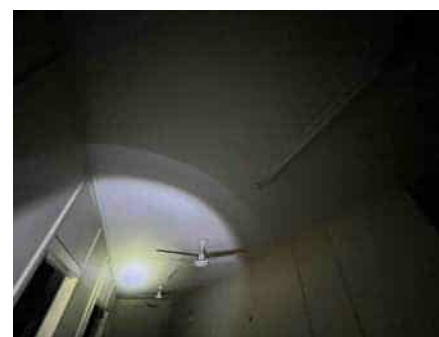
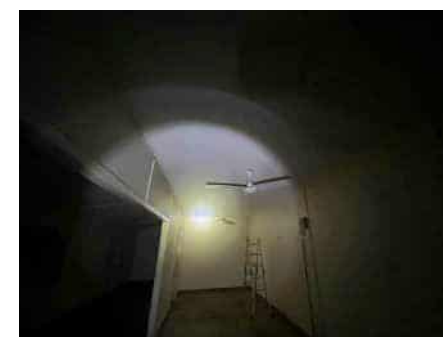
Main room ceiling

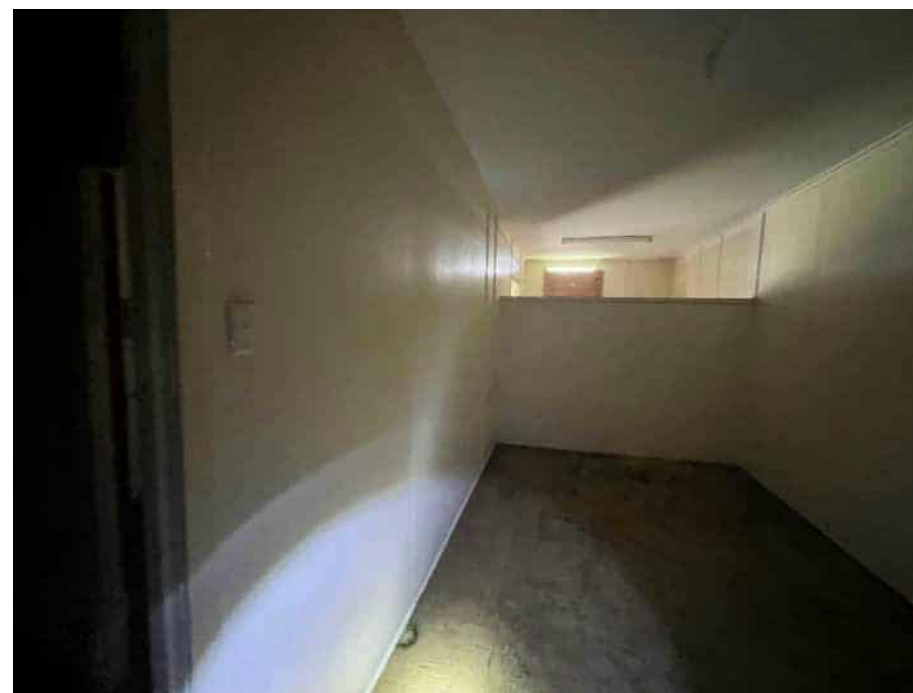
Secondary room wall lining

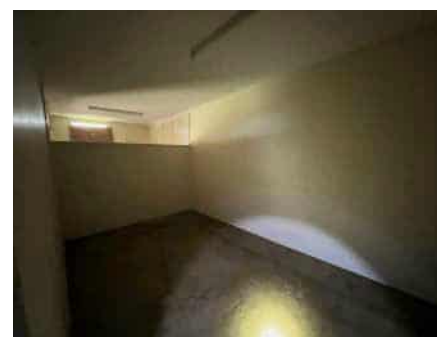
Secondary room wall lining

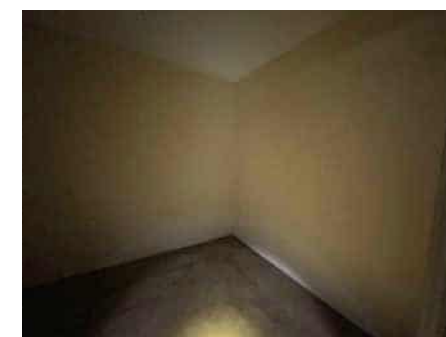
Secondary room wall lining
