I.B. Town Planning

**RE: DEVELOPMENT APPLICATION FOR MATERIAL CHANGE OF USE
1545 GYMPIE ROAD, CARSELDINE
COUNCIL APPLICATION NUMBER: A006743613**

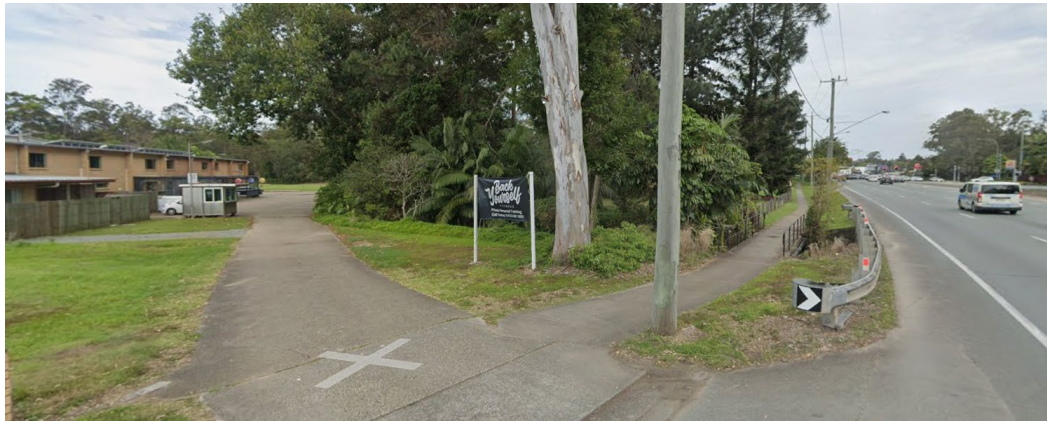
Location of Tree #40 behind existing guard rail and power pole

2. Council will have noted from your site inspection and/or review of Street View imagery that Tree #40 is located behind the guard rail on Gympie Road, as well as the existing power pole on the site frontage (please refer to Street View image below).

As all works associated with the access to the site and internal driveway are located to the north of the guard rail and power pole to ensure the works are clear of these features, there is sufficient separation distance between the new works and the location of the tree to ensure it can be retained.

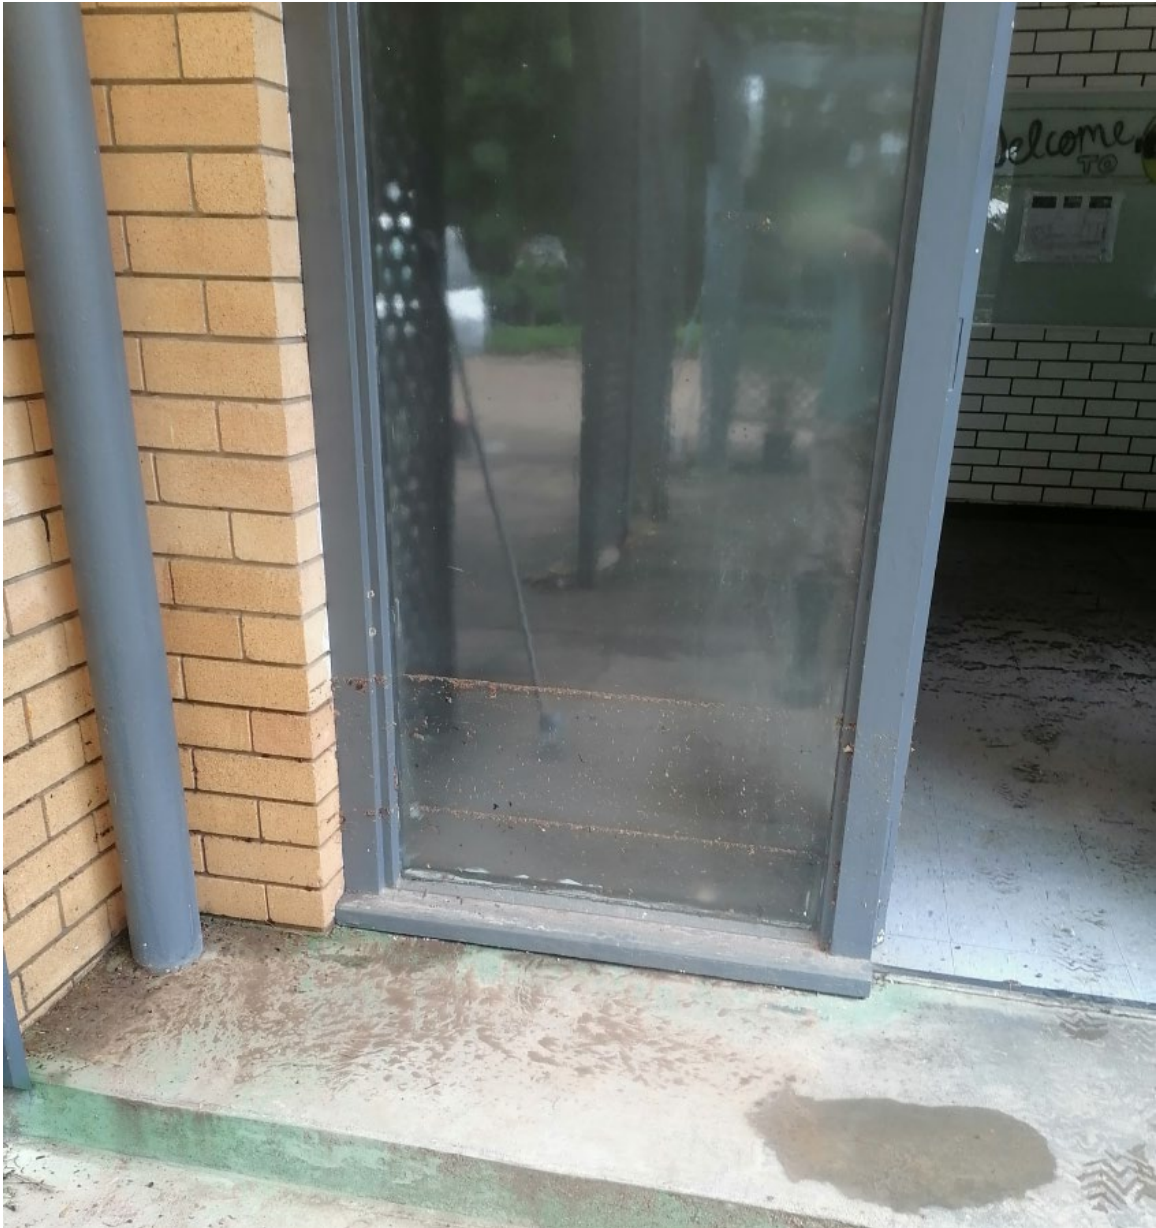
ATTACHMENT 1

EXTENT OF 2022 FLOOD EVENT INUNDATION

- The 'recorded' flood level of 19.8m AHD is not correct or accurate. Please refer to the attached photo of the inundation line on the entry to the squash courts building from the 2022 event (Attachment 1), which shows that the level of inundation was 5.5 bricks (approx. 480mm) above the current ground level of 18.5m AHD in that location. The maximum inundation during that event was therefore below 19m AHD.

- The amended architectural plans and engineering plans attached to this response have been updated to provide a finished floor level of 19.5m AHD for the medical centre building at the front of the site. This level provides 900mm of freeboard above the 1% AEP level stated in Council's FloodWise Property Report, and at least 500mm freeboard above the flood level recorded on the site in the 2022 flood event.

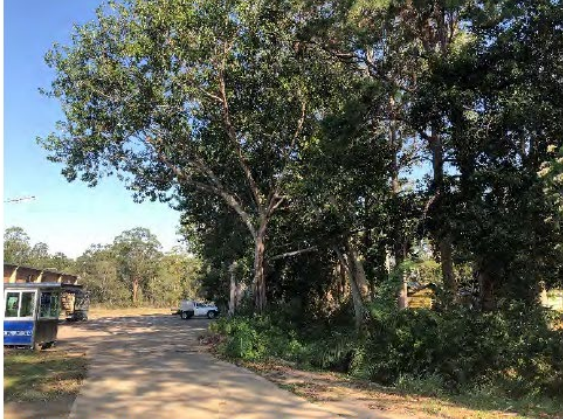
Photo Plate 3 – view east into the Site from Gympie Road and existing vegetation along waterway channel

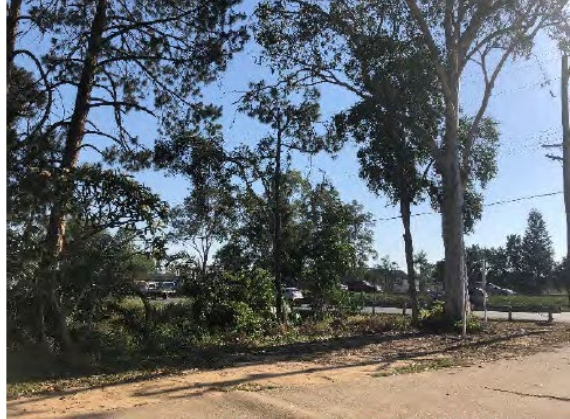
Photo Plate 4 – view of existing vegetation along waterway channel and towards Gympie Road

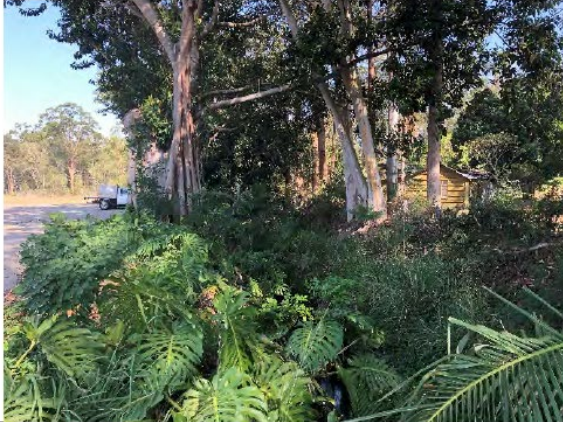
Photo Plate 5 – view of dense exotic understory and shrub layer within the waterway channel

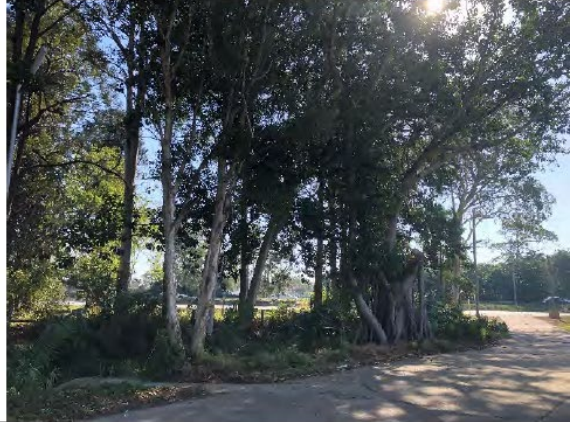
Photo Plate 6 – view of large rubber figs and other vegetation immediately adjoining the existing formalised car park

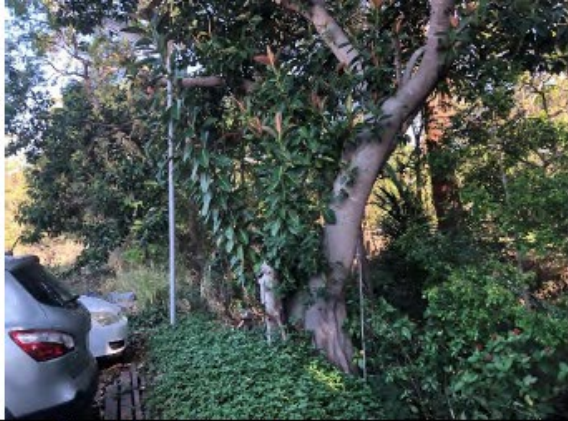
Photo Plate 7 – view of large rubber figs and other vegetation immediately adjoining the existing formalised car park

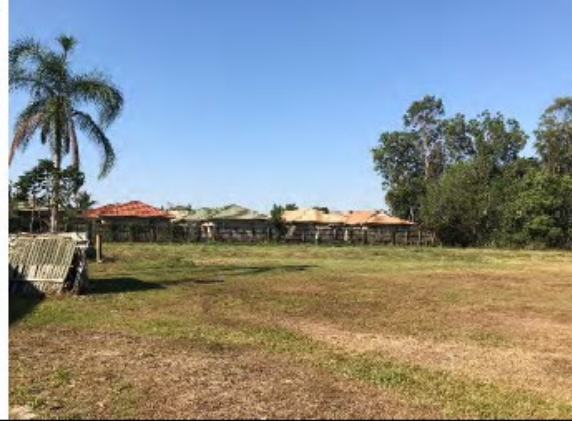
Photo Plate 8 – view north east indicating open lawn and lack of ecological values

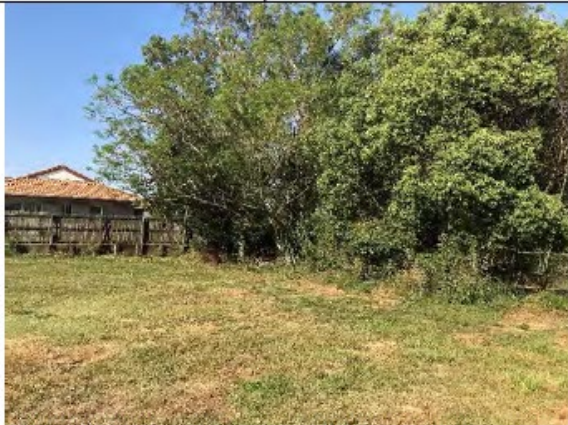
Photo Plate 9 – view of vegetation in the far north eastern corner of the Site (all exotic)

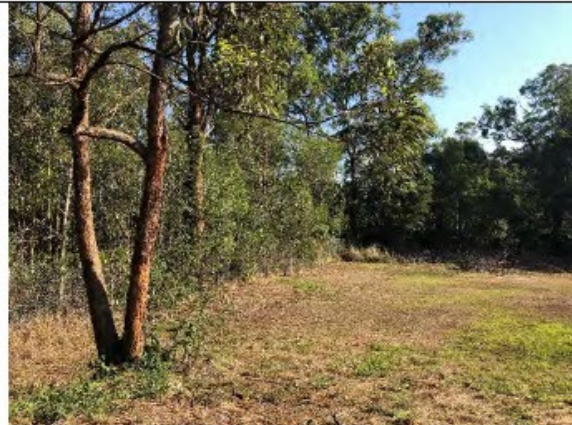
Photo Plate 10 – View south along the eastern boundary indicating Tree 2 and the waterway vegetation (background).

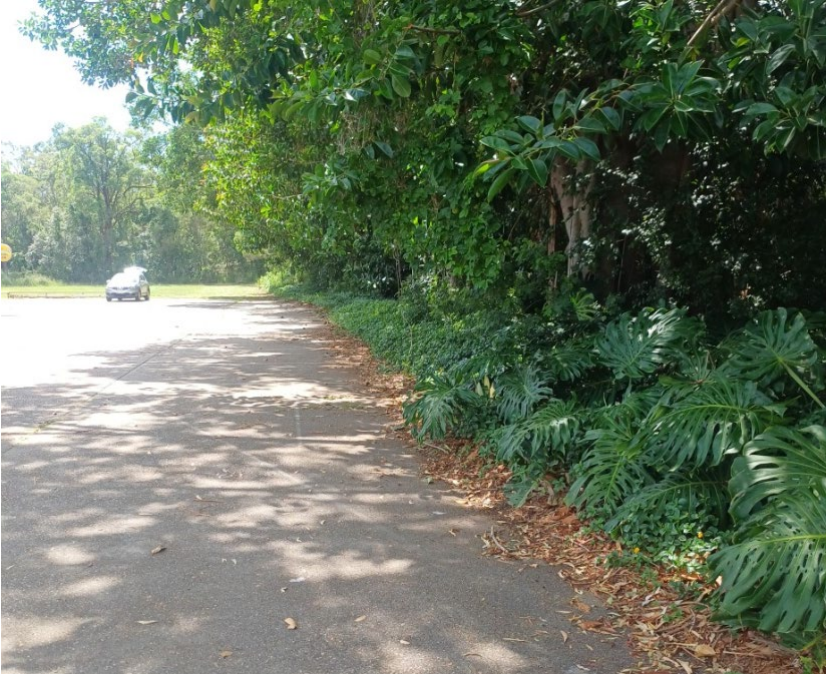
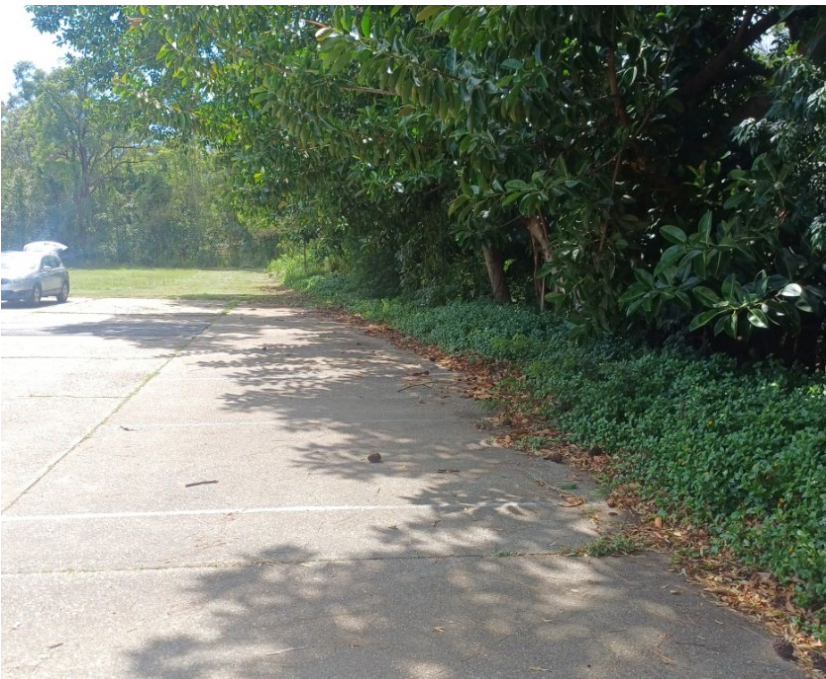
Interface of existing carpark and existing vegetation (to remain unchanged)

As there has been no change to the proposed development footprint on the site, or the design of the development (car parking) interface with the existing trees along the southern boundary, the previously completed ecological survey and assessment is still relevant for the site and does not require re-survey or re-assessment.

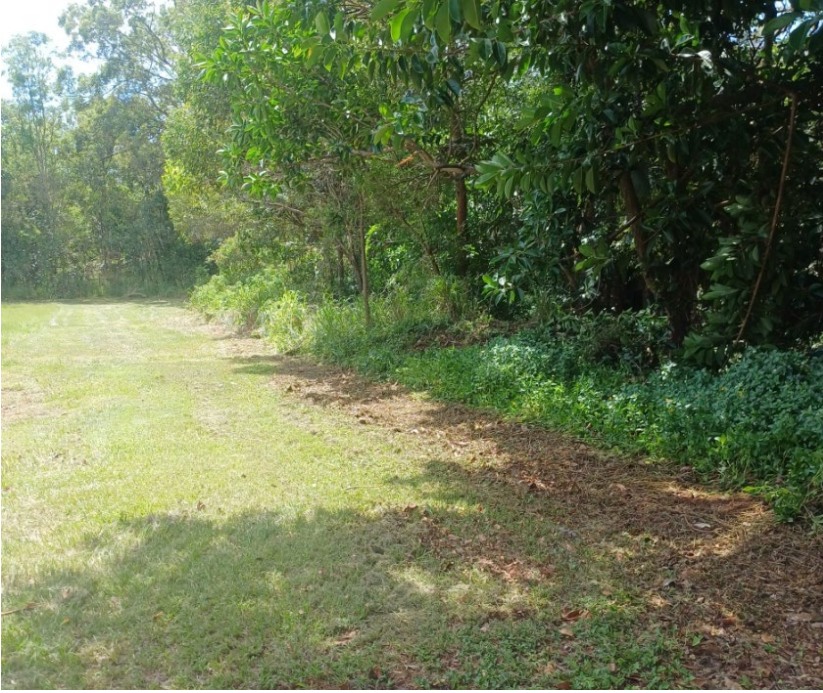
Proposed carpark extension interface with existing vegetation
No substantial vegetation growth

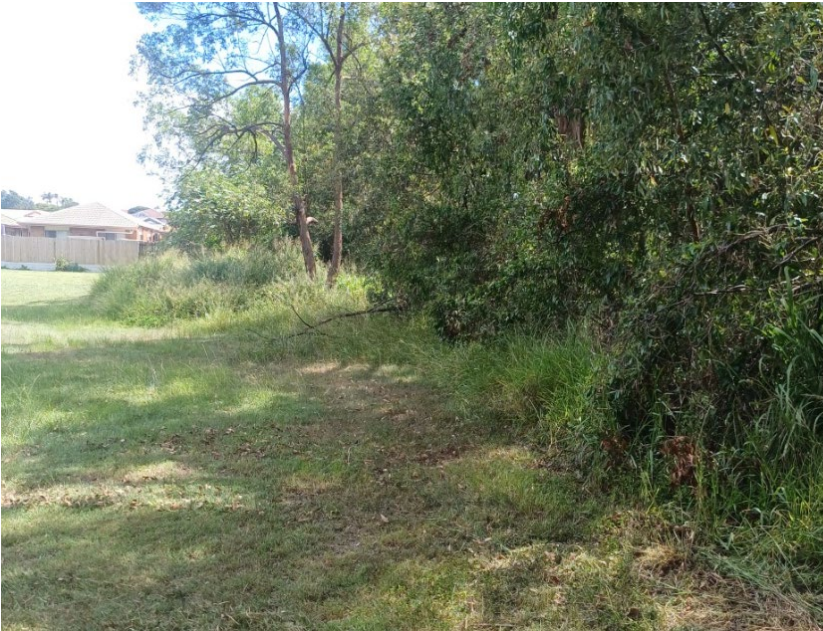
Eastern Site Boundary – Proposed Rehabilitation/Landscape Area

6. The new development proposal in this application has been specifically designed to maintain the same development footprint that has been approved on the site under Application A005434524. In particular, the proposed development maintains the same landscaped/rehabilitation area at the eastern end of the site, and the same alignment and interface of car parking spaces with the tree-lined gully in the easement along the southern boundary of the site. In addition, the vegetation on the site was at maturity at the time it was surveyed in 2019, and therefore there has not been any substantial vegetation growth or changes in the characteristics of the vegetation since that time. Please refer to the attached photos comparing the 2019 assessment and current site conditions (Attachment 2). As these photos indicate, the most notable change that has occurred since that time is increased growth of understorey weed species, which will be removed and rehabilitated as part of the proposed development.
