Issue	Description	Date	Client	Project Name	Project No.
D	For Submission - Minor Change	12/06/26	Beaudesert Holdings Development Pty Ltd	229 Perse Road, Runcorn	S524123
Drawing Name	DETAILED REHABILITATION MANAGEMENT PLAN				DRMP001

S5 Environmental have prepared this Detailed Rehabilitation Management Plan (DRMP) for Beaudesert Holdings Development Pty Ltd, to comply with Condition 30(a) of the Development Approval A006978357 dated 07/05/2026), issued by Brisbane City Council (BCC) at 229 Persse Road, Runcorn (herein referred to as the 'subject site'). This conditions package is for the approved development of a material change of use (MCU) for a multiple dwelling at the subject site. This document details the rehabilitation techniques proposed within the western portion of the subject site, proposed as an Environmental Protection Zone (EPZ). This area is mapped as containing High Ecological Significance Strategic (HESS) sub-category of the Biodiversity areas overlay, Local waterway corridor sub-category of the Waterway corridors overlay and as containing Wetlands overlay mapping, under the *Brisbane City Plan 2014*. Koala habitat within the HESS mapped area was limited to three e

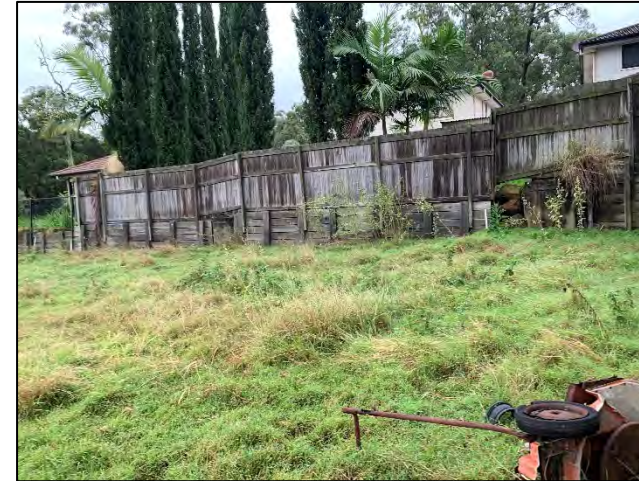
Plate 1. View south of RMU1

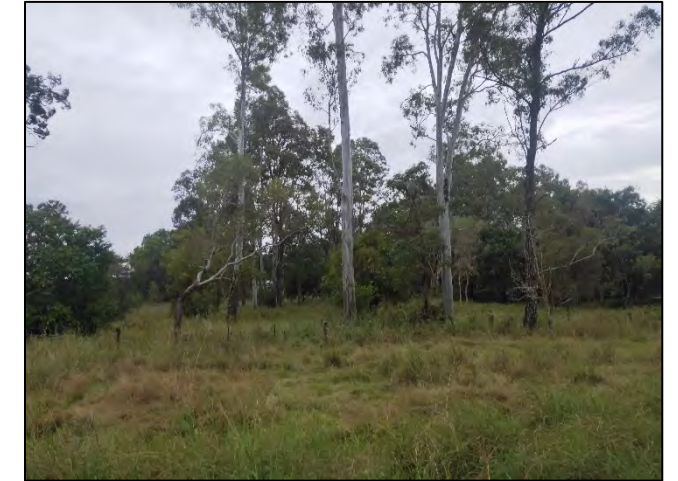
Plate 2. View north from RMU1 into adjoining lot

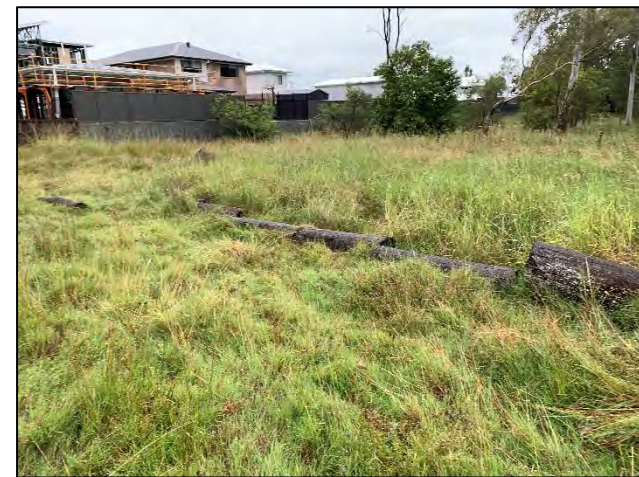
Plate 3. North-west into area of mapped wetland

A patch in the north-western extent of the subject site was mapped by BCC under the Wetlands overlay, however no vegetation resembling a wetland was observed nor were any wetland indicator species. The pre-clear RE mapped over the HESS and Local waterway corridor is RE 12.3.11, with the balance of the site mapped as RE 12.5.3a. These REs are described as:

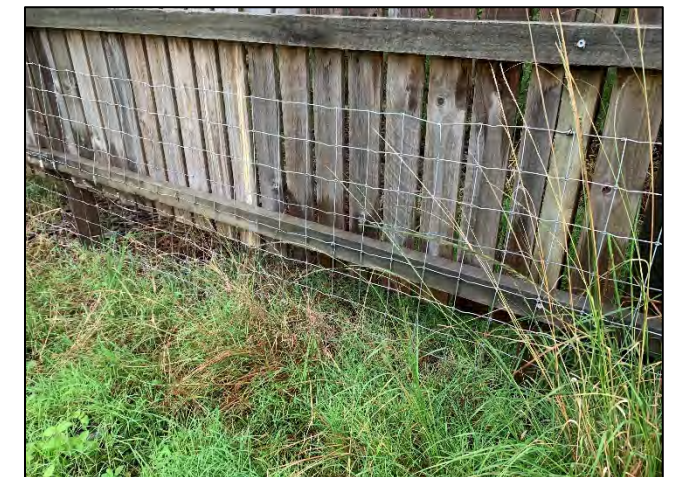
Plate 4. View of eastern boundary fence

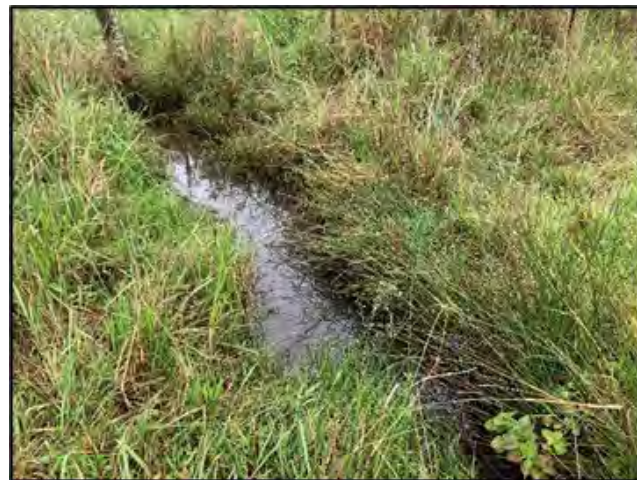
Plate 5. View of waterway exiting the site to the north

Rehabilitation Management Unit 2 (RMU2) incorporates most of the HESS vegetation and Local waterway corridor, as mapped under BCCs *City Plan 2014*. The aim of RMU2 is to remove exotic species and undertake compensatory planting (RE 12.3.11) to improve the ecological integrity, functionality, and value of the area. Under *City Plan 2014*, this area is also mapped within the Flood overlay as overland flow. As such, the rehabilitation within this area must not increase the risk of localised flooding. Flooding and building up of debris may occur in the presence of high densities of trees and shrubs. This will be mitigated through limiting the rehabilitation to ground cover species within this RMU.

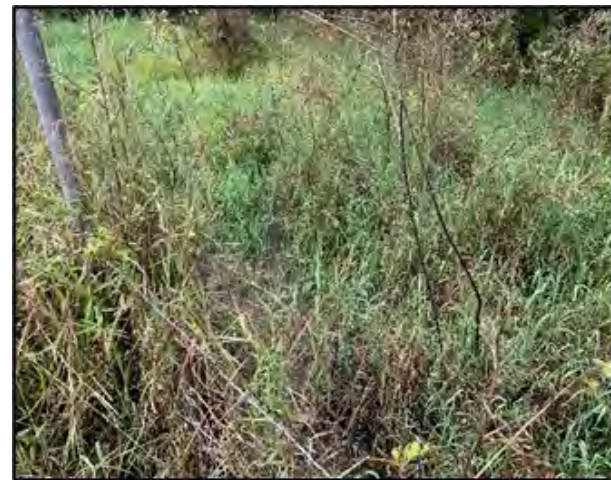
Plate 6. View of waterway entering the site in the south

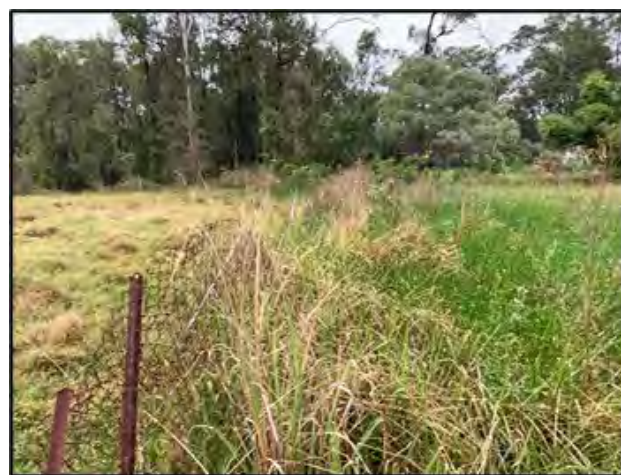
Plate 7. View south along waterway

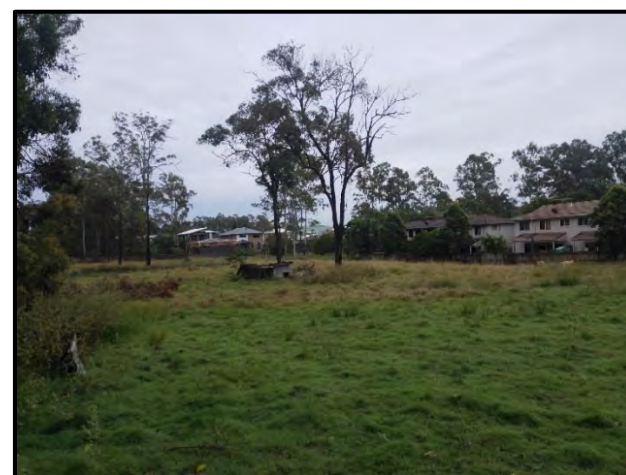
Plate 8. View east of RMU2
