Issue	Description	Date	Client	Project Name	Project No.
B	IR Response	17/04/2026	Alexandra Porter C/- Urban Strategies	104 Idonia Street, Bridgeman Downs	S525099
Drawing Name	<b>CONCEPT REHABILITATION MANAGEMENT PLAN</b>				<b>CRMP001</b>

S5 Environmental have prepared this Concept Rehabilitation Management Plan (CRMP) for the Alexandra Porter C/- Urban Strategies, has been provided in response to a Brisbane City Council (BCC) Information Request (ref: A006894653, dated: 28/11/2025) for a Reconfiguration of Lot (1 into 2 residential lots) for the site at 104 Idonia Street, Bridgeman Downs.

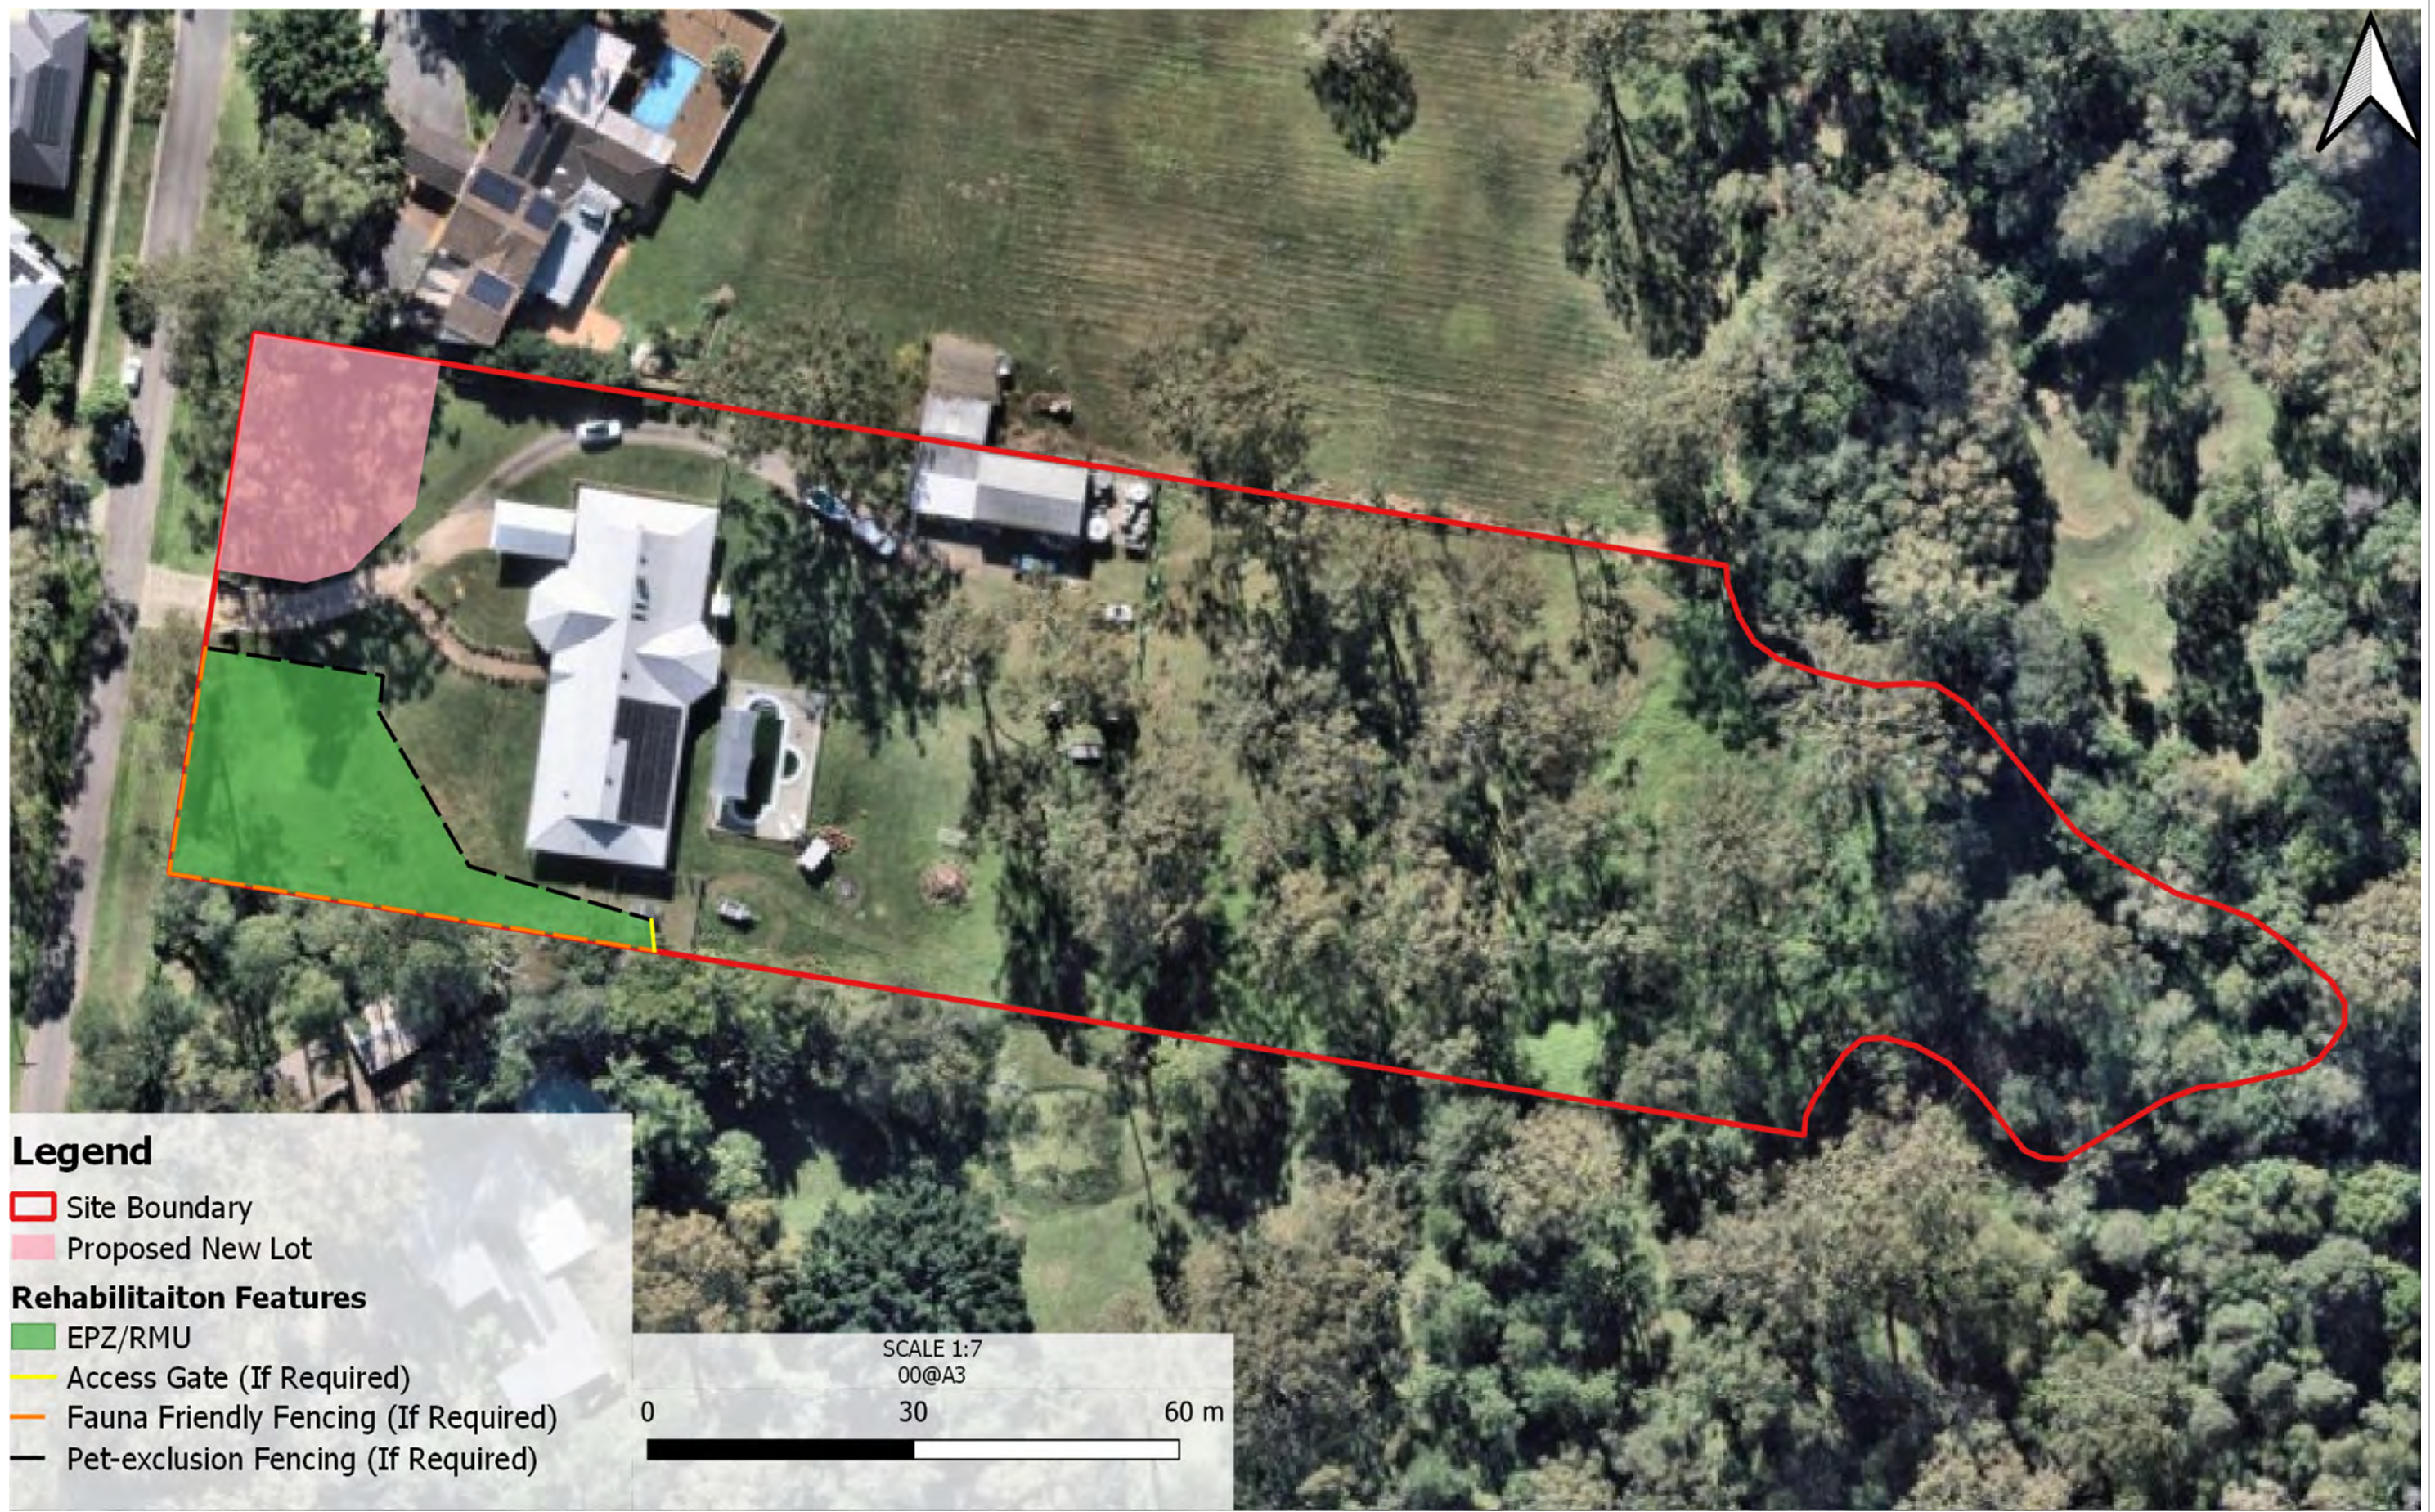
The proposed subdivision is restricted to the north-western corner of the site, with an Environmental Protection Zone (EPZ) to be rehabilitated along the south-western extent of the site as per this CRMP.

The western extent of the subject site adjoins Idonia Street, while the eastern portion backs on to Cabbage Tree Creek, a significant BCC waterway that forms the property boundary. An empty drainage line extends across the site (south to north) connecting a dam, located within the neighbouring lot to the south, to Cabbage Tree Creek, located along the north-eastern boundary of the site. Still water was present within Cabbage Tree Creek during the site inspection however no water was observed within the drainage line and ground-cover consisted predominantly of exotic dyschoriste (*Dyschoriste depressa*) and blue billy goat weed (*Ageratum houstonianum*). The balance of the eastern extent consisted of scattered mature *Eucalyptus spp.* with a managed understorey.

The south-western extent of the site primarily consisted of mowed turf containing three native trees, a spotted gum (*Corymbia citriodora subsp. variegata*) and two broad-leaved paperbarks (*Melaleuca quinquenervia*), while the western boundary was lined with exotic mock orange (*Murraya paniculata*). The establishment of the EPZ will enhance a strategic east-west ecological corridor, identified by BCC, which will become more effective for fauna to connect to the Cabbage Tree Creek north-south ecological corridor.

A maintenance trail is not required as access into the RMU will be possible along the northern extent of the RMU's boundary. If fencing is required along the northern and southern boundaries of the RMU, a self-closing gate as per the specifications for the Brisbane Standard Drawing (BSD) – 7004 is to be installed within the proposed pet exclusion fencing located along the northern extent of the RMU (refer to **CRMP001** for indicative location).

1. If required, Pet exclusion in accordance with BSD 7004 fencing is to be erected along the northern boundary of the RMU (refer to page **CRMP001** for fence location);
2. Pet exclusion fencing must be at least 1.5m high, and must be continuous with no gaps greater than 50 mm;
3. Metal sheeting and corrugated iron fencing must be capped;
4. Pet exclusion fencing must include a self-closing access gate to allow future access for maintenance. An indicative location has been shown on Page **CRMP001**.
