# Management (Identification) Survey *Asbestos Survey Report*

**10059445-C1**

16 Twenty Fourth Avenue, Brighton QLD 4017

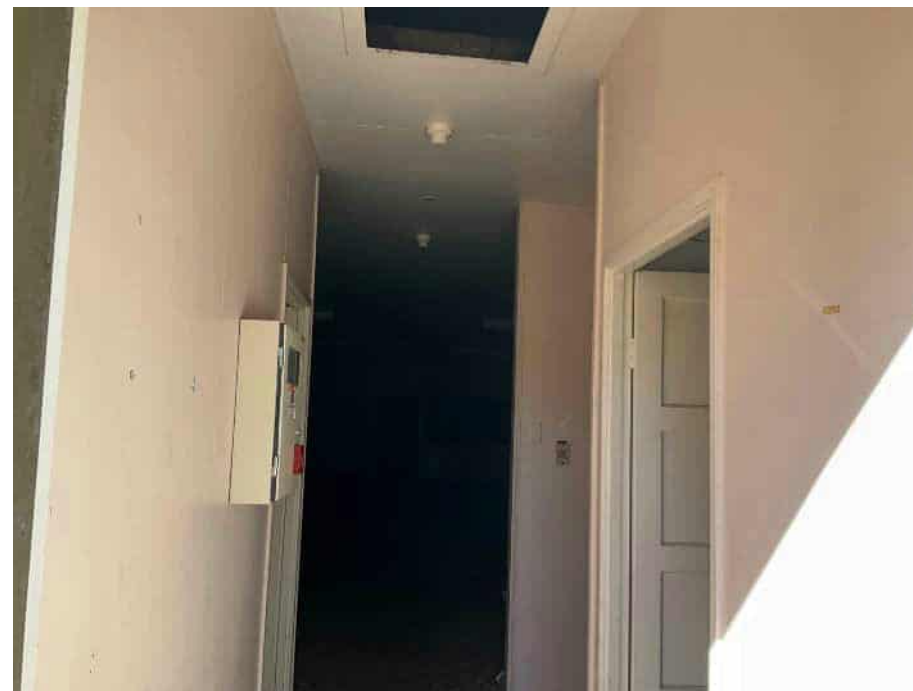
Entry foyer walls

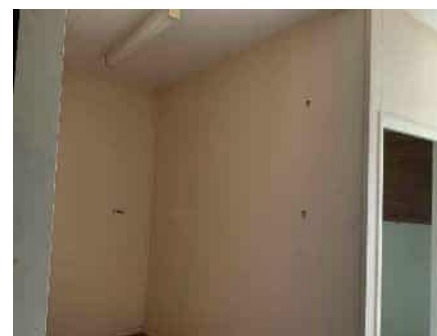
Entry foyer walls

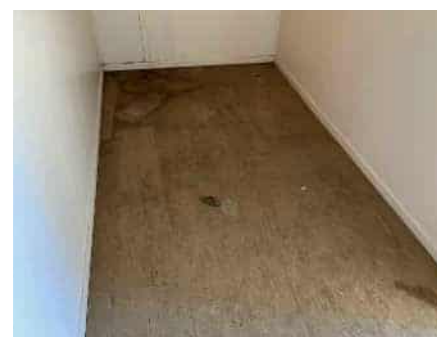
Vonyl floor sheeting

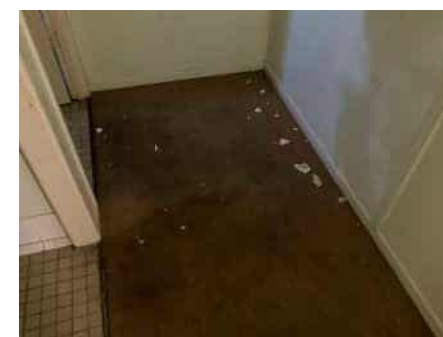
Vonyl floor sheeting

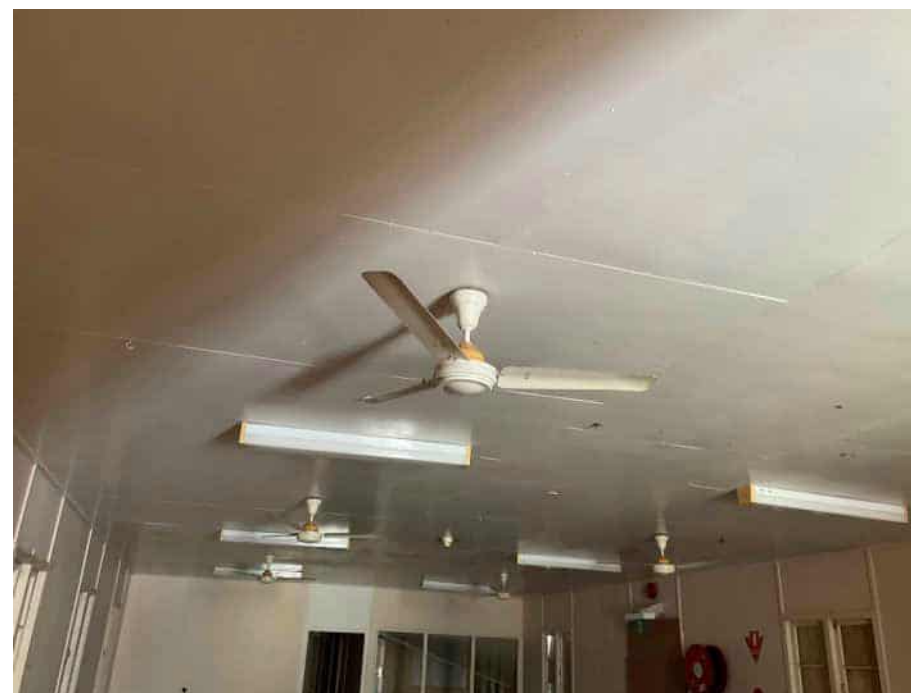
Main hall ceiling

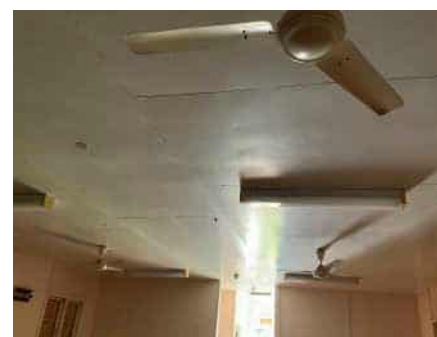
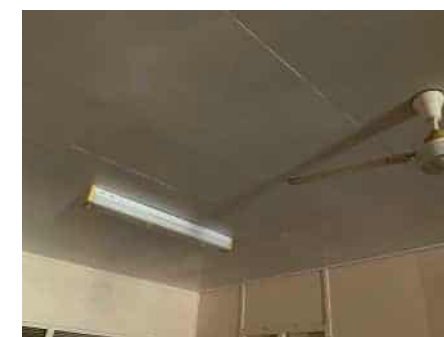
Main hall ceiling

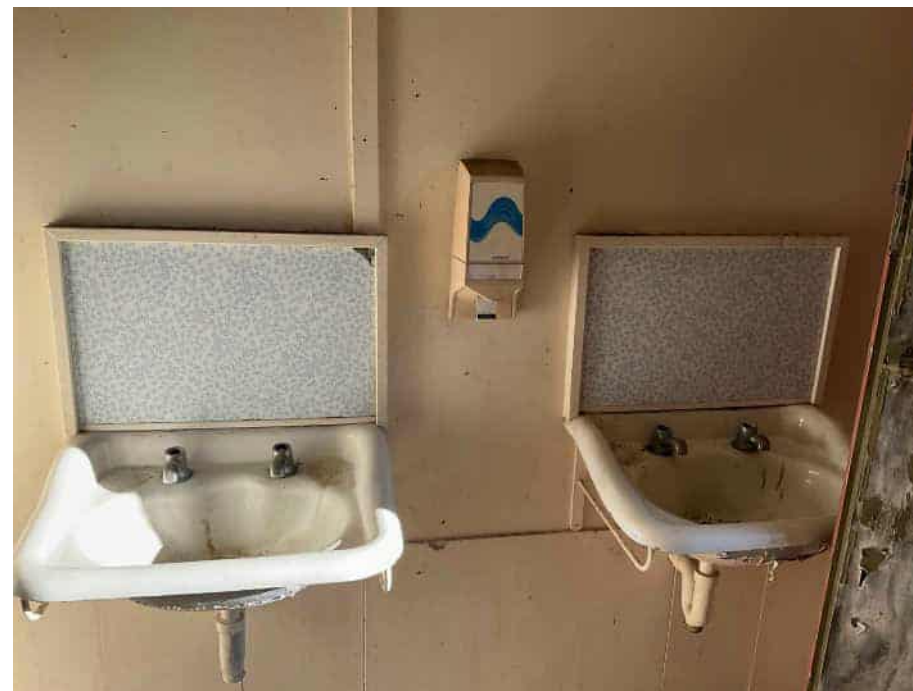
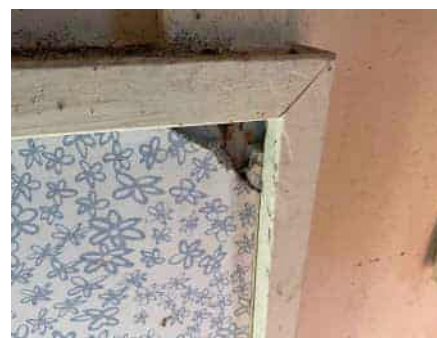
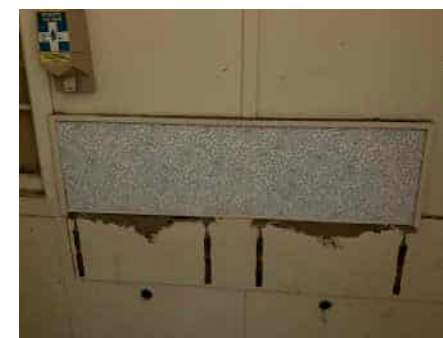
Entryway splash backs

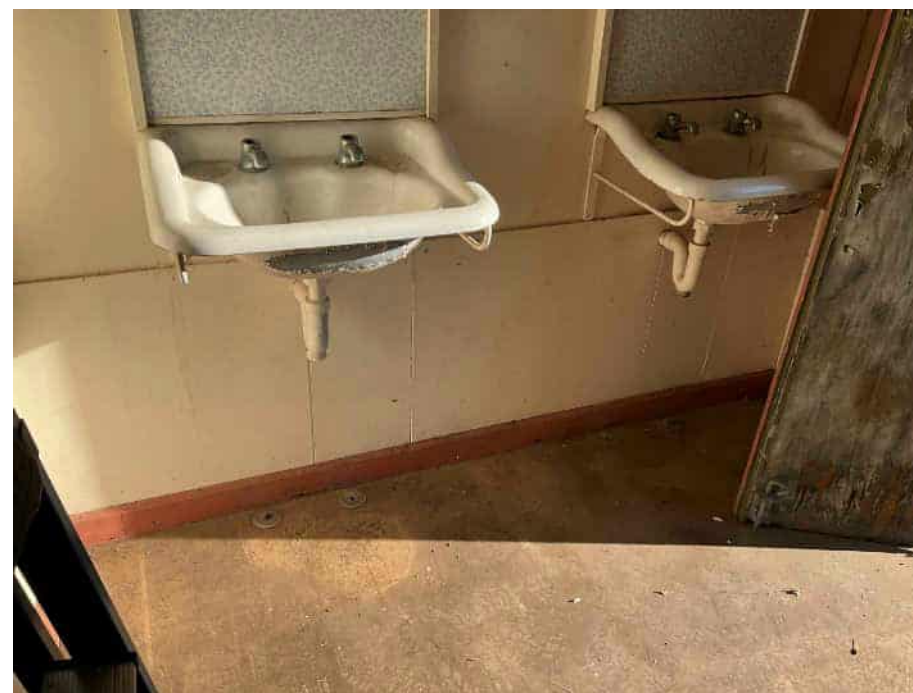
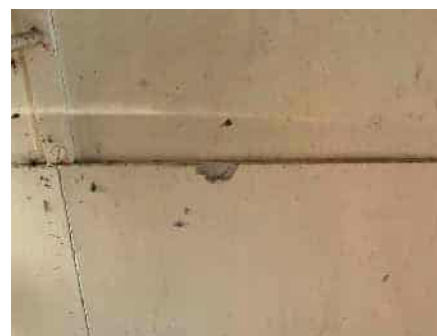
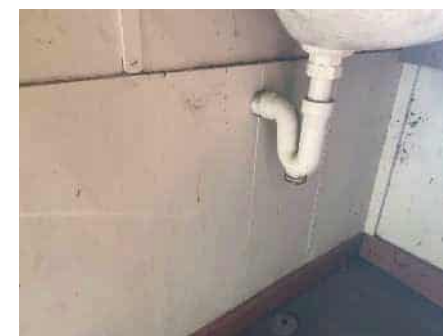
Entryway infill panels

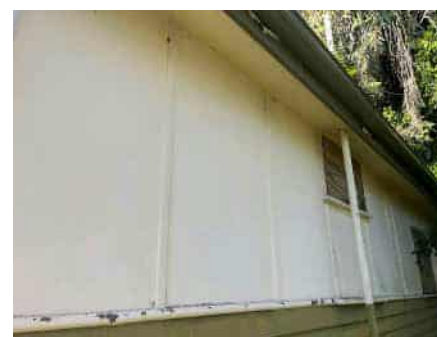
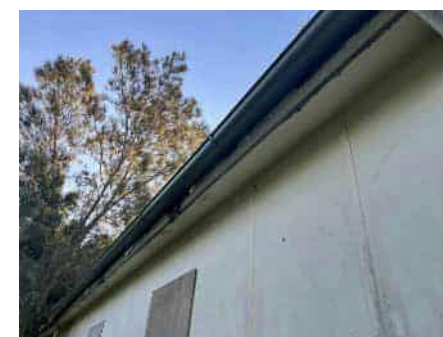
Soffits overview

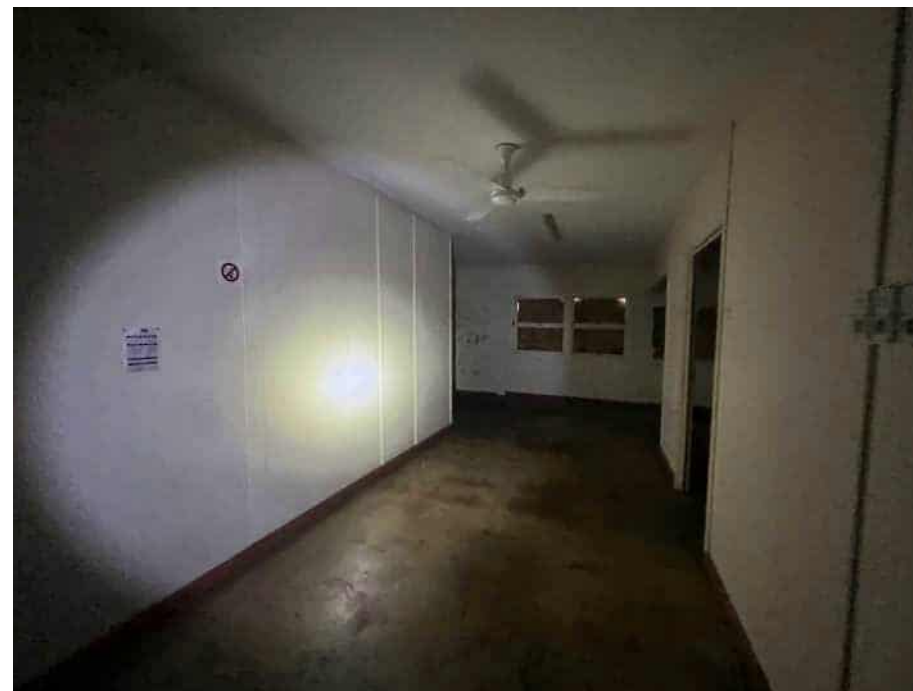
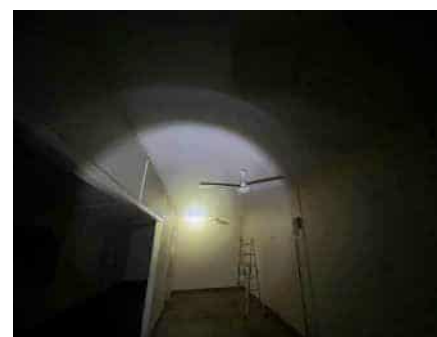
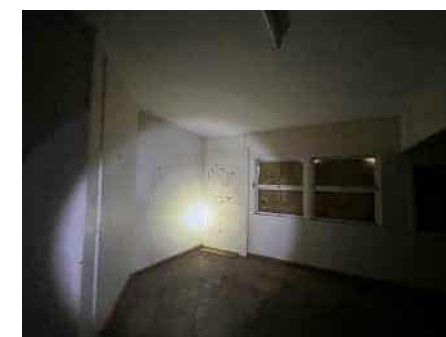
Main room walls

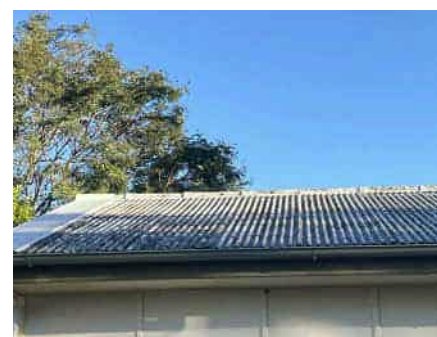
Roof sheeting is degraded, contamination of the gutters from the roof sheeting is presumed and would be removed during asbestos roof removal.

Roof sheeting
